Blackberry Torch 9800 Replacing rear camera

This guide will help you replace a not working camera on a Blackberry Torch 9800 phone. Making any physical change to this phone will void the warranty.

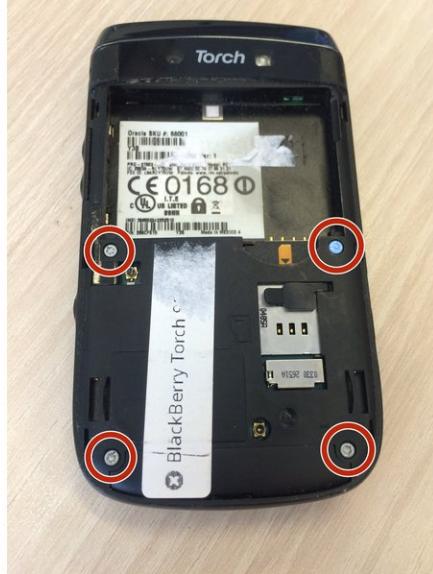
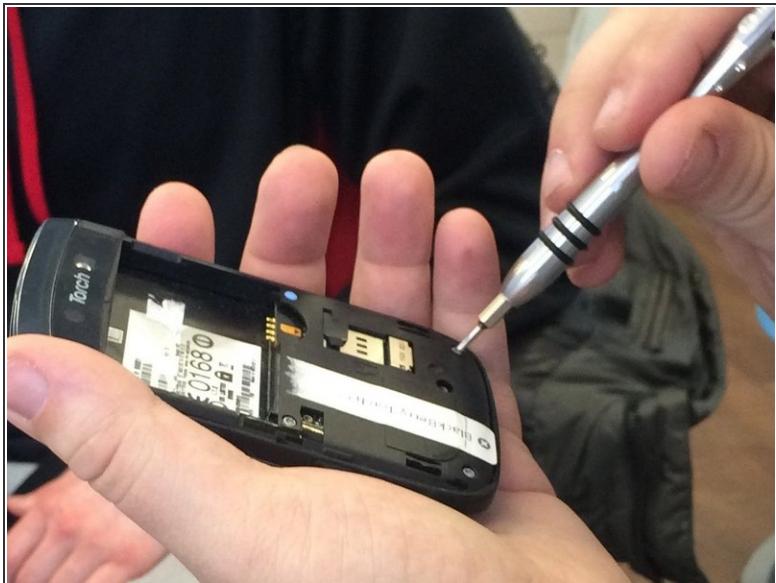
Step 1 — Replacing rear camera

- Remove the back cover and the battery.
- Remove the four exposed screws using a T7 screwdriver.
- Warning: Removing the top right screw (with the blue cover) will void the warranty.

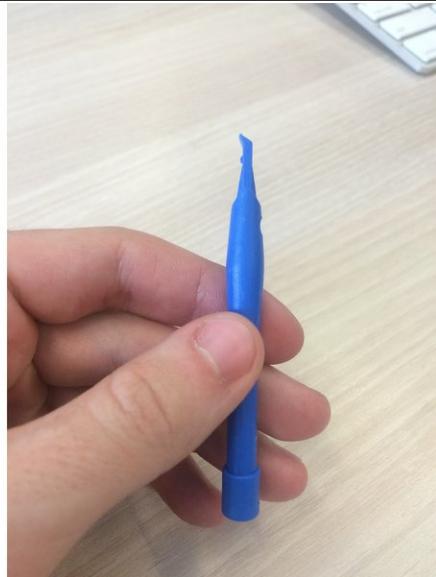
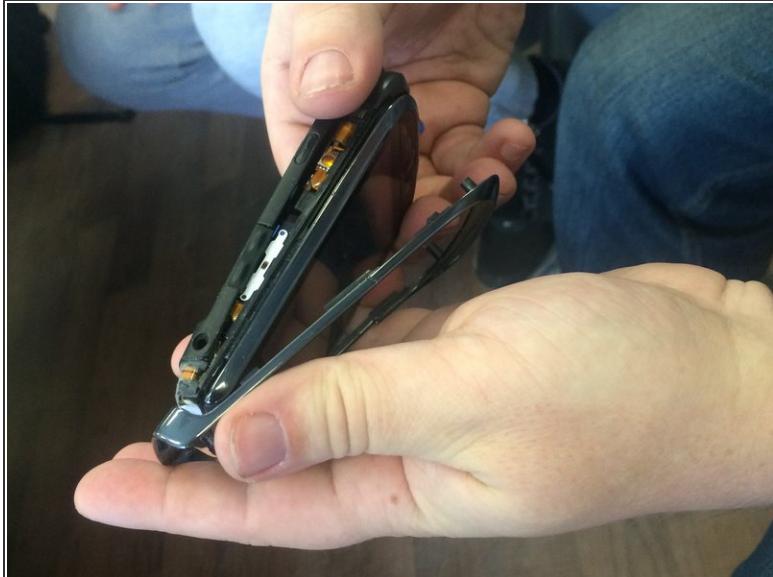
Step 2

- Remove the side trim using the plastic opening tool.
- When loose, push the top backwards and the bottom forwards to remove.

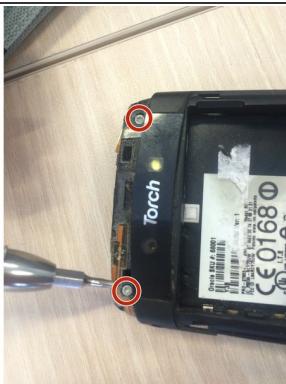
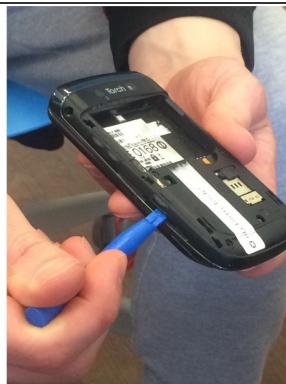
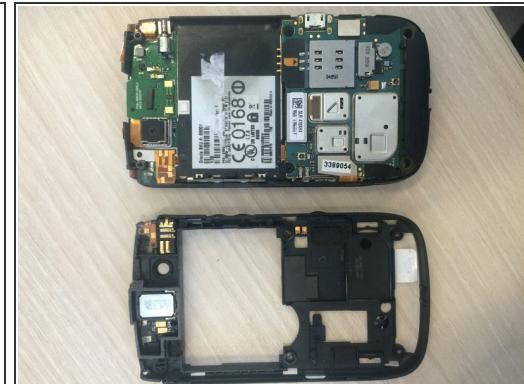
Step 3

- Two new screws have been exposed near the top of the back.
- Remove the two screws using the T7 screwdriver.
- Remove the back panel using the plastic opening tool.

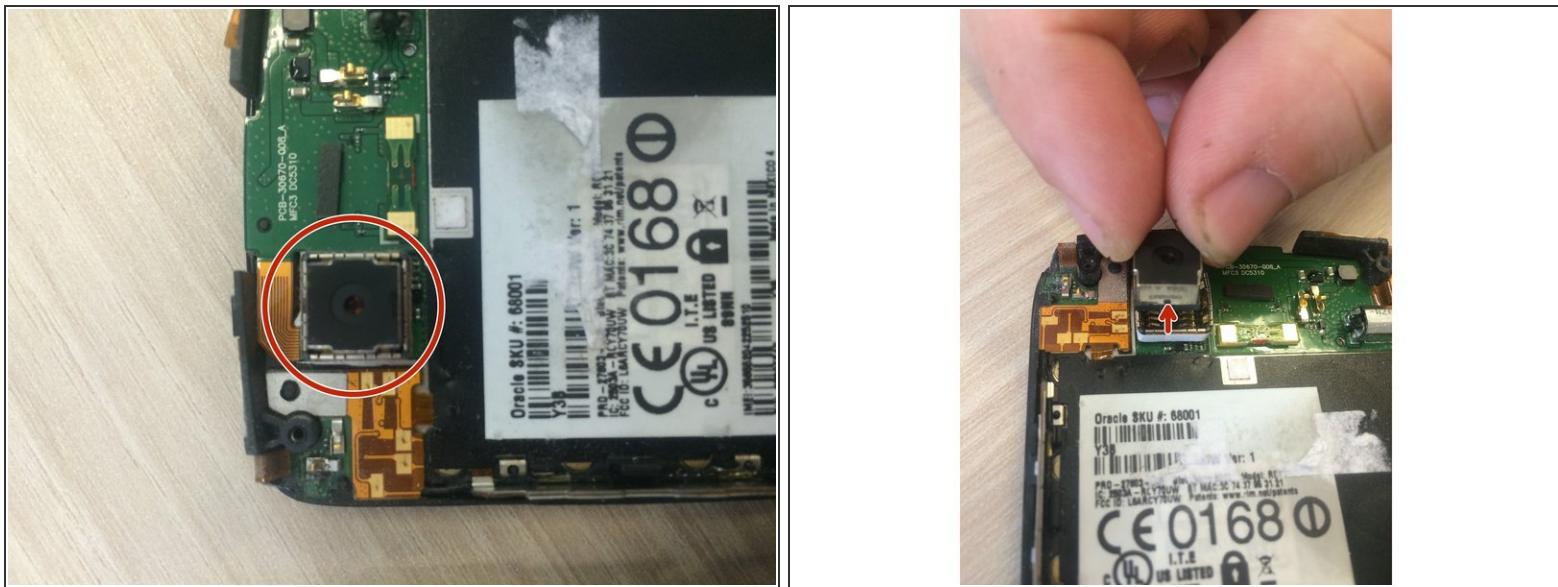
Step 4

- Carefully use flathead screwdriver to free camera sensor.
- Wiggle on the right and left sides, not the top and bottom sides.

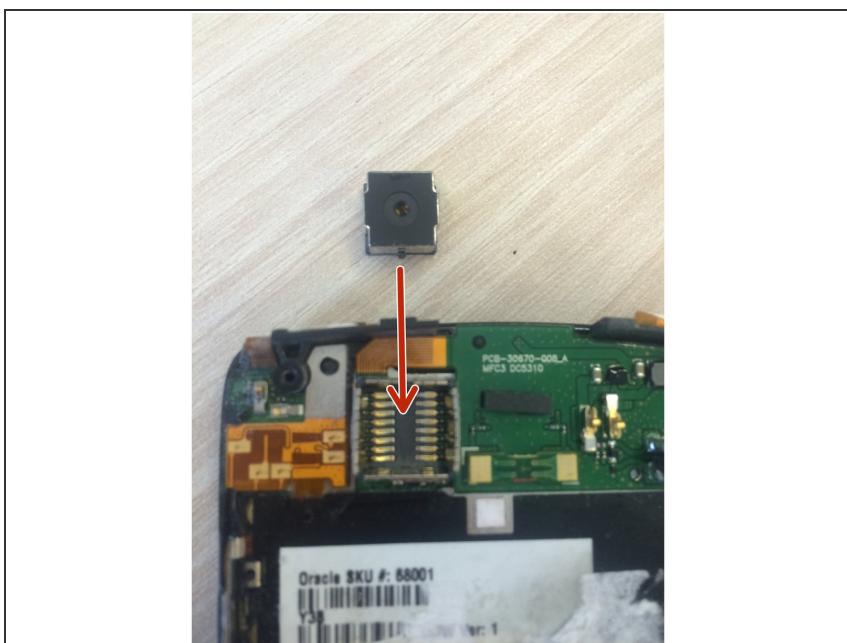
Step 5

- To install the new camera sensor, place in slot. Reassemble phone by doing steps 1-3 in reverse order.
