Canon Vixia HF R500 Speaker Replacement

This guide will help you replace your broken or damaged speaker in your device.

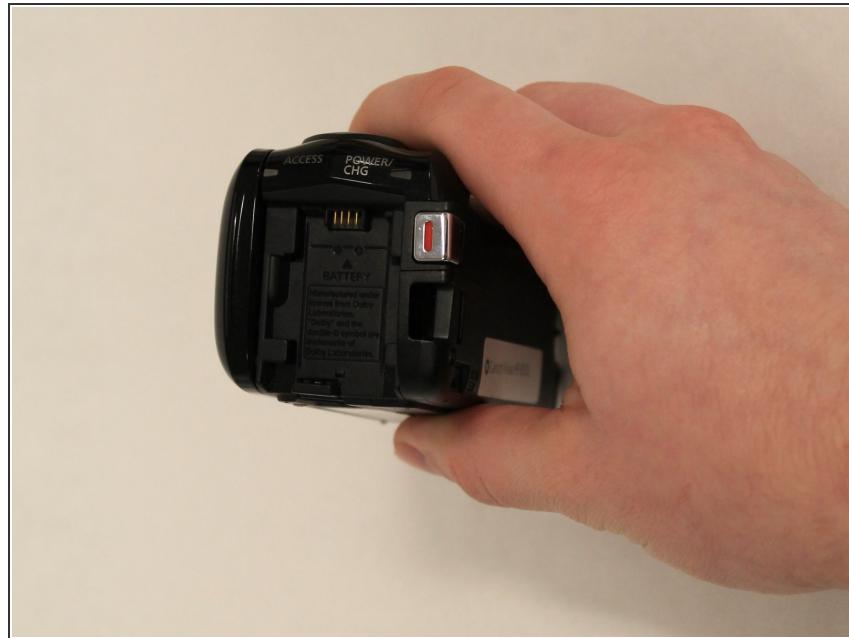
Step 1 — Battery

- Hold on to the battery.

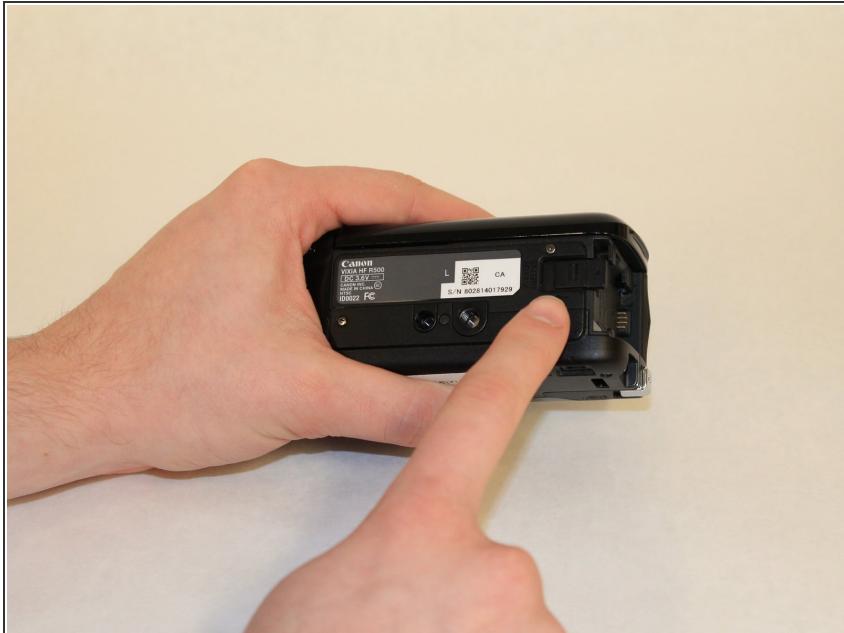
Step 2

- On the bottom of the battery hold the battery release switch.

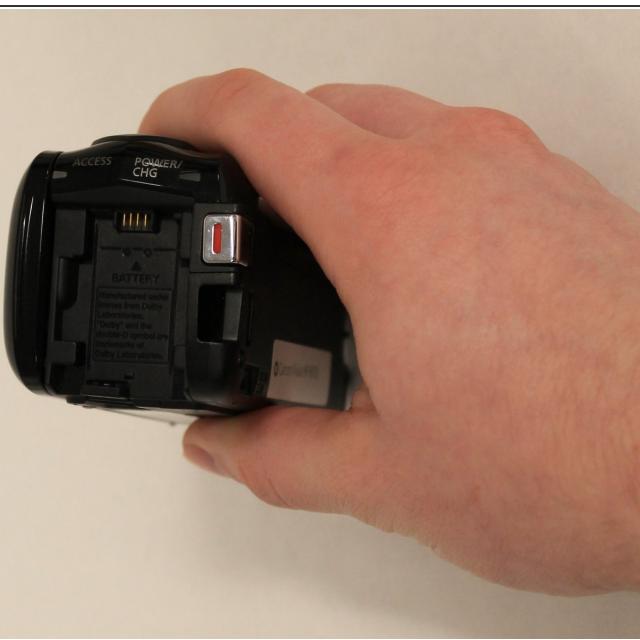
Step 3

- Remove the battery slowly away from the camcorder.

⚠ Removing the battery quick or in a different angle may cause sparks and damage to device.

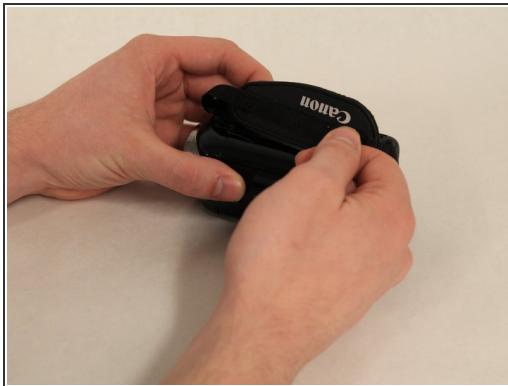
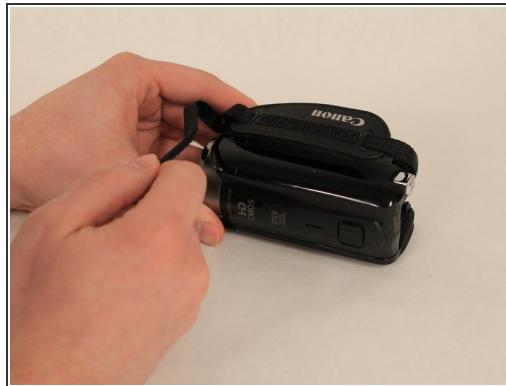
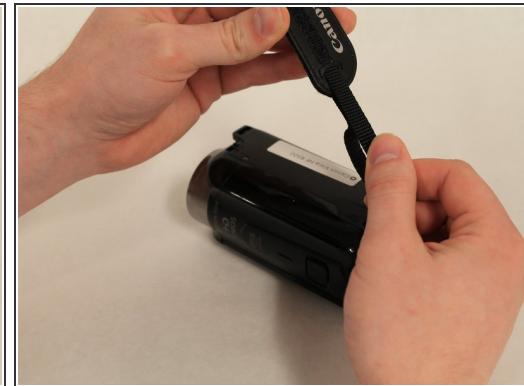
Step 4 — Grip Belt

- On the right side of the camcorder remove the grip belt.

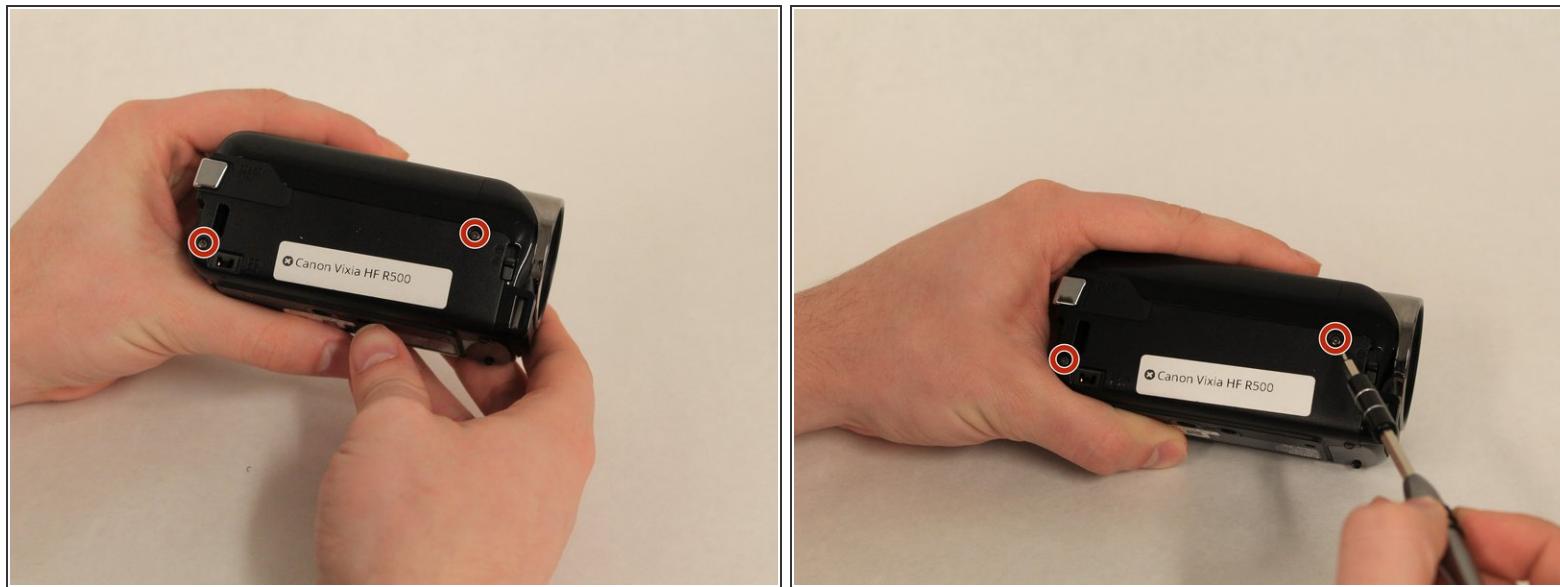
Step 5 — Canon Vixia HF R500 Disassembly

- Remove the two 8mm Philips #000 screws on the side where the grip belt was located on.

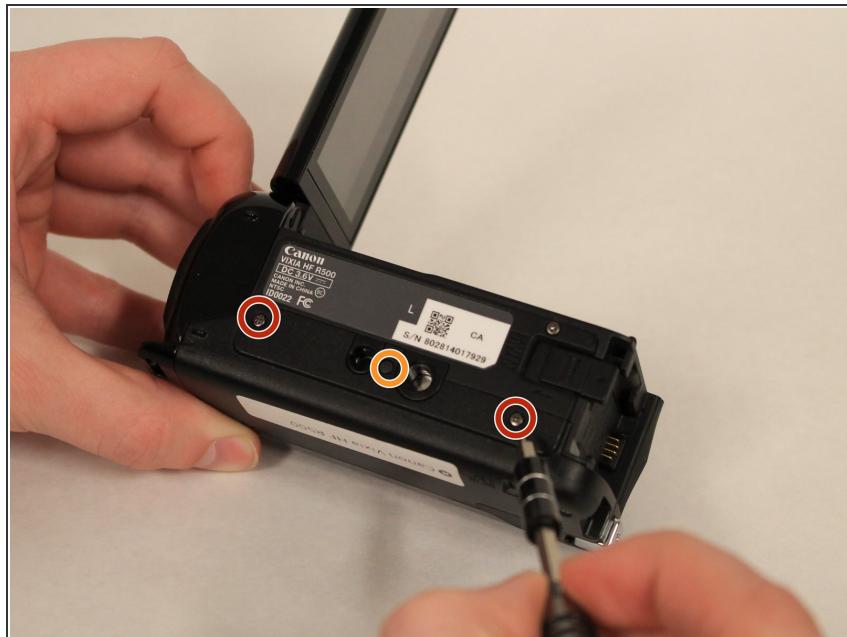
Step 6

- Remove the two 4mm Philips #000 head screws from the bottom of the camcorder.
- A hidden 4mm Philips #000 screw is shown under the black plug shown.

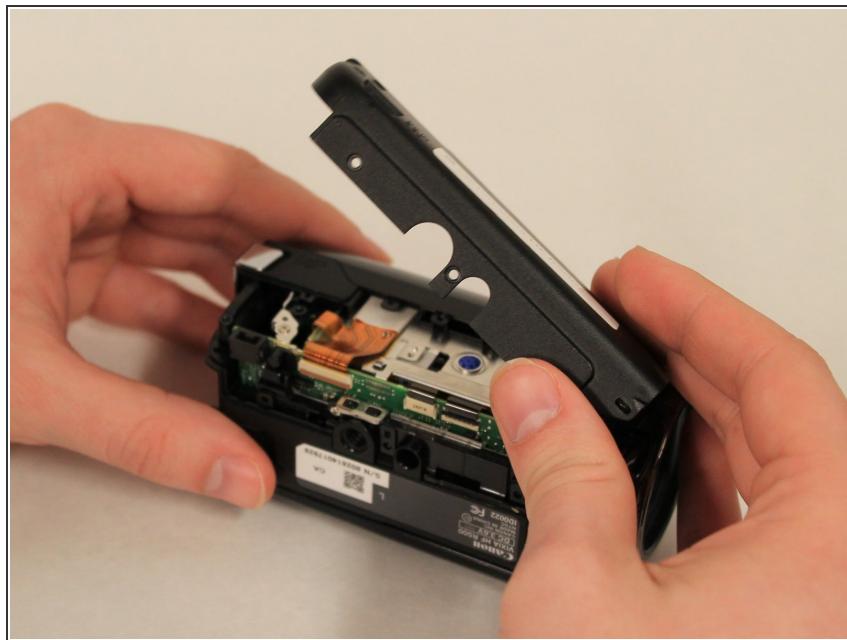
Step 7

- Remove the side piece plate.

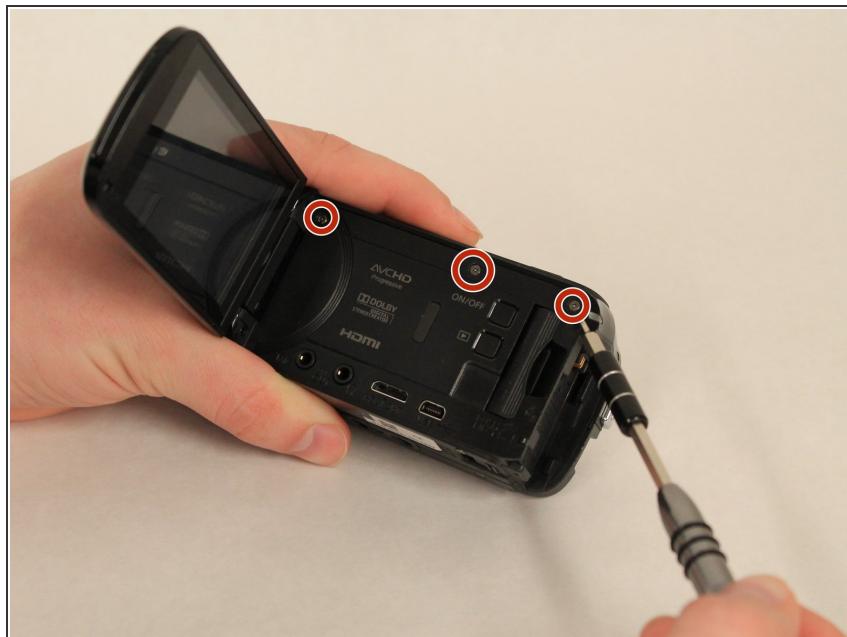
Step 8

- Near the LCD screen, remove the three 7mm Philips #000 screws in the picture shown.

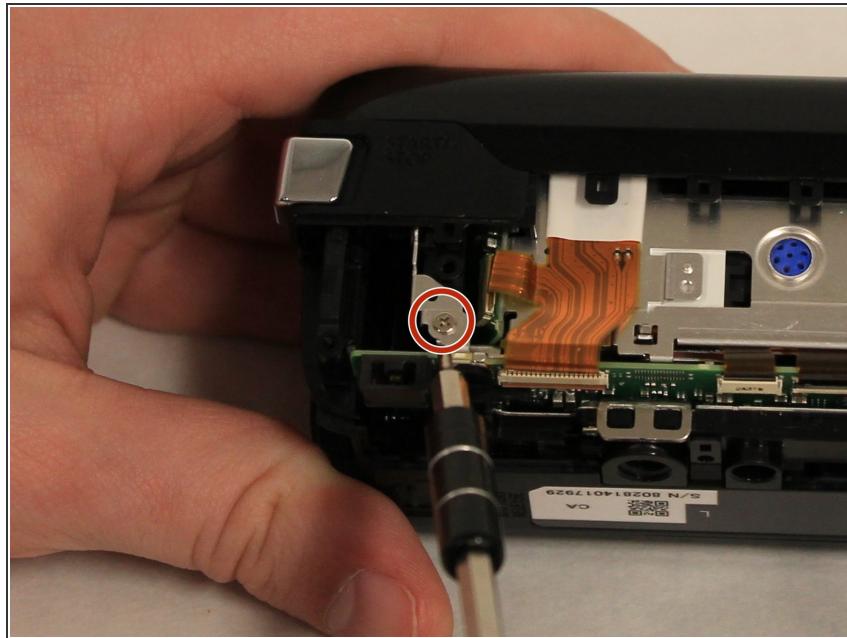
Step 9

- Carefully place the camcorder where the inside of the device is facing upwards and remove the 3mm Philips #000 screw shown.

Do not use strong magnetic parts on the inside, as they may damage the device.

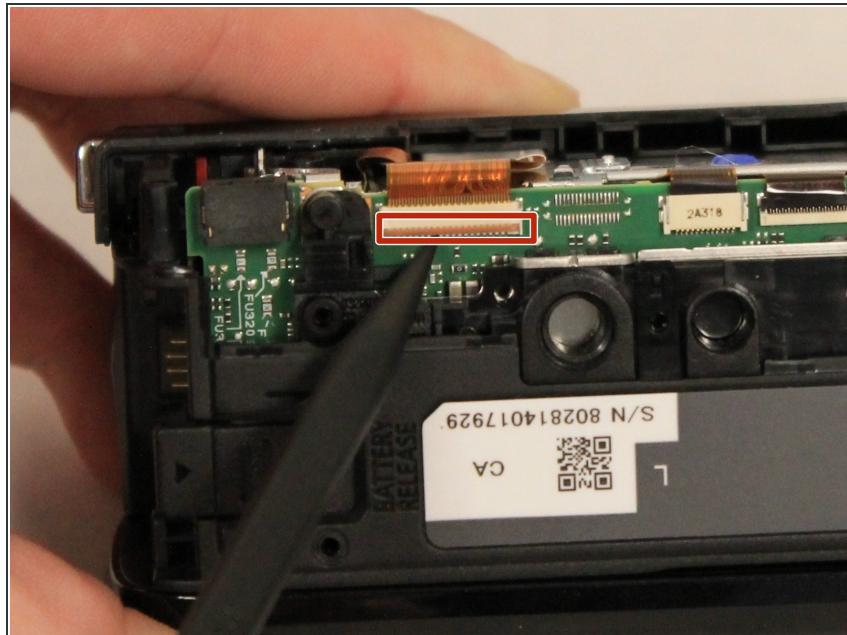
Step 10

- Using the spudger, pull the tab shown to start removing the ribbon cable.

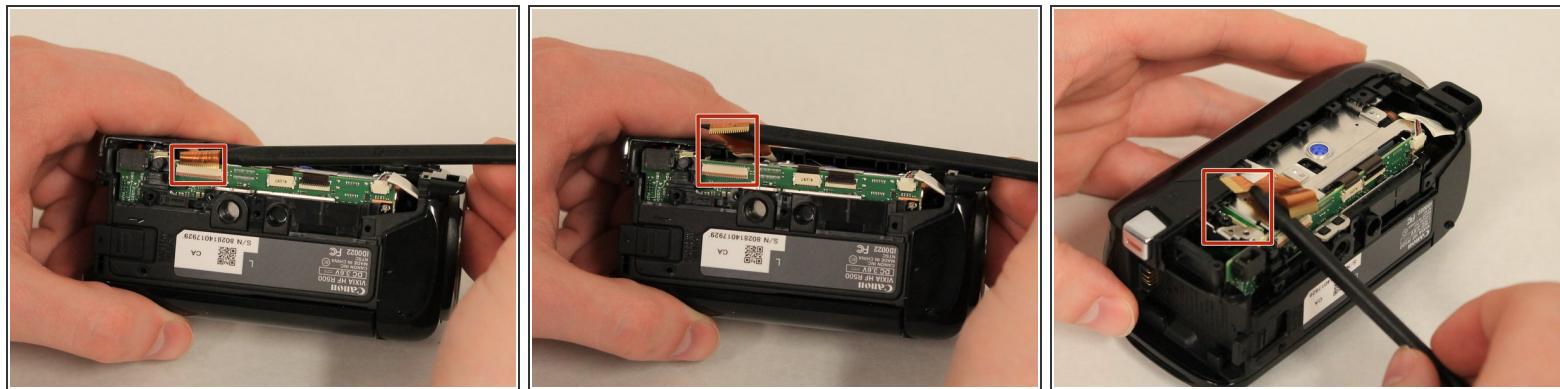
Step 11

- Using the Spudger, carefully remove the two ribbon cables that are connected to the top of the device.

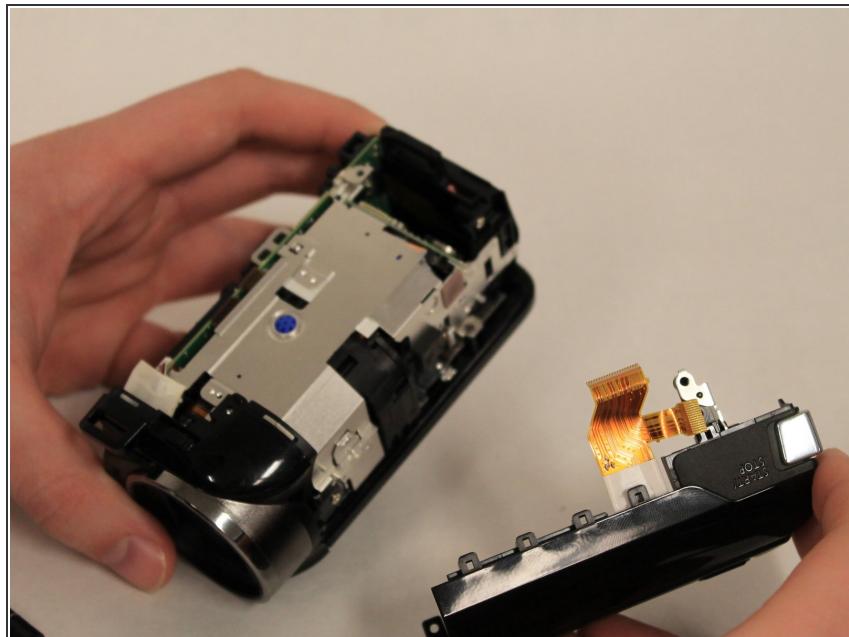
Step 12

- Remove the top piece.

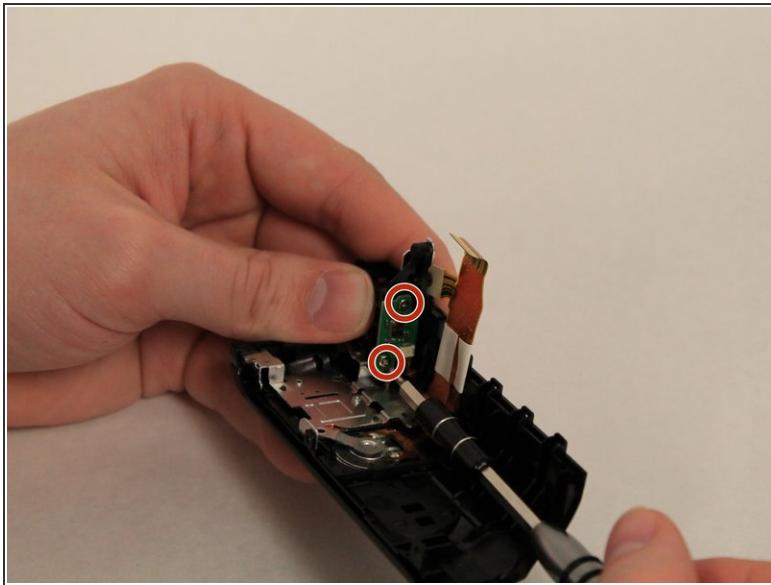
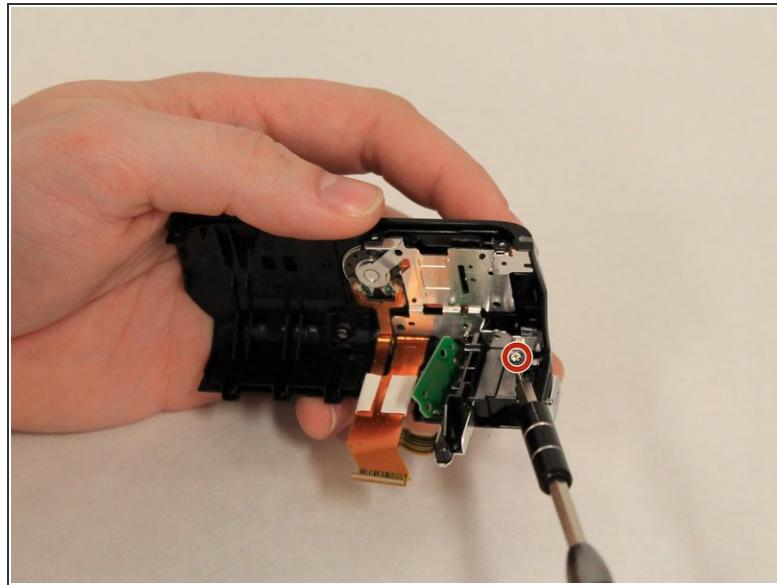
Step 13 — Speaker

- Remove the three 6mm Philips #000 screws holding the black record piece.

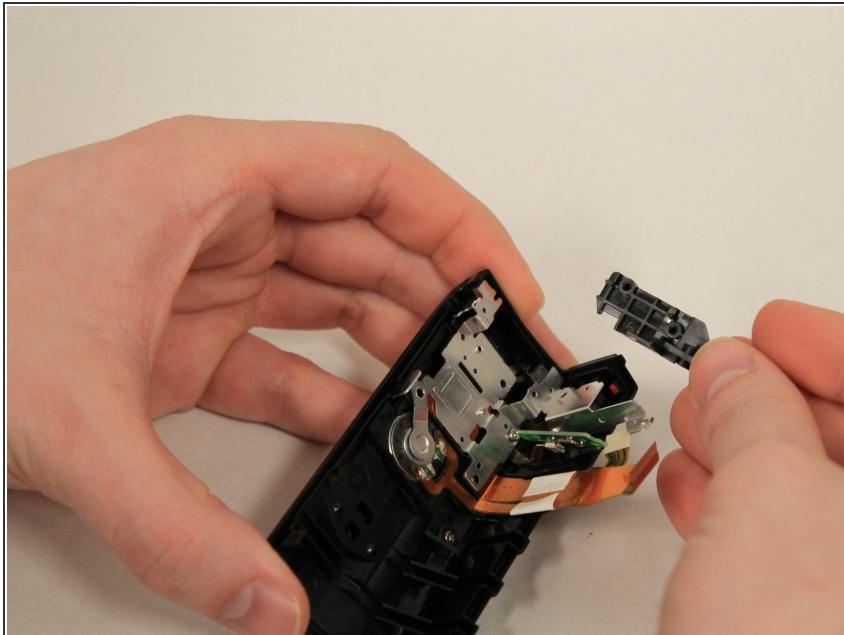
Step 14

- Remove the black record piece.

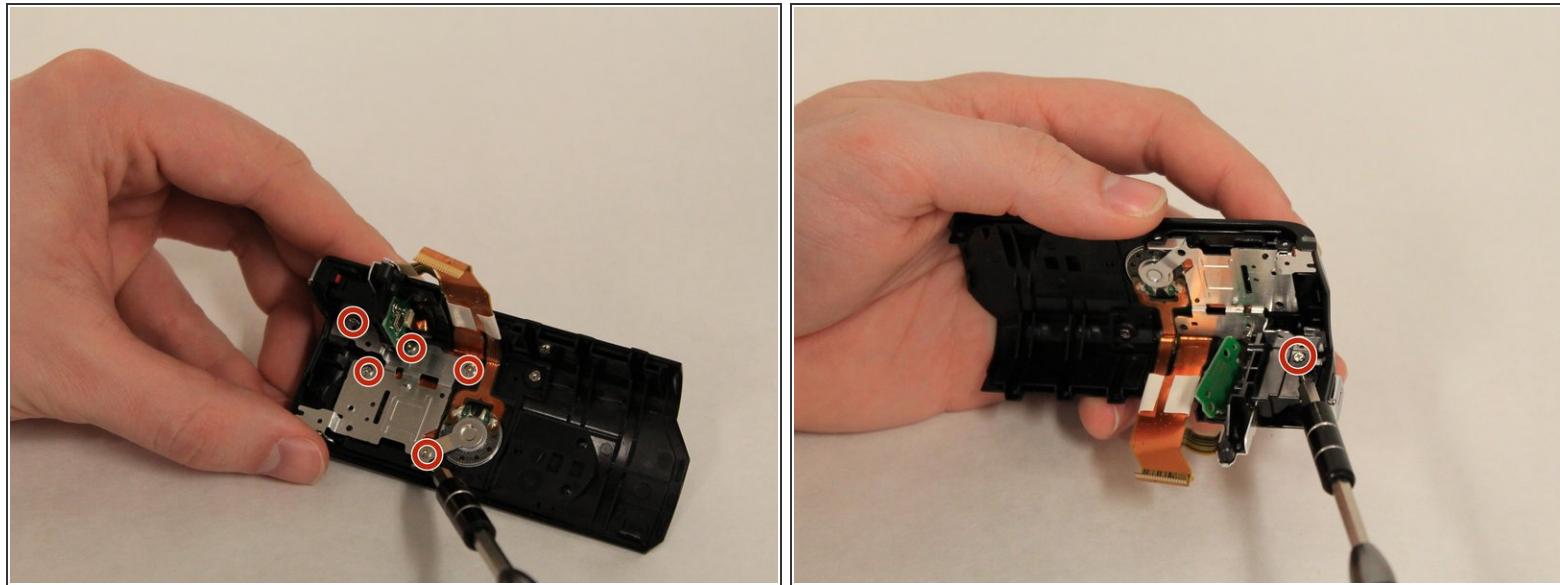
Step 15

- Holding the full top piece remove the six 5mm Philips #000 screws holding the metal frame to the top piece.

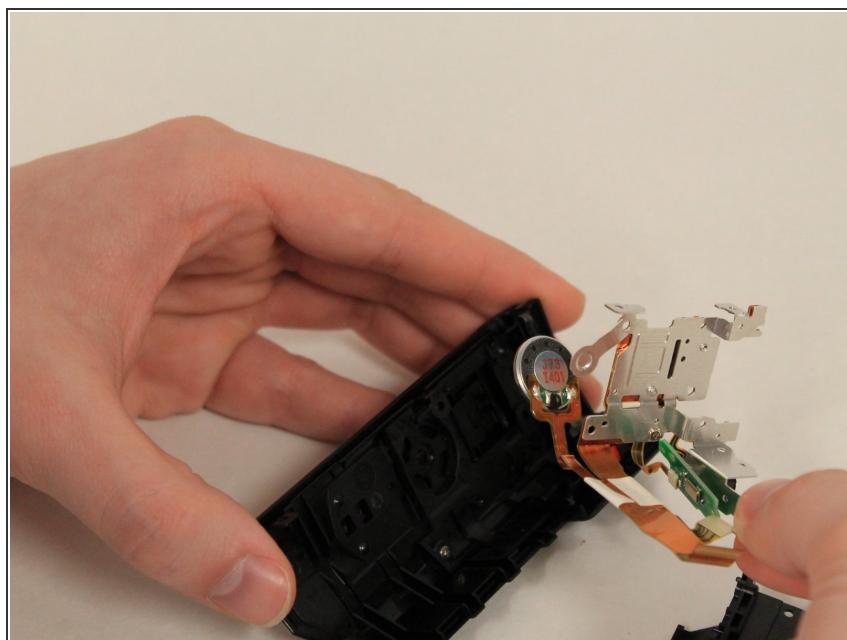
Step 16

- Carefully remove the the whole metal frame out of the device piece.

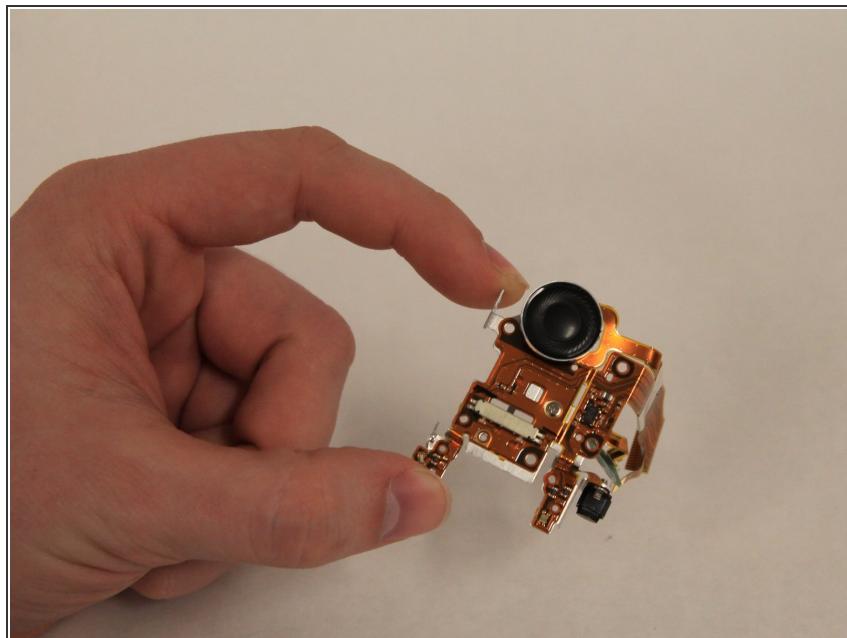
Step 17

- Replace the defective speaker with a functioning one.

To reassemble your device, follow these instructions in reverse order.
