Casio G'zOne Commando Verizon MIL-SPEC

Camera Replacement

In this guide, we will be replacing the camera on the rear side of the Casio G'zOne Commando Verizon MIL-SPEC with a brand new one.

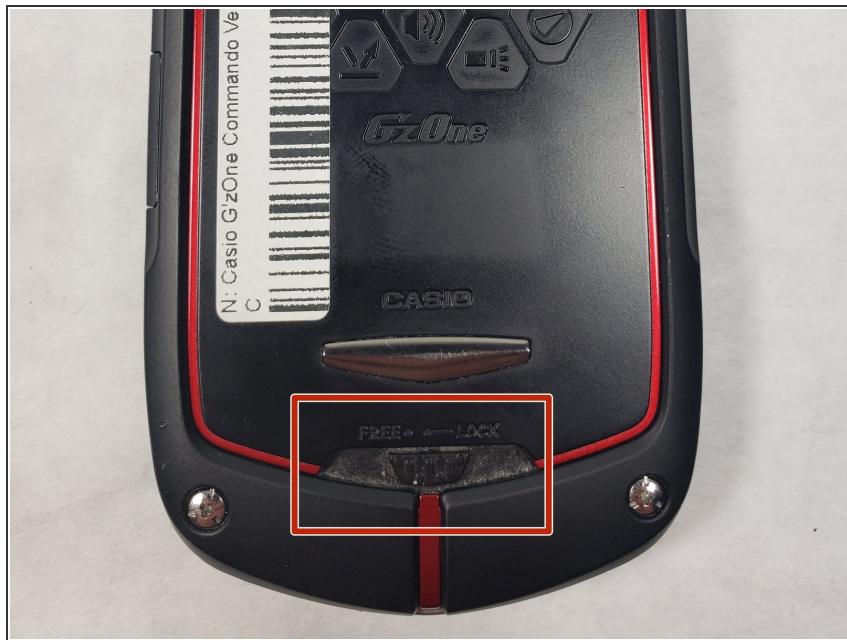
Step 1 — Battery

- Slide the slider on the back of the phone to the free position.

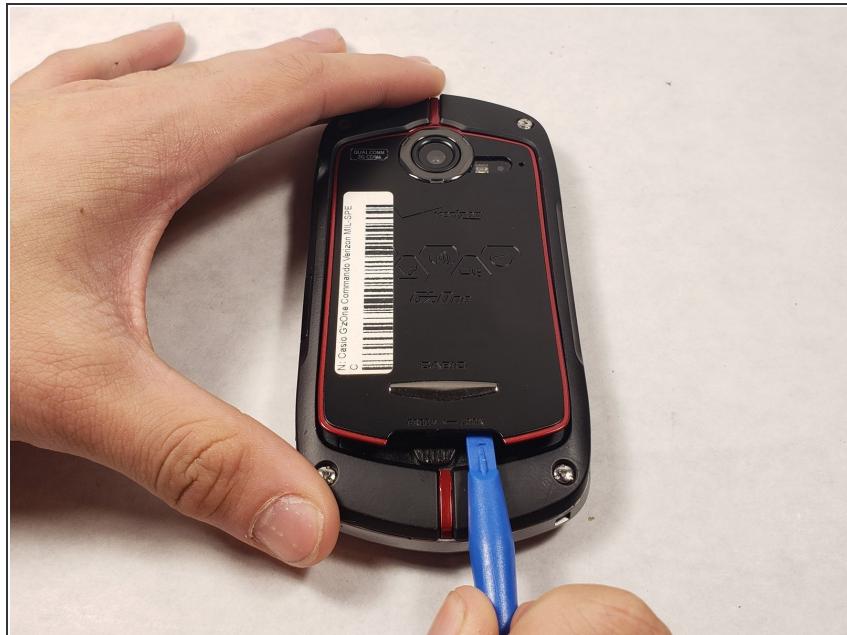
Step 2

- Using a plastic opening tool, gently lift open the back panel from bottom of the panel.

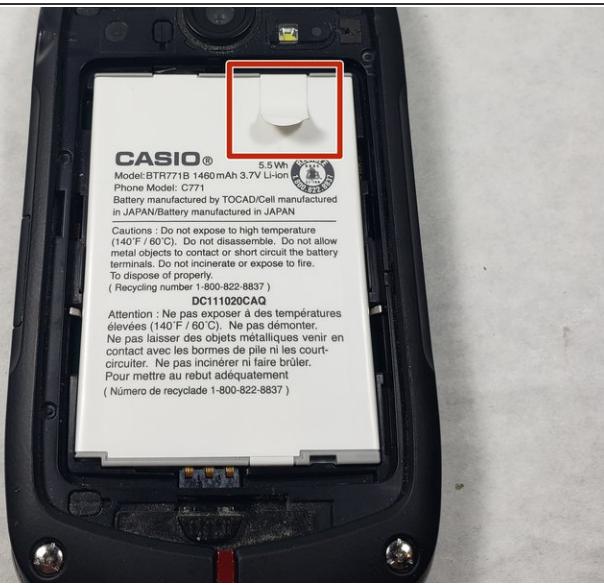
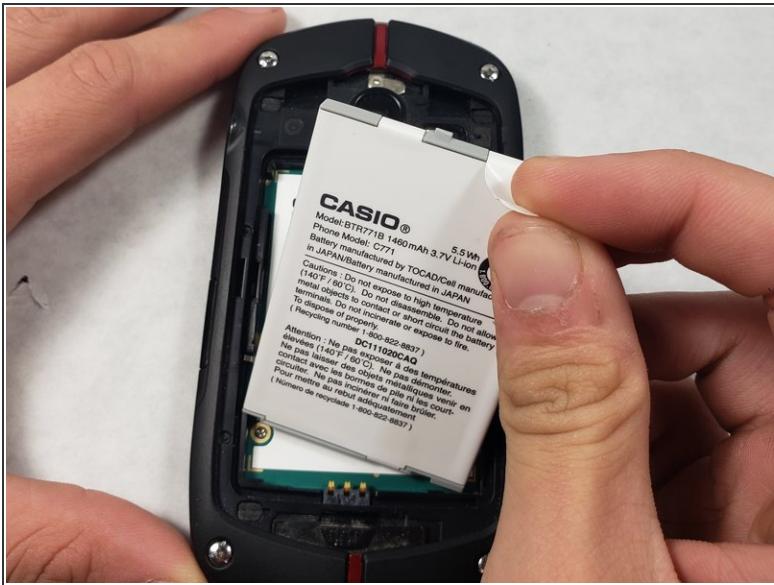
Step 3

- Pull the white battery tab upwards and remove the battery.

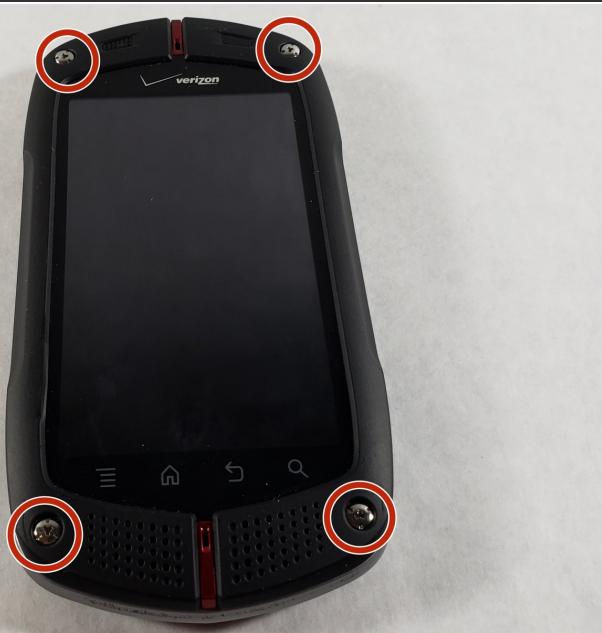
Step 4 — Motherboard

- Remove the four 6mm Y0 screws from the corners of the device.

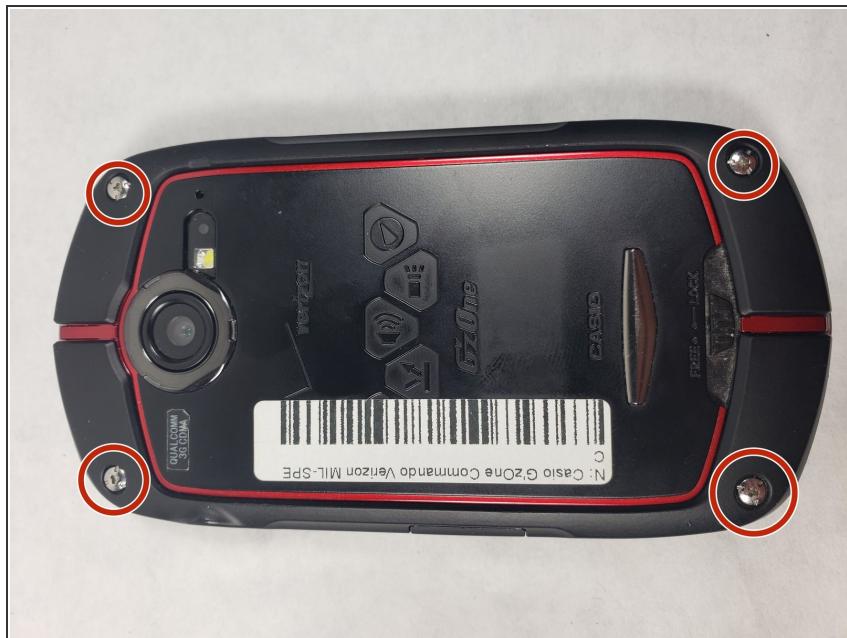
Step 5

- Remove the four 5mm Y0 screws from the back of the device.

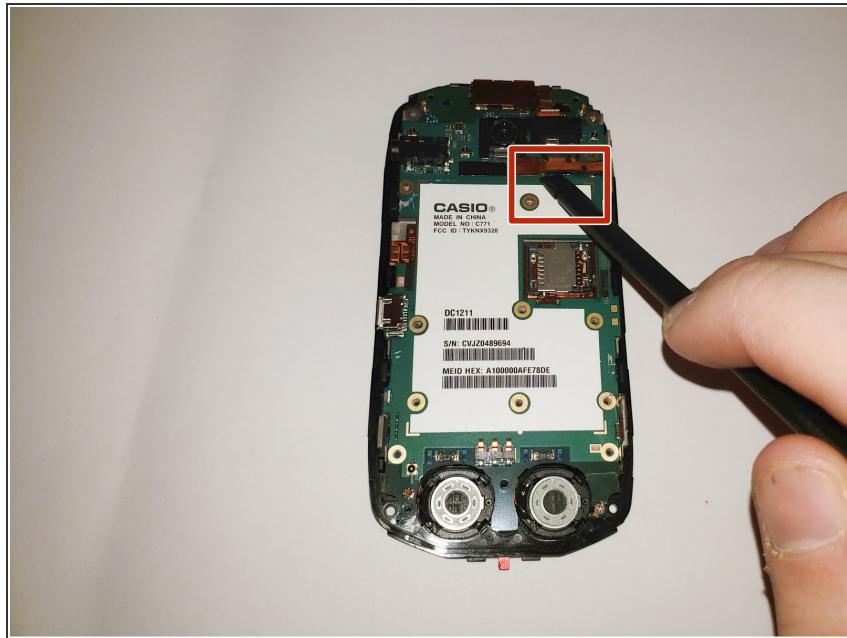
Step 6

- Using a spudger, pry away the motherboard from its compartment, by inserting the spudger in the compartment and lifting upwards until fully out.

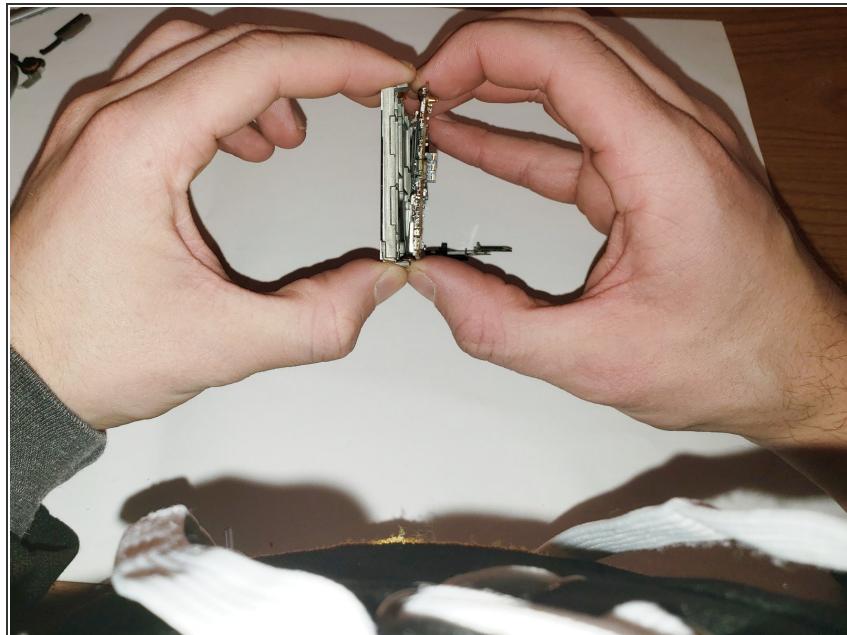
Step 7

- Lastly, using your hands, separate the motherboard from its compartment.

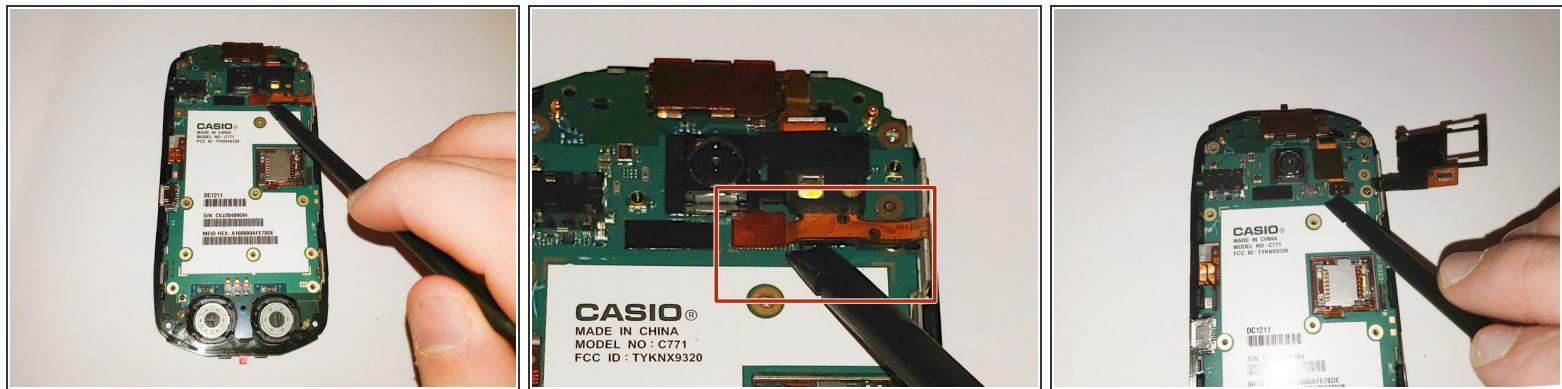
Step 8 — Camera

- Using a spudger, gently lift up the orange connector.

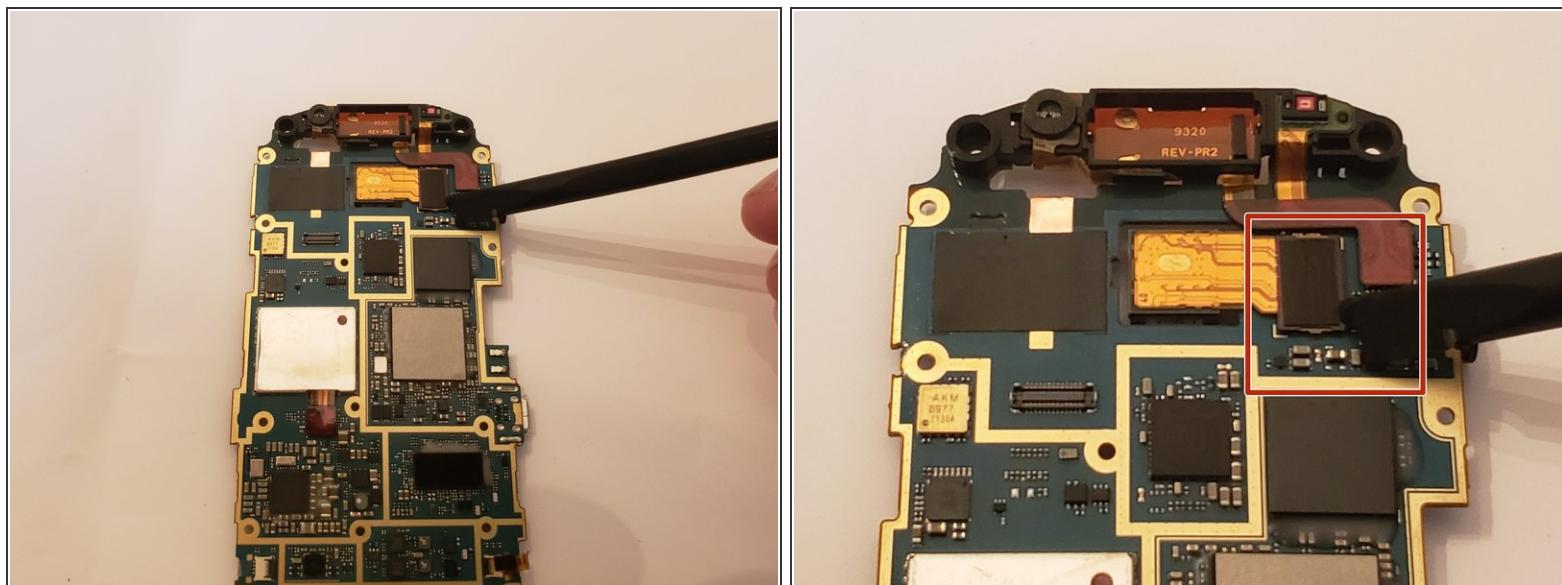
Step 9

- Flip over the motherboard
- Using a spudger, lift up the small black connector and remove the camera.
