Cobra SPX 5300 Audio Dial Replacement

Replace your audio dial if you are having problems with audio distortion in the Cobra SPX 5300.

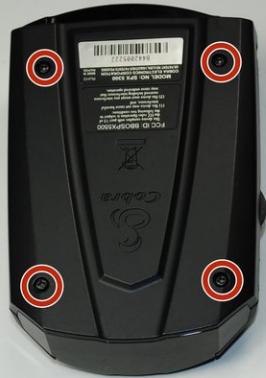
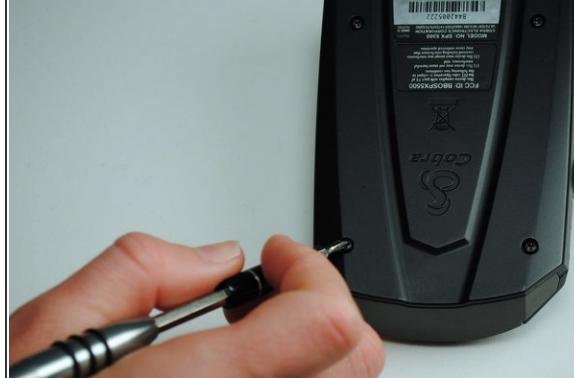
Step 1 — Windshield Bracket Mount

- Remove the four 9.5 mm Phillips #0 screws from the back of the device.

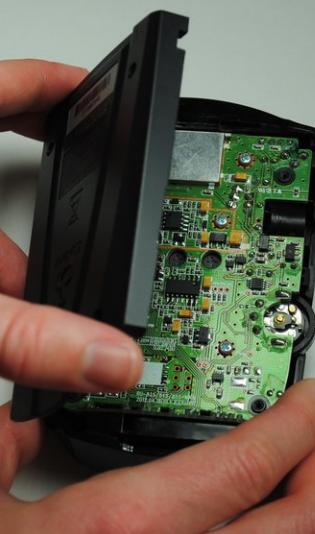
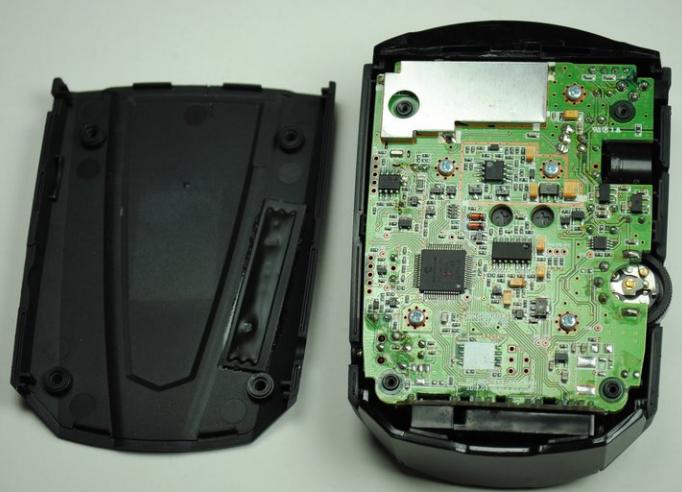
Step 2

- Pull the black plastic back case off of the device.

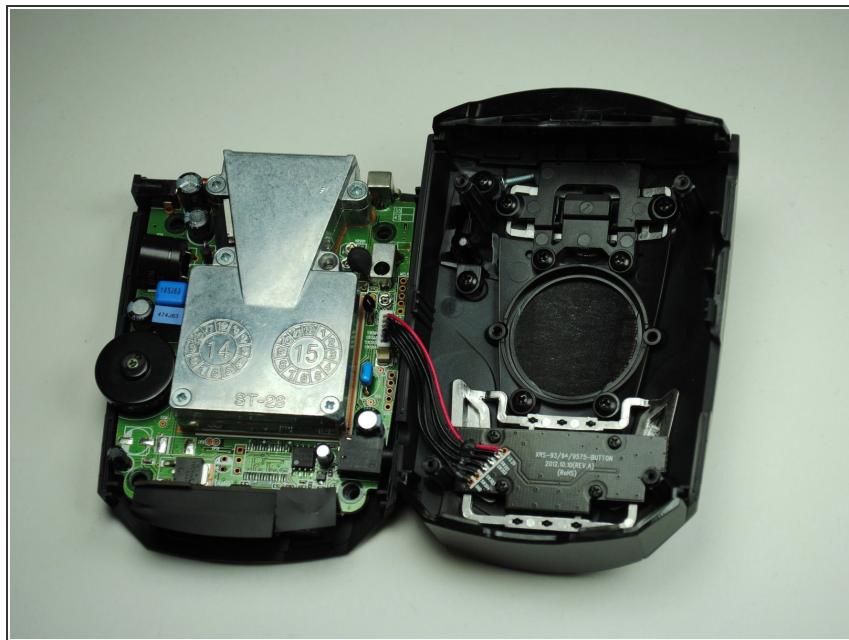
Step 3

- Lift up the motherboard and lay it flat next to the device.

⚠ Be careful not to sever the wires. The buttonboard is connected to the motherboard by the wires.

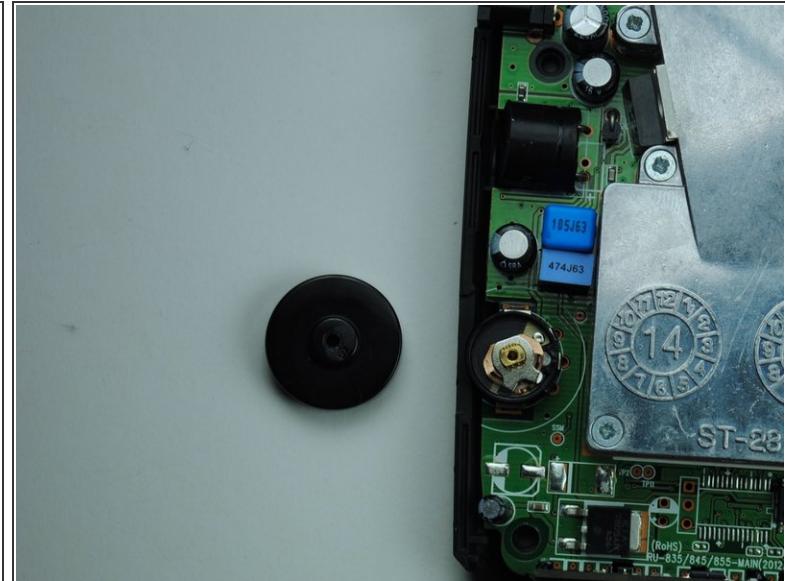
Step 6

- Remove audio dial.

To reassemble your device, follow these instructions in reverse order.
