# Dell Chromebook 11-3120 Bottom Base Cover Replacement

Replace the bottom base cover of a Dell Chromebook 3120

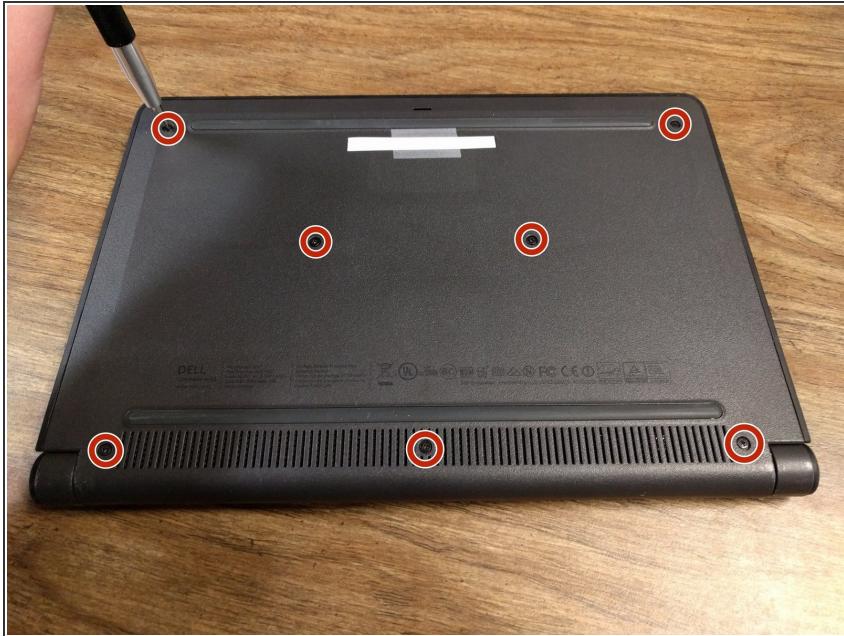
## Step 1 — Remove screws

- Flip the device over so the bottom is facing up
- Remove the 7 visible Philips screws from the device's bottom cover

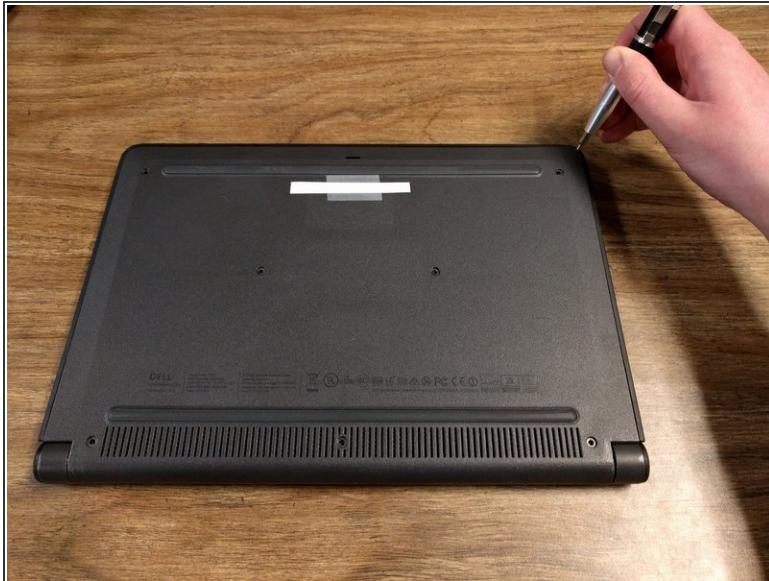
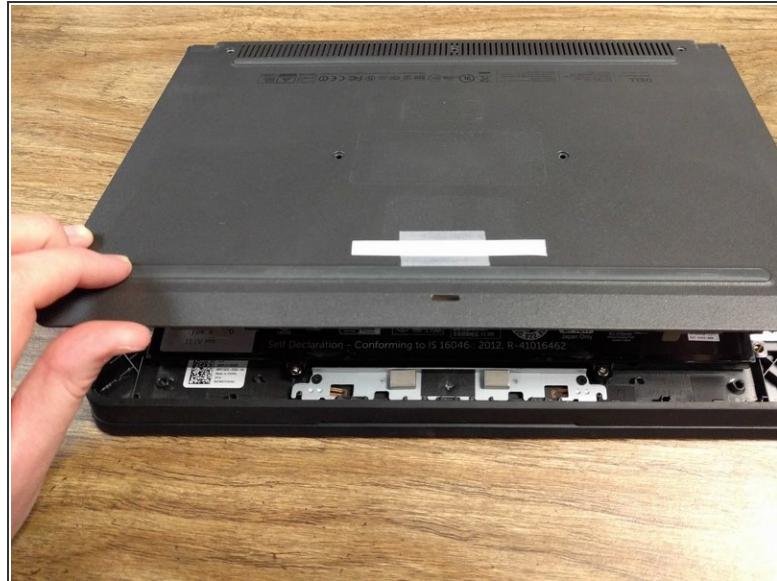
## Step 2

- Insert a thin prying tool into the front (facing the user) corner between the rubber bumper and the plastic case to pop several latches.
- Starting from the partially-opened corner, pull the case away from the device in a hinging motion. I rotated the computer so that the opened corner faced me in the image.
