Dell Latitude E5500 CD ROM Drive Replacement

How to replace the Dell Latitude E5500 CD ROM Drive.

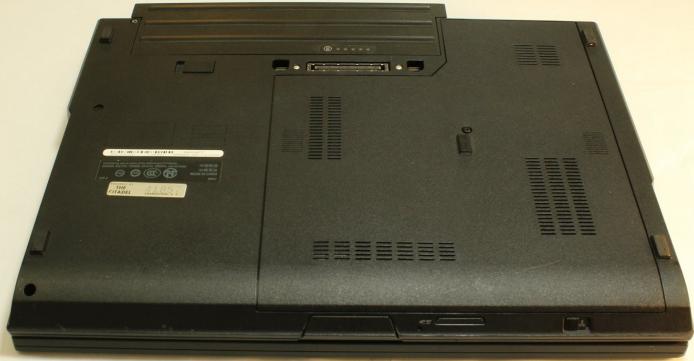
Step 1 — CD ROM Drive

- Place the front of the laptop on the table so that the hinges are facing away from yourself.

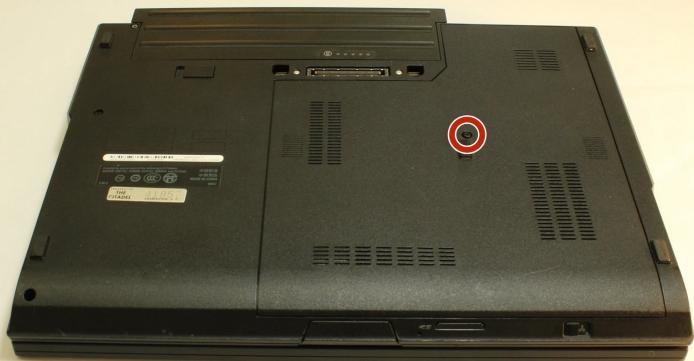
Step 2

- Remove the screw located in the red circle shown.

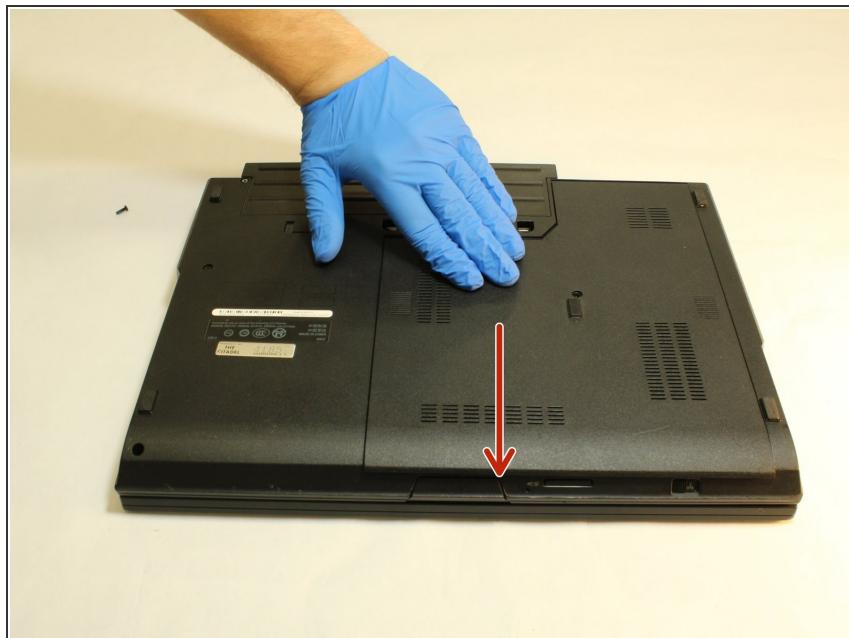
Step 3

- Apply a small amount of pressure and slide the cover towards yourself in the direction indicated.

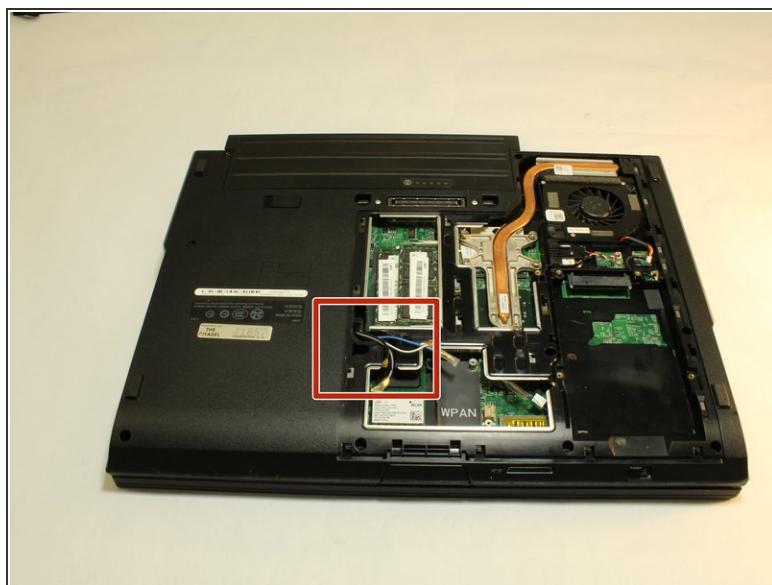
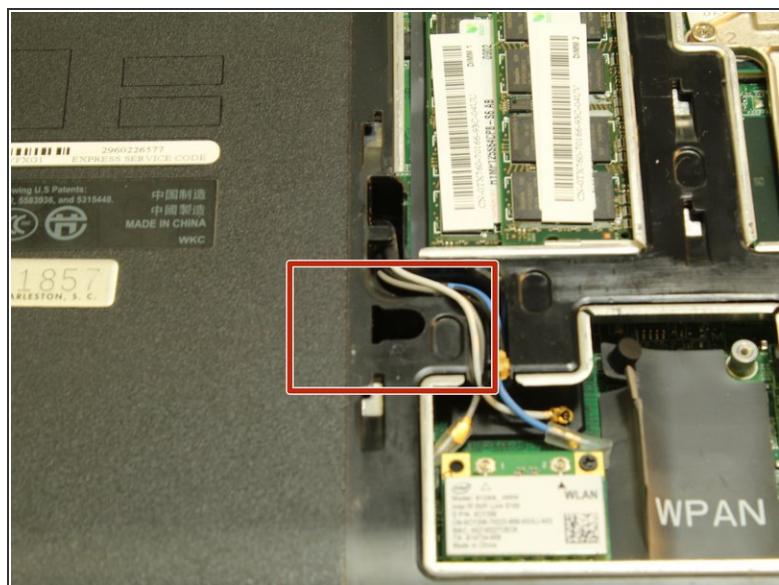
Step 4

- Locate the slot for the CD ROM ejector found inside the red box shown.

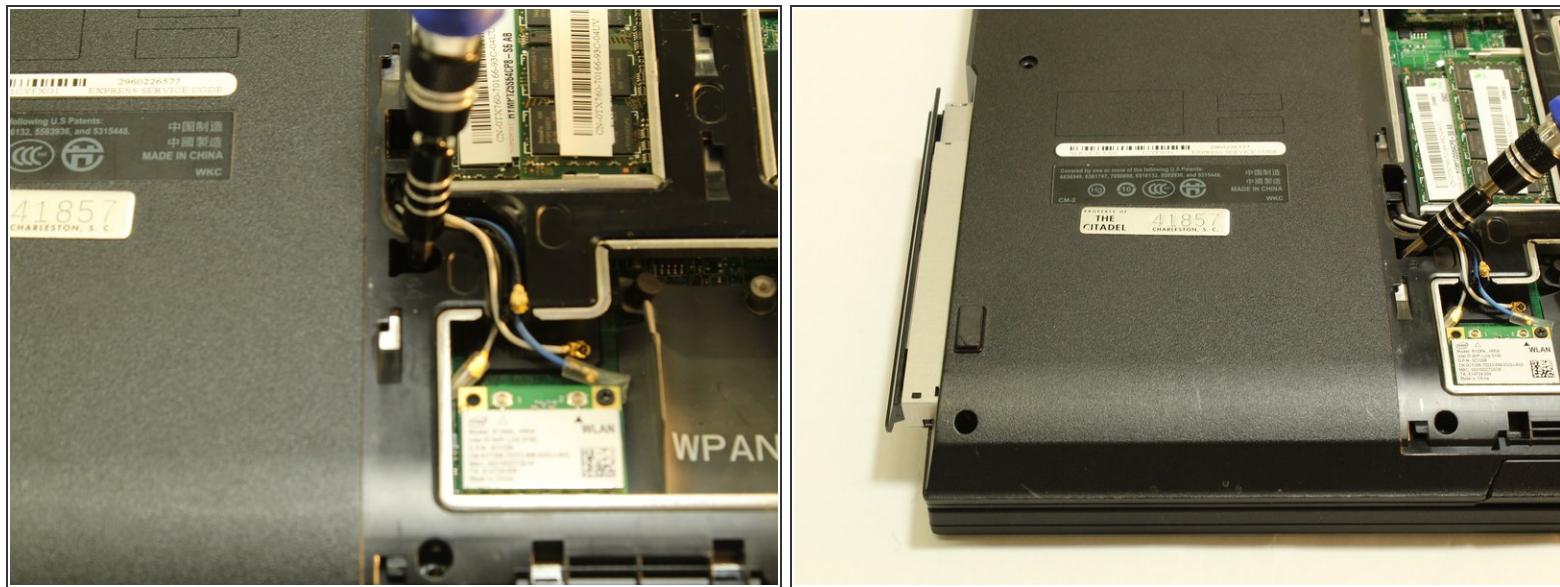
Step 5

- Using a #2 Phillip's head screwdriver, push the CD ROM ejector to the left.
- Once the CD ROM clicks out, carefully slide it out of the laptop.

To reassemble your device, follow these instructions in reverse order using your new CD Rom.
