Dell VRP100 HDMI/USB Cable Replacement

How to replace the HDMI and USB Type A cable in the Dell VRP100 virtual reality headset.

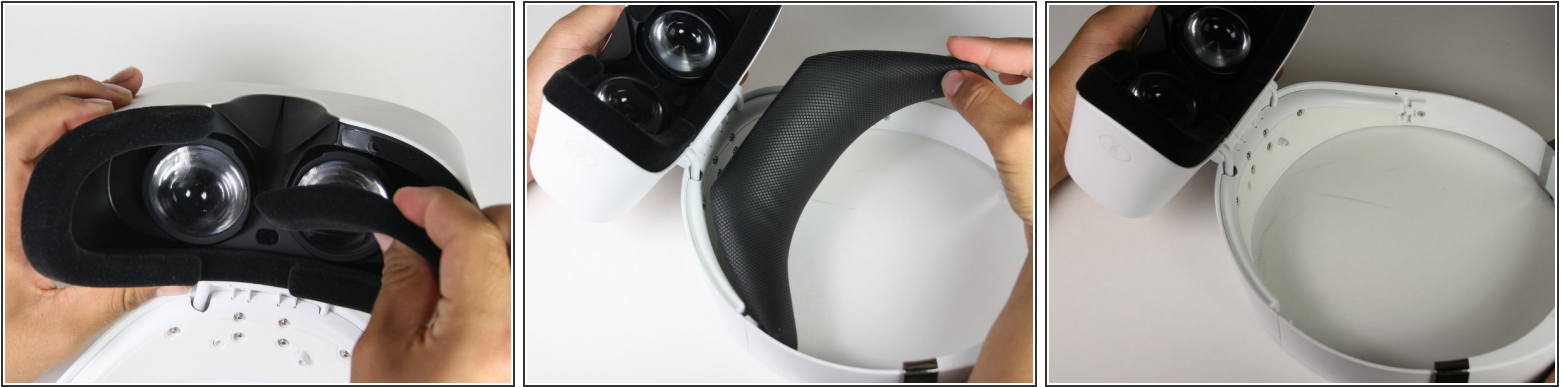
Step 1 — Cover Panel

- Remove the black foam padding by peeling away slowly.
- Remove the front and back padding from the headset by peeling away slowly.

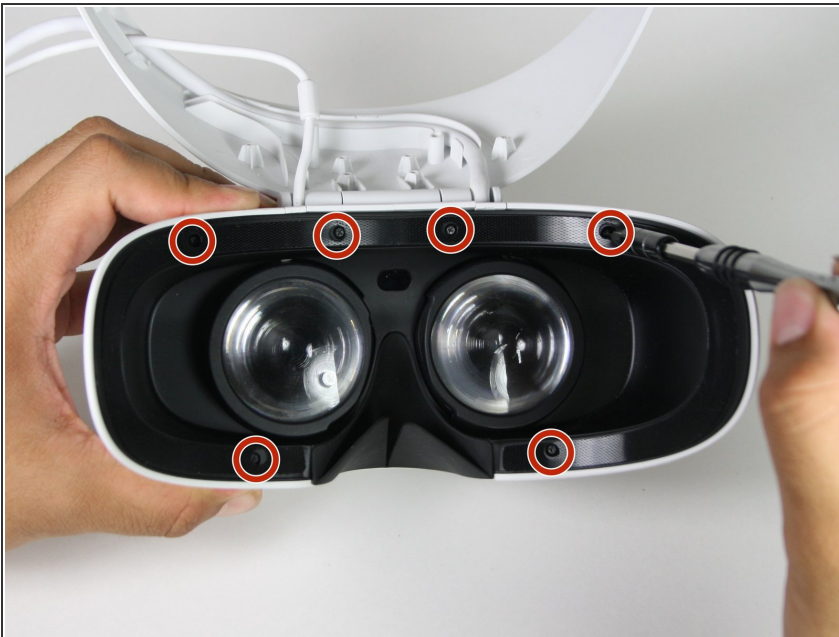
Step 2

- Remove the six 5.5mm PH000 screws from the cover by rotating counter-clockwise.
- ☒ Cover panel may need to be pushed in before inserting screws.

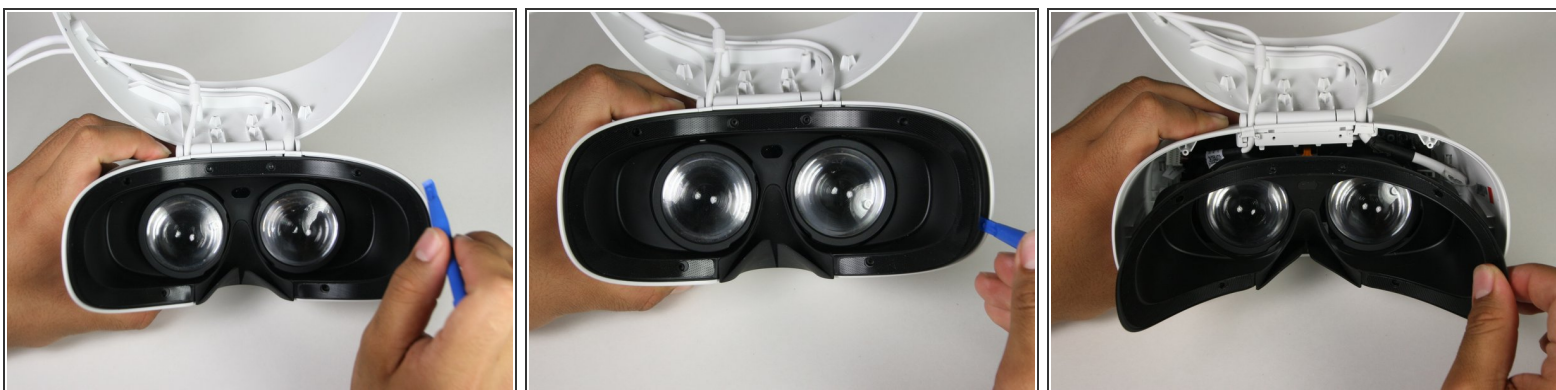
Step 3

- Remove the cover using one of the plastic opening tools, and then carefully pull it from the casing.

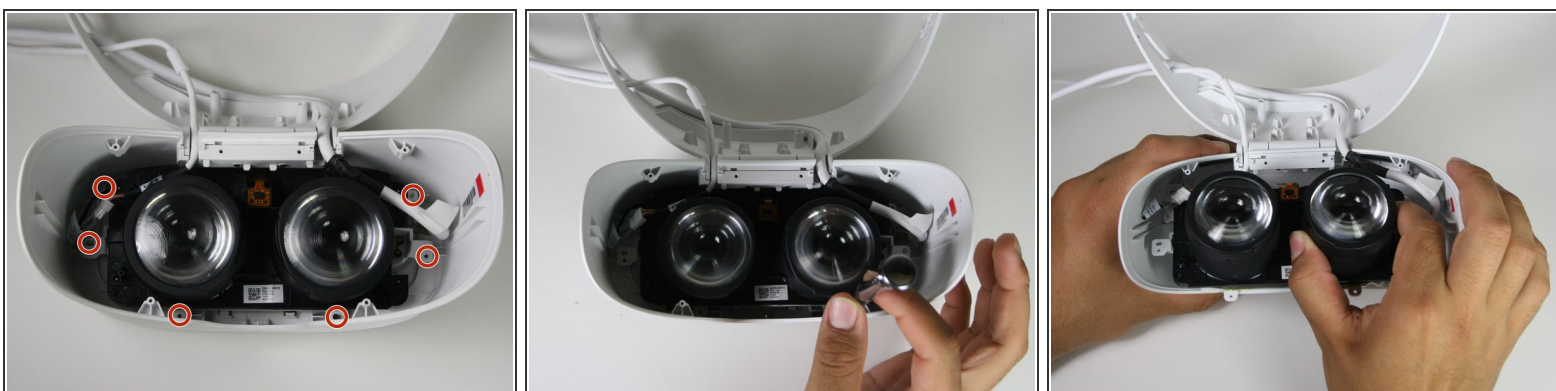
Step 4

- Remove the six 5.5mm PH000 screws from the cover by rotating counter-clockwise.
- Carefully remove the lens and motherboard assembly from the white casing.

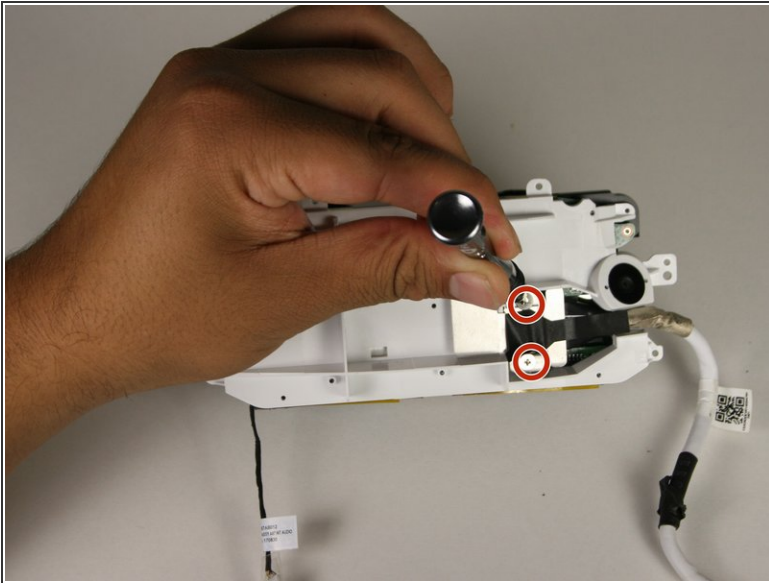
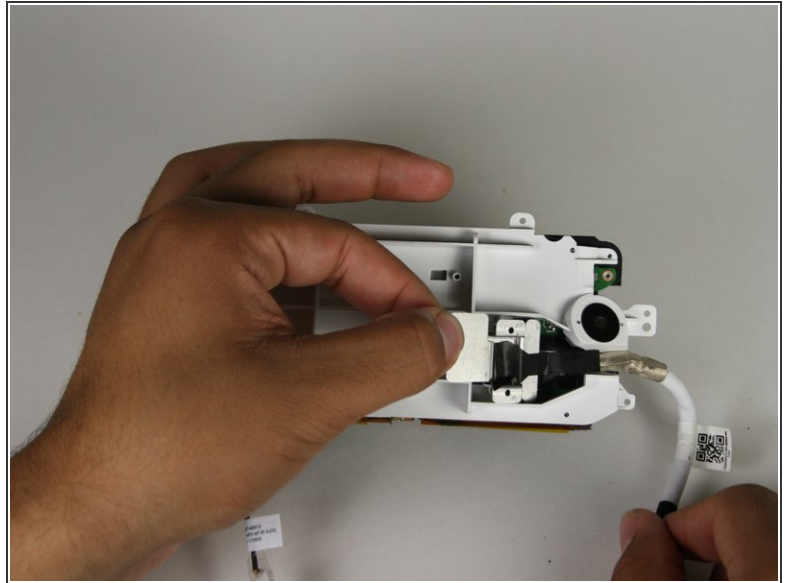
Step 5 — HDMI/USB Cable

- Remove the two 3.4mm PH000 screws from the cover by rotating counter-clockwise.
- Peel off the tape using your hands or the blunt nose tweezers.

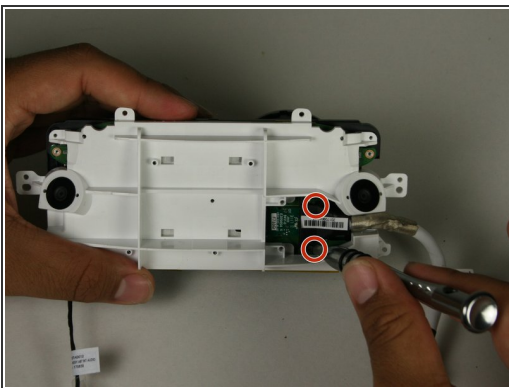
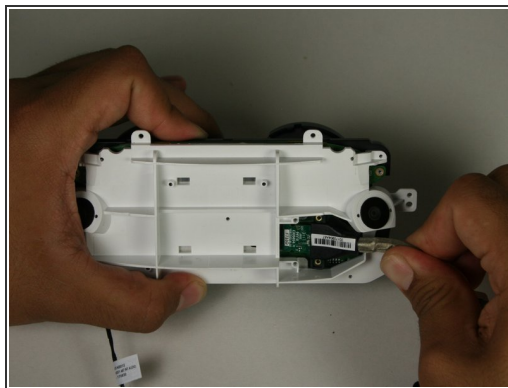
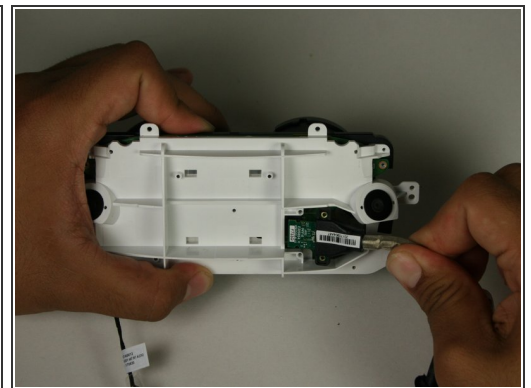
Step 6

- Remove the two 5.5mm PH000 screws from the cover by rotating counter-clockwise.
- Hold the HDMI/USB cable and remove from the connection.
