DigiLand DL8006 Internal Ribbon Replacement

This guide will assist the user to replace the internal ribbon that lays on top of the battery, accessible in the back end of the tablet.

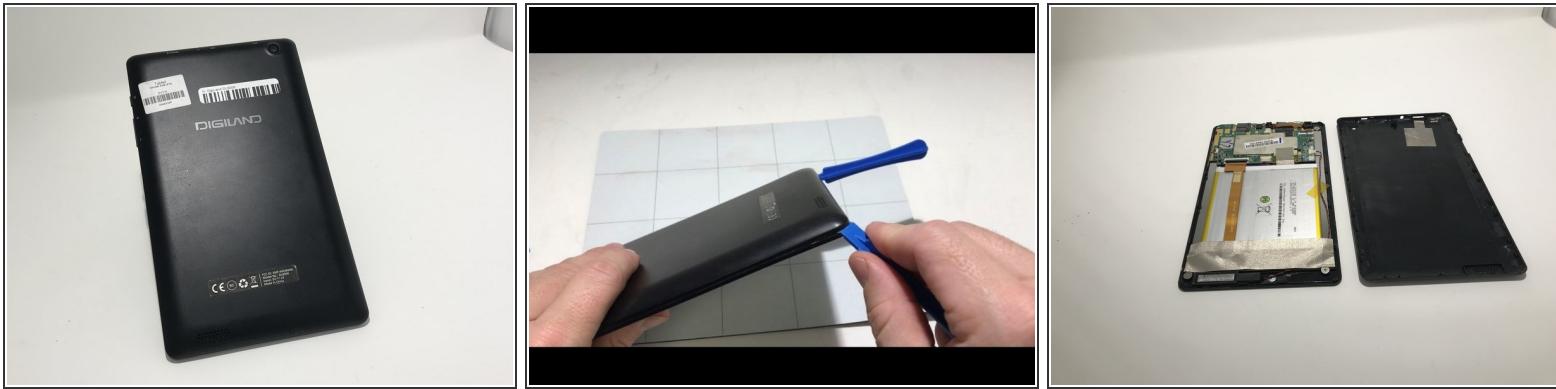
Step 1 — Internal Ribbon

- Flip the tablet to where its back is facing upward.
- Remove the back cover by prying the sides with a plastic opening tool.
- Lay the opened device with the circuit board exposed.

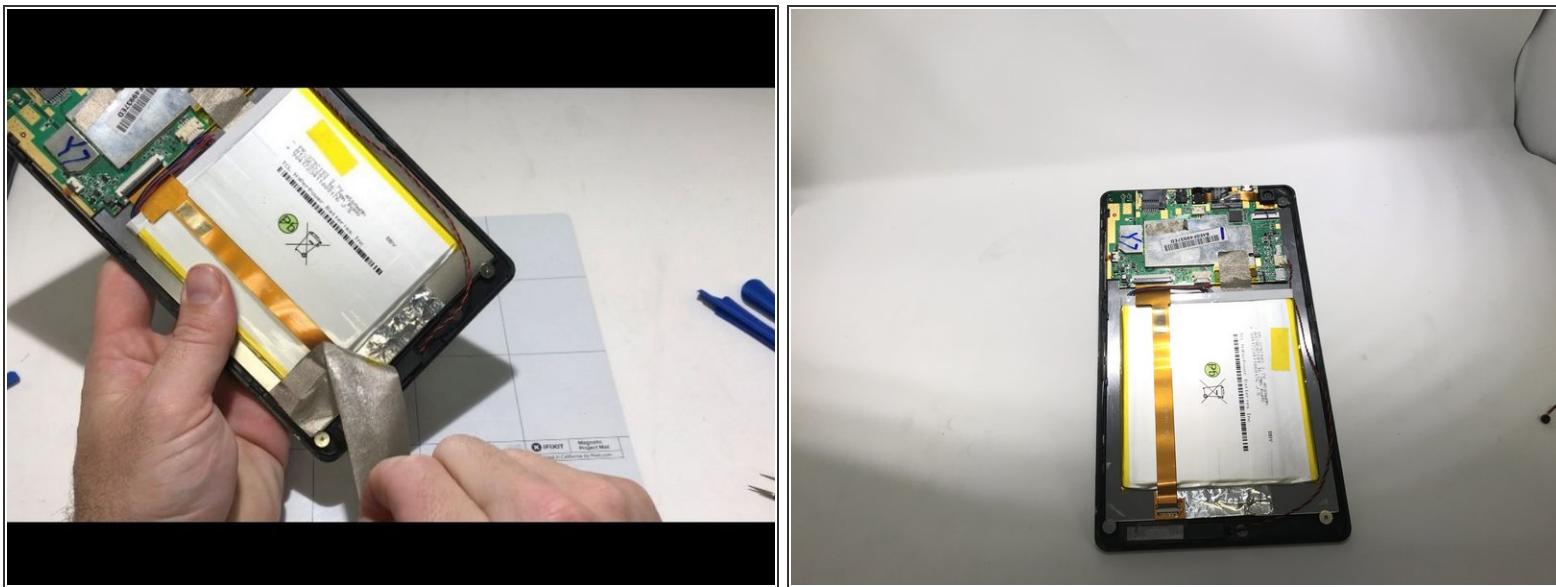
Step 2

- Remove the silver/metallic tape covering the blue and red wires overlapping the upper and lower end of the ribbon cable.

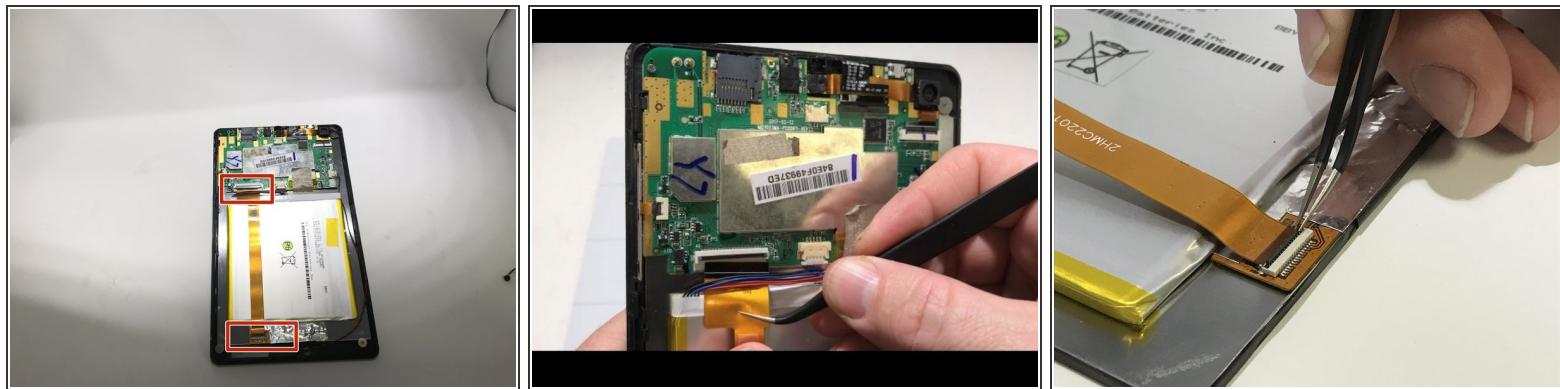
Step 3

- Remove the ribbon cable by pulling the locking tab of the ZIF connector up and pulling the ribbon cable out with tweezers.

To reassemble your device, follow these instructions in reverse order.
