Disassembling Kenwood Chef A701A Gearbox and Orbital Mixer assembly

Dissassembly of the top half of the Kenwood Chef A701A to investigate the low speed attachments not working - this could be due to belt or gearbox failure, but is usually due to a plastic gear mounted on a pinion failing. This guide covers replacement.

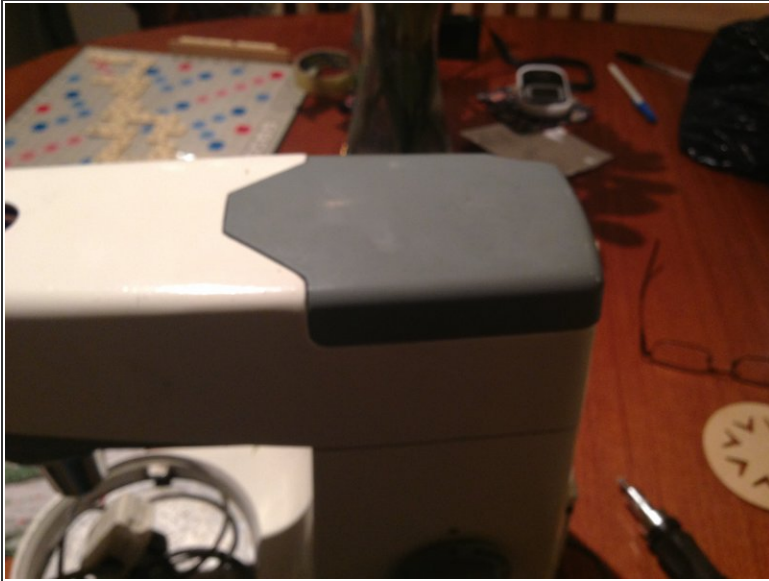
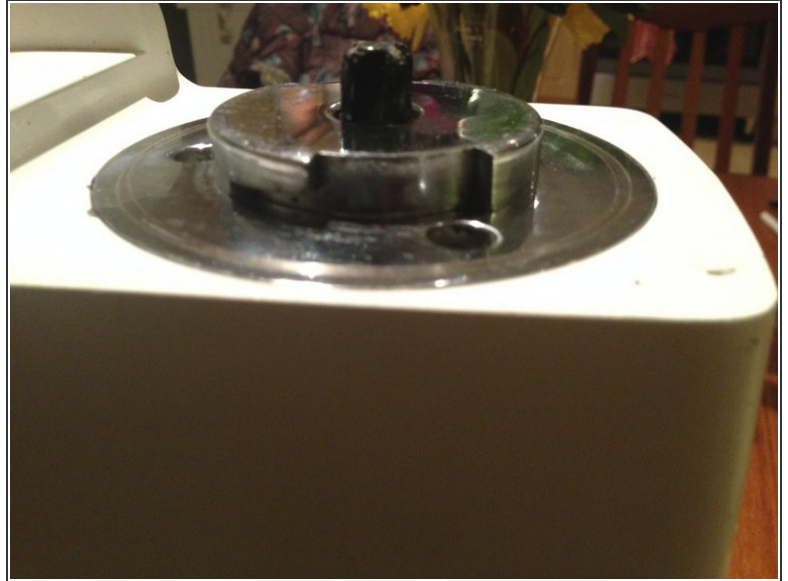
Step 1 — Disassembling Kenwood Chef A701A Gearbox and Orbital Mixer assembly

- Before doing anything, ensure that the mixer is not plugged in! Then, remove the cover from the high speed attachment. If you don't have this cover, then the low speed attachments will not work anyway, as the cover engages the clutch when it is latched on.

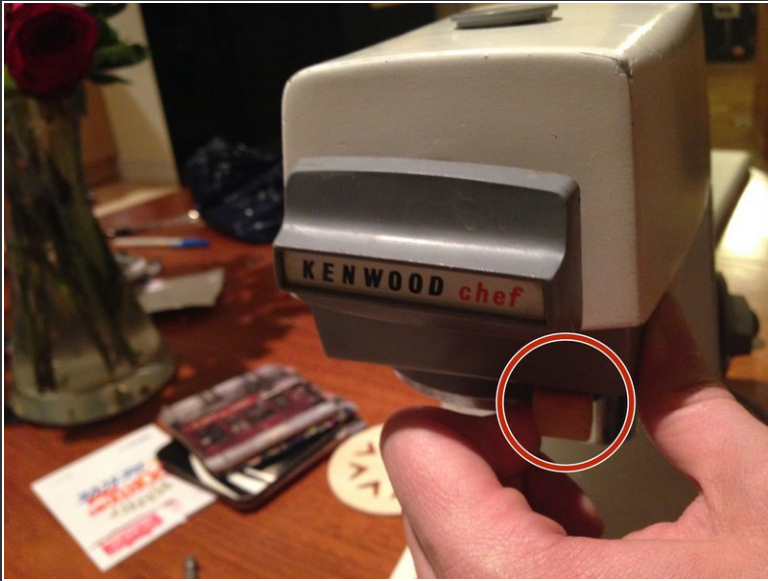
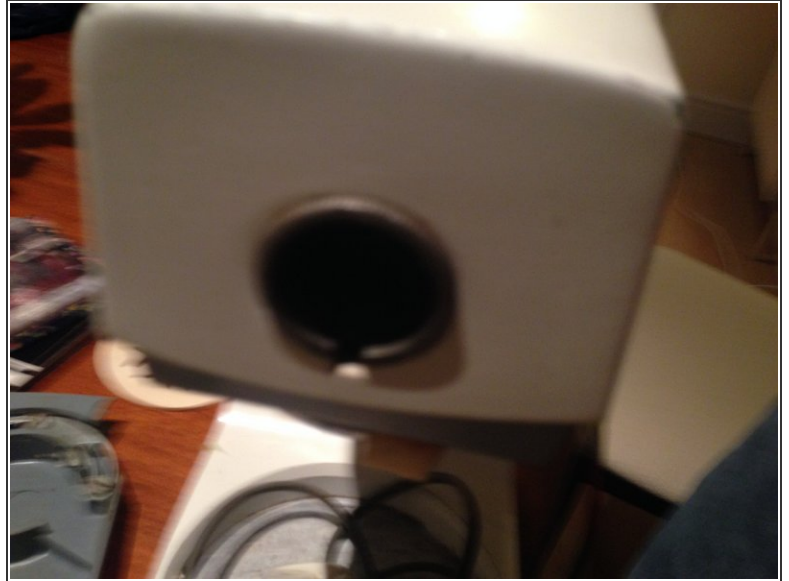
Step 2

- Now, remove the kenwood chef logo covering the front grinder attachment by pulling the white handled lever towards the edge of the mixer and then pulling the Kenwood panel away from the mixer.

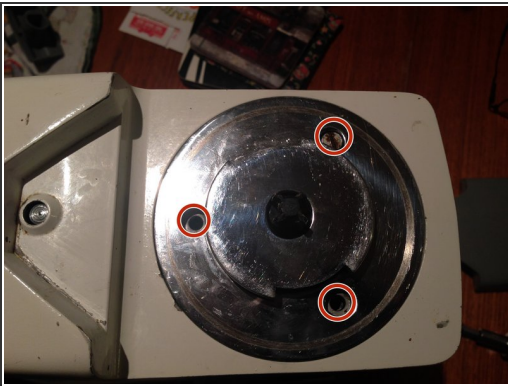
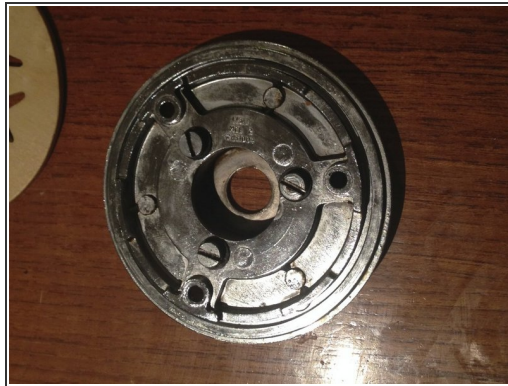
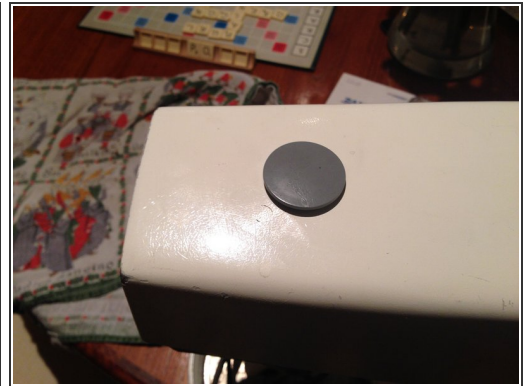
Step 3

- Next, unscrew the three screws holding the high-speed attachment port in place. Once removed, the attachment port lifts up freely.
- Then, take the plastic cover off the other attachment port on the top of the mixer.

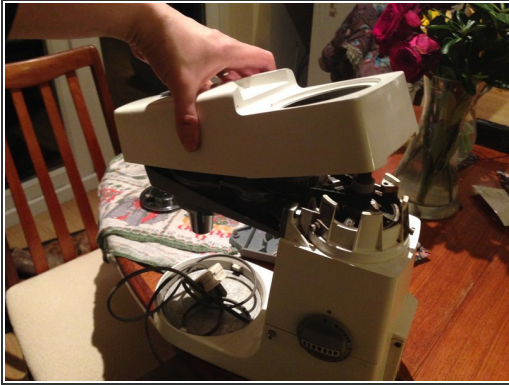
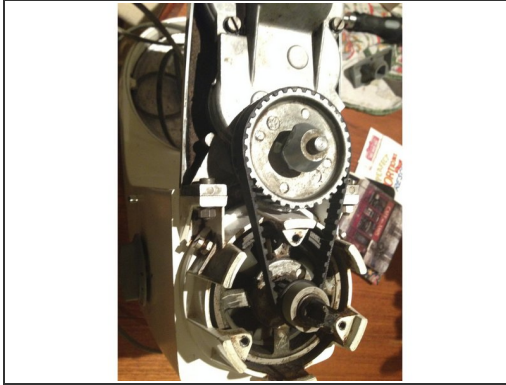
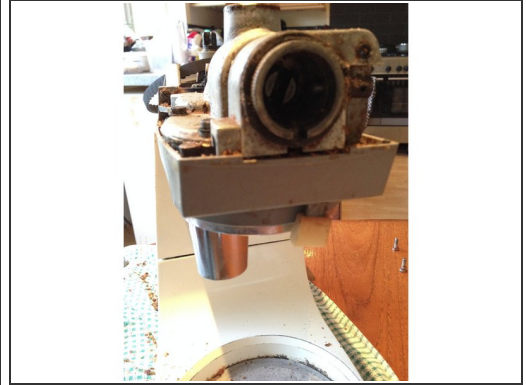
Step 4 — Remove the gearbox cover

- Now, lift the gearbox cover up and towards the front of the mixer - it should slide straight off
- Marvel at the decades of ingredients stored safely inside your mixer!

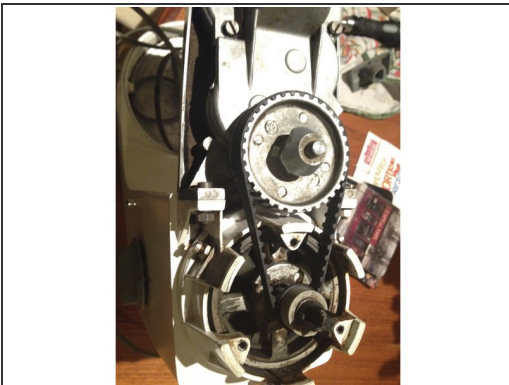
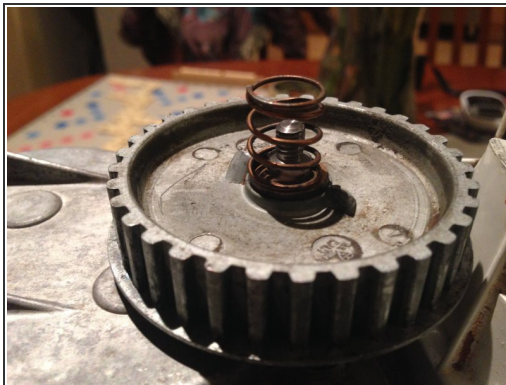
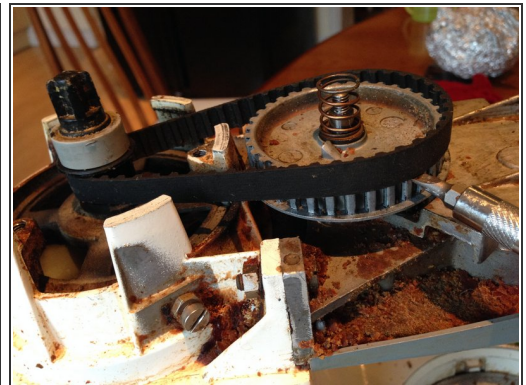
Step 5 — Remove the drive belt and springed gear

- You can remove the belt that drives the gearbox at this point - if this has worn out then only the high speed attachment will have been working. It will lift off nicely with a screwdriver.
- The large gear then needs to be gripped, and the "dog" on top of it needs to be removed.
- You'll need to hold the gear in place (by holding the bit that grips the K attachment - get someone else to hold onto it tight) and turn the dog with a spanner. Eventually the person holding will feel it release, and you can unscrew the final turn carefully so the spring doesn't fly off!
- Apologies for the cake/belt continuity errors in this set - some are taken during reassembly

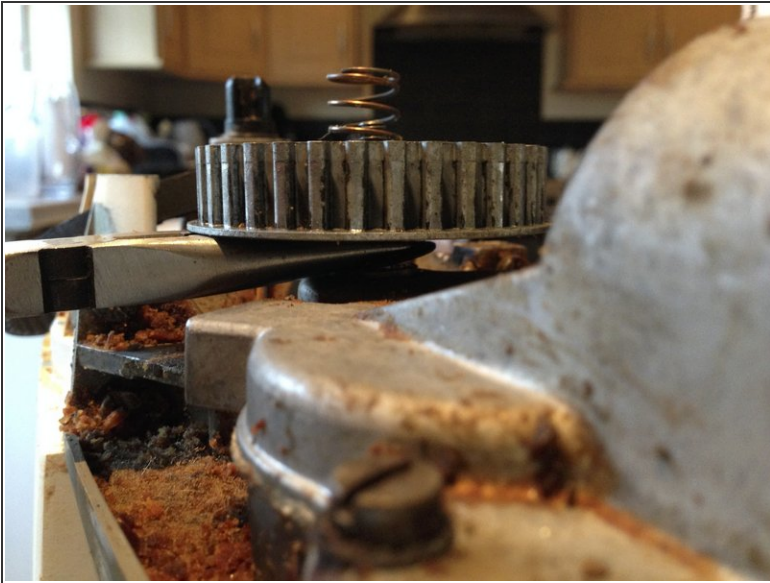
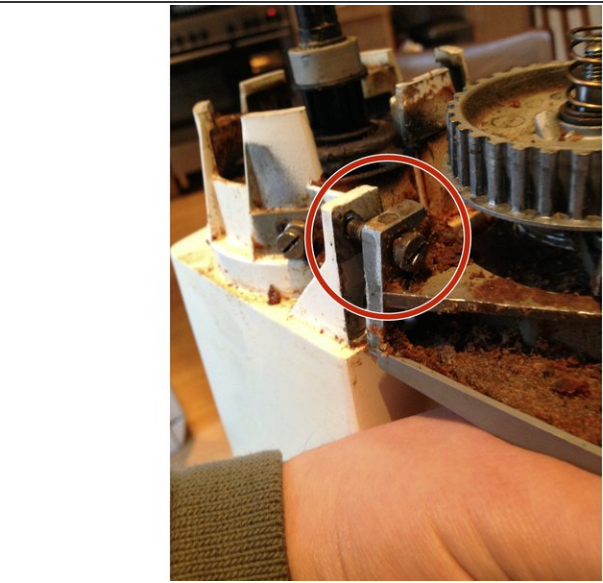
Step 6 — Remove/Service the Gearbox - Part 1/3

- If you just need to remove the large gear, here's the time to do it. You can lift it off with a pair of pliers underneath. Note that this is attached to a plastic gear inside the gearbox and this is the usual failure point if your low speed attachment is not working but your mixer runs.
- Next, undo the screws holding the gearbox onto the mixer body. There is one on either side of the mixer (only one shown). If your motor is dead, you may not need to do this.

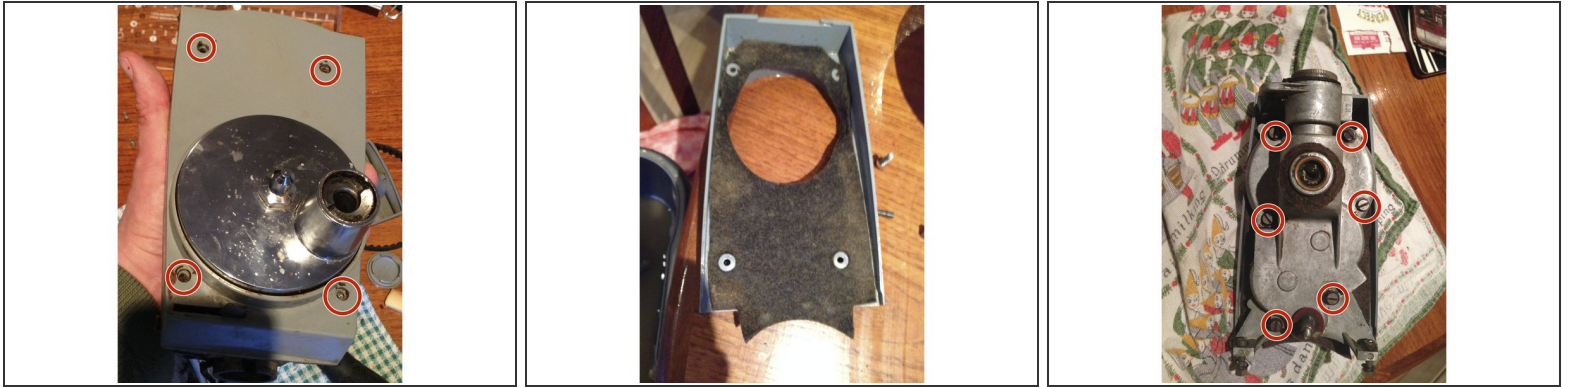
Step 7 — Remove/Service The Gearbox Part 2/3

- Next, remove the plastic cover on the bottom of the gearbox. At this point, old crumbs will be getting everywhere. This is held on by four screws, which are removed in the first picture. At this point, you also need to pull the plastic cover off the lever at the front of the mixer.
- You now have access to the lower plastic cover - best to give this a wash along with the felt. (picture 2)
- Behold the beauty of the Kenwood gearbox (picture 3). Best not to wash this, but remove the 6 screws to gain access.

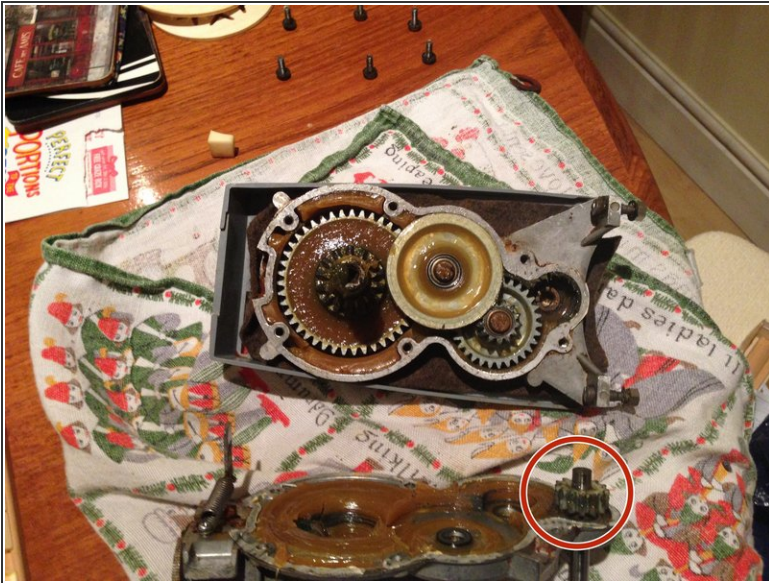
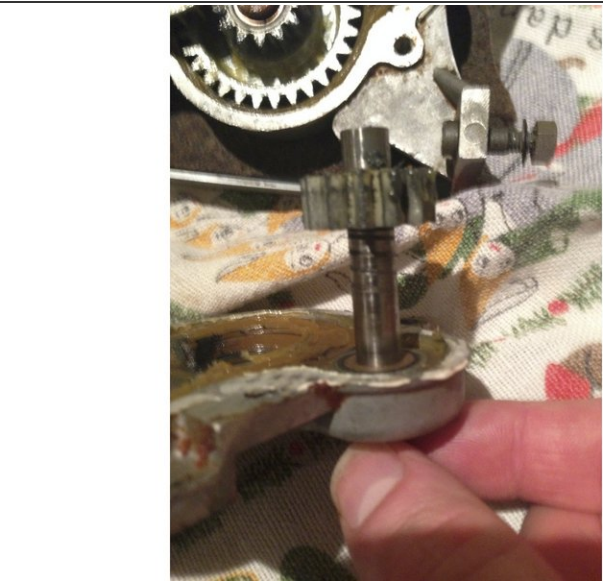
Step 8 — Remove/Service The Gearbox Part 3/3

- One thing to do with that - open it up! The cover lifts off showing the still well lubricated gears. Normal failure point ringed - remove this and replace with a new one to fix!
- Reassembly is the reverse of dismantling the mixer.

To reassemble your device, follow these instructions in reverse order.
