Dyson V6 Motorhead Brush Bar Replacement

Brush bars have a history of failing, issues of them not rotating as well as wearing out.

Brushbar replacement, the brushbar may need frequent cleaning removing hair or other debris wrapped around the brush. After long use the bar may need replacement.

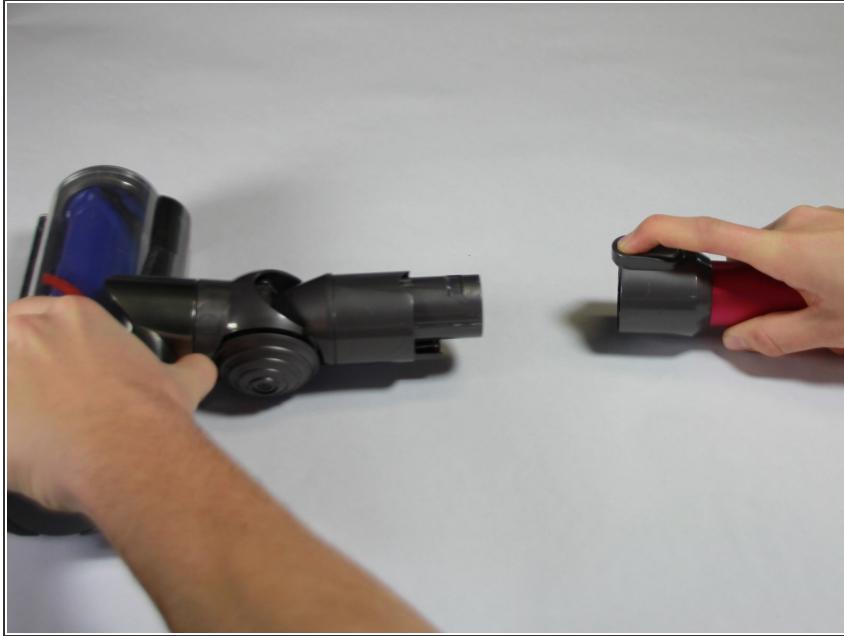
Step 1 — Brush Bar

- Press the button to disconnect the vacuum head from the connecting pole.

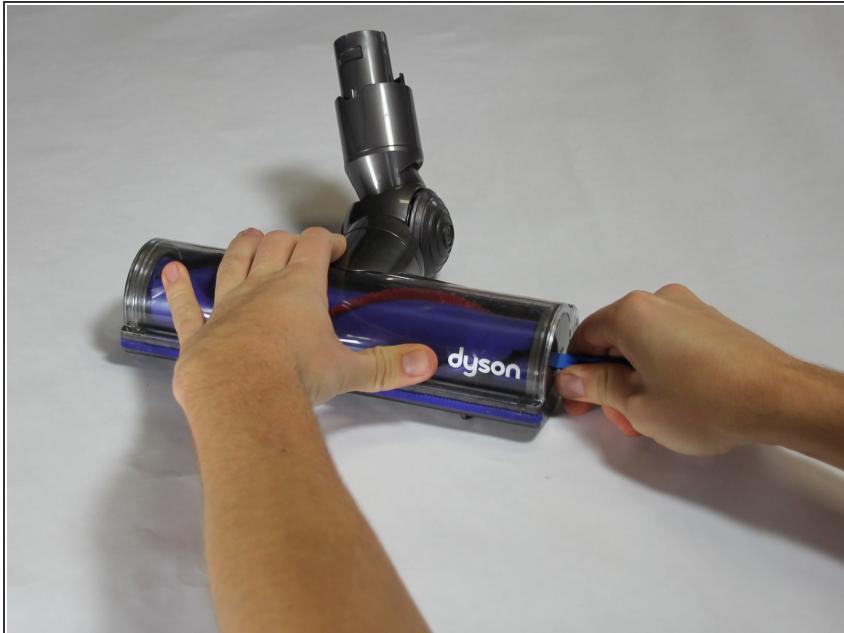
Step 2

- Turn the end cap counterclockwise using the iFixit Opening Tool.

i If you do not have an iFixit Opening Tool, a quarter may be used instead.

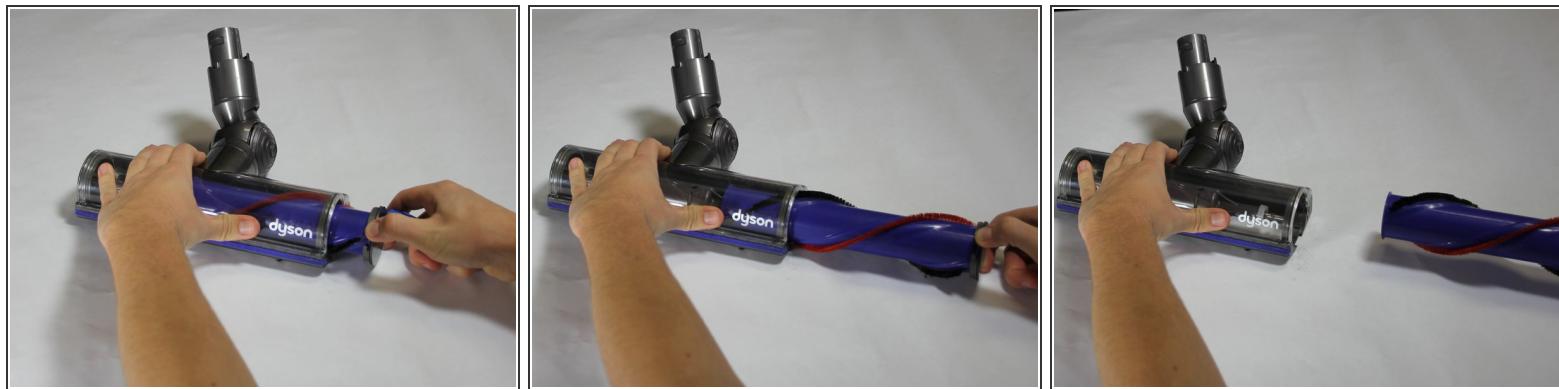
Step 3

- Pull the brush bar out of the housing.

To reassemble your device, follow these instructions in reverse order.
