Epson Stylus Photo 820 Teardown

Teardown of an Epson Stylus Photo 820 Inkjet Printer.

Written By: jrw01

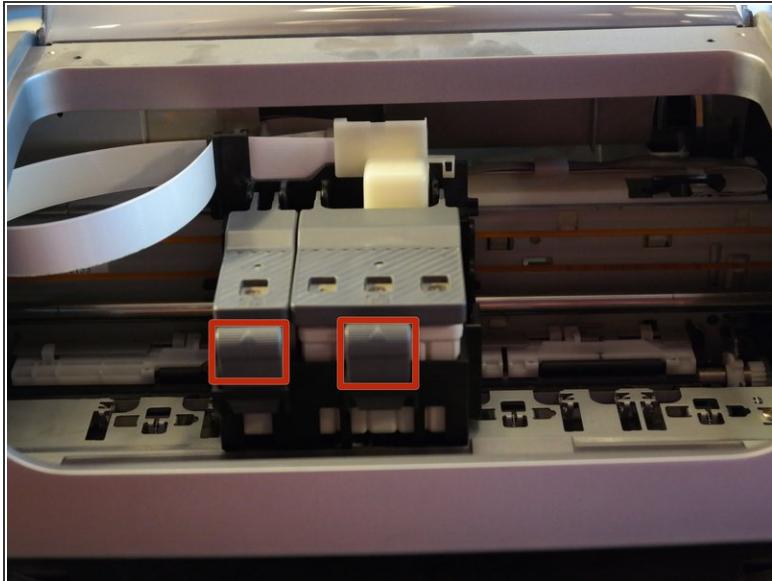
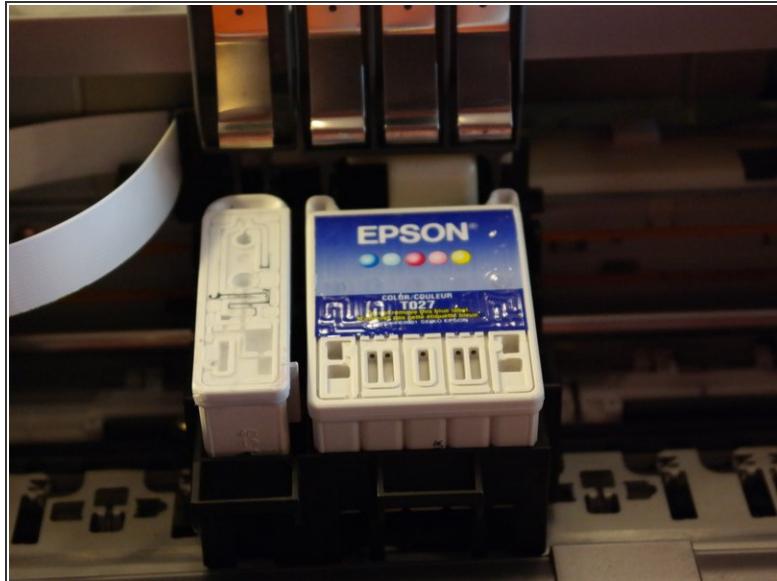
Step 2

- The ink cartridges are replaceable. That is a good sign.

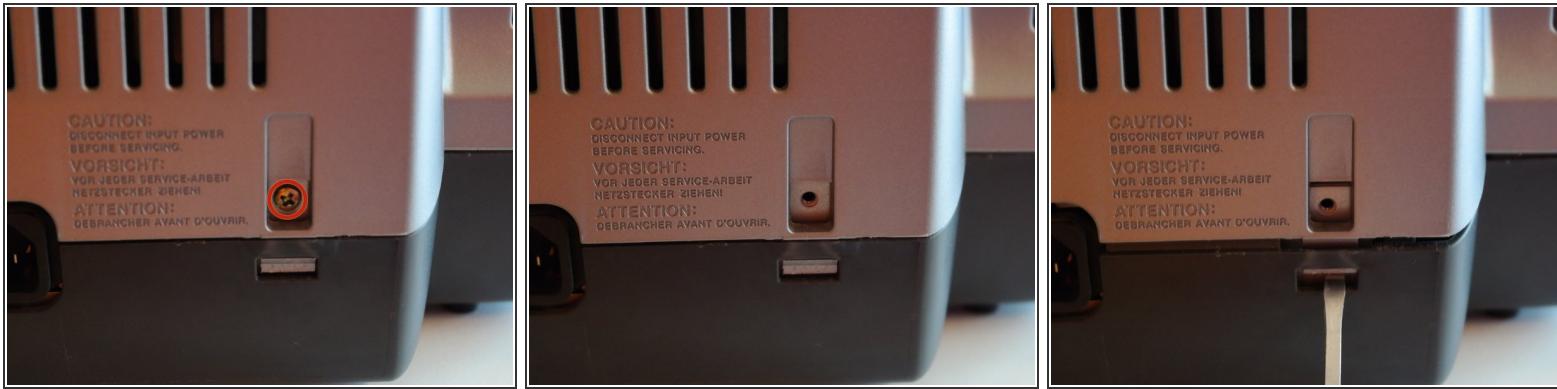
Step 3

- Only one screw on the outside. That looks like a good sign.
- After removing the screw, the three tabs on the back can be unhooked.

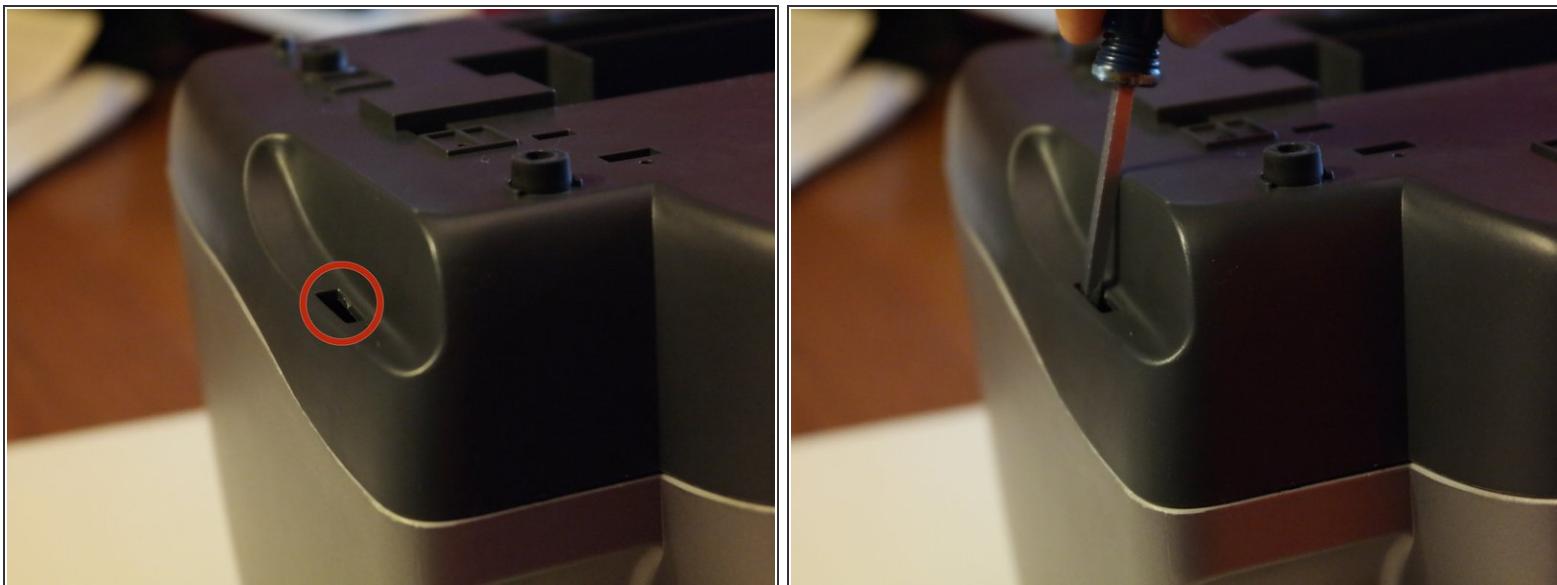
Step 4

- What are these strange slots on the bottom of the printer?
- Answer: according to the existing iFixit guide, they allow access to the tabs holding the cover in place.

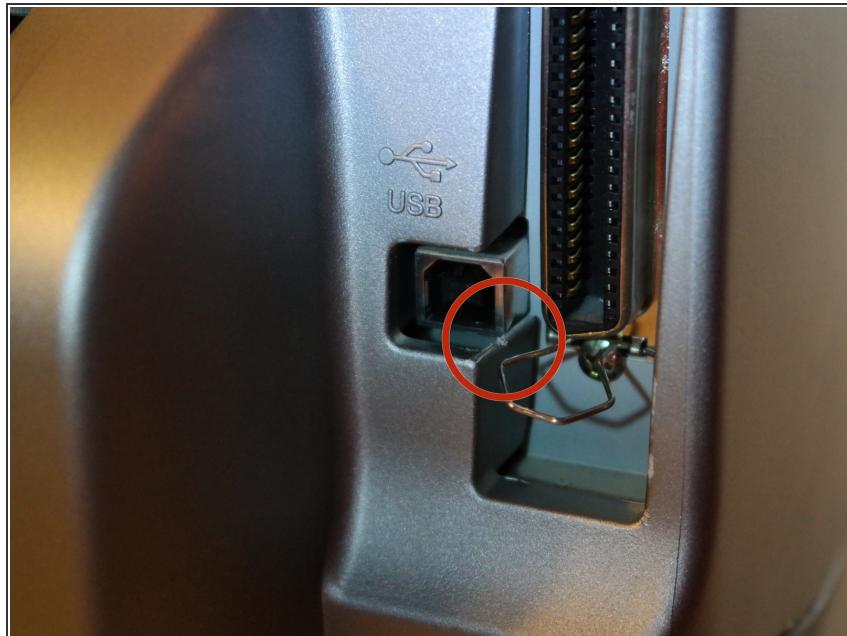
Step 6

- It was necessary to pry this piece of plastic away from the USB port while removing the case.

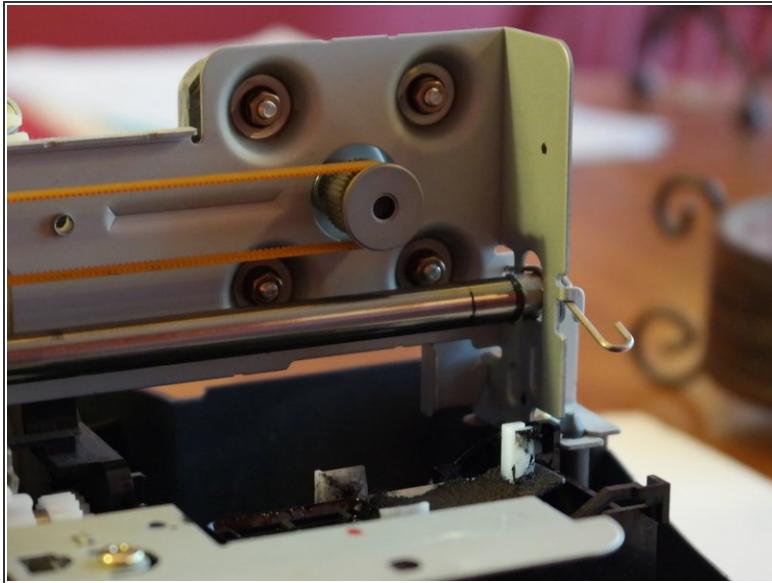
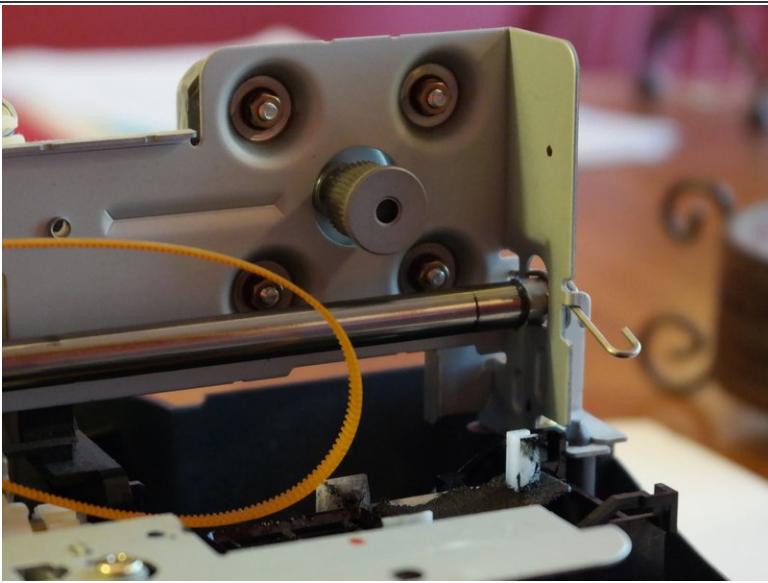
Step 8

- Next step: the stepper motor.
- The drive belt can be easily removed by pressing on a tensioner on the other side of the printer.
+1 for reparability!

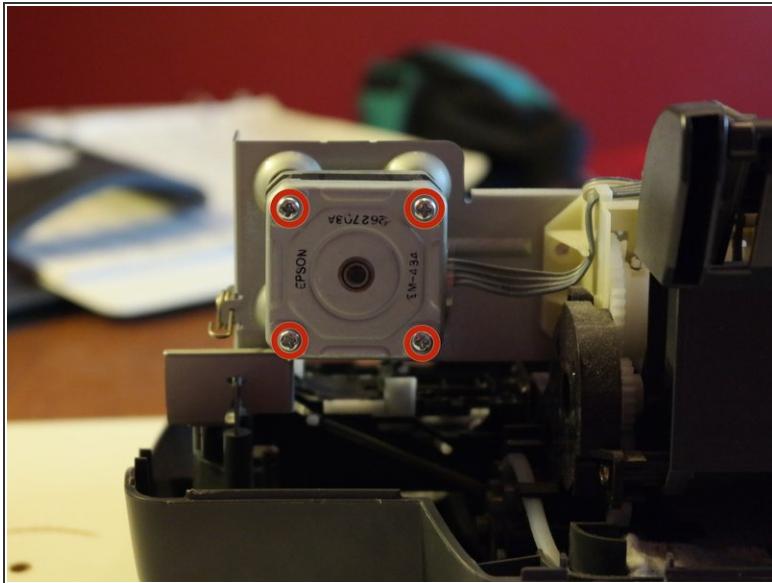
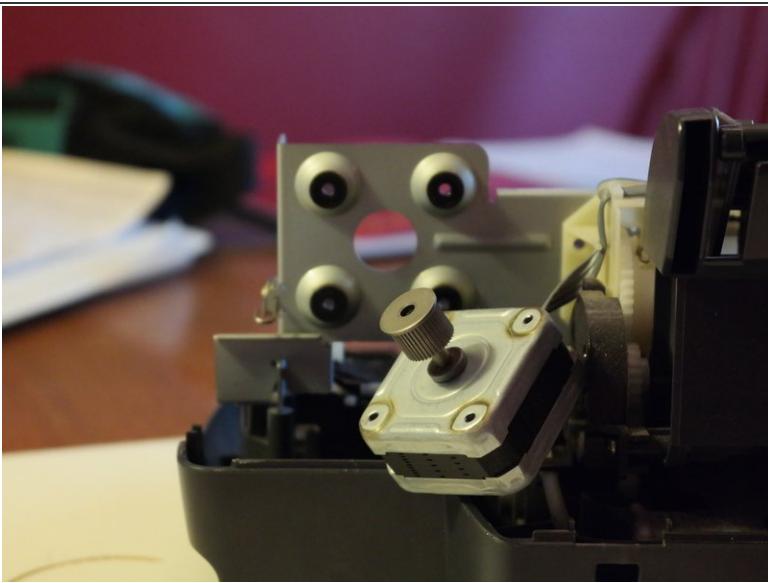
Step 9

- After removing 4 screws, the stepper motor comes out.

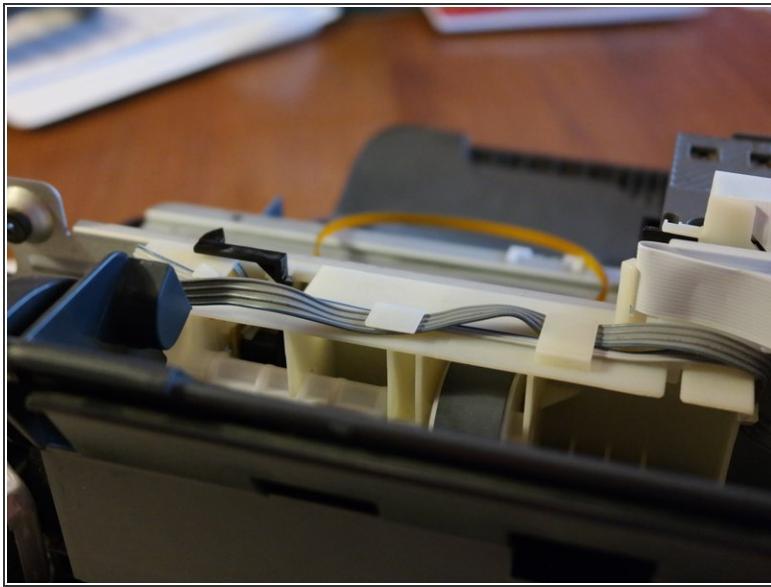
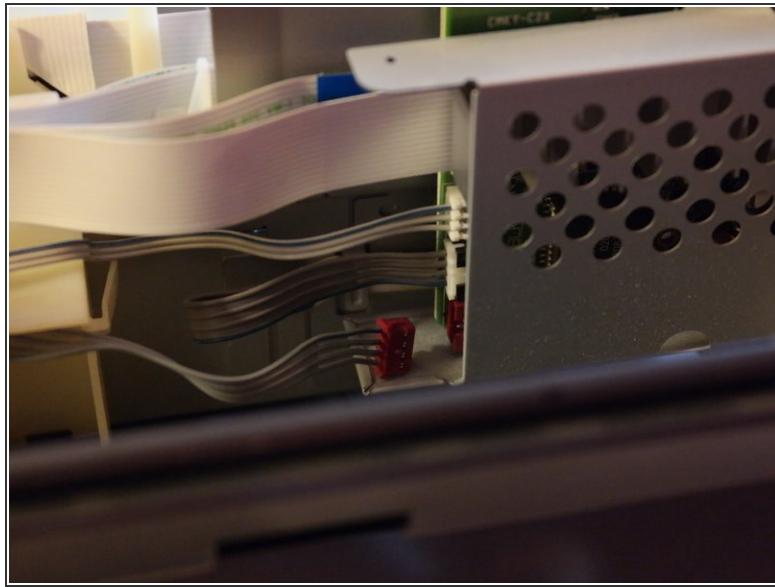
Step 10

- The stepper motor cable is routed through a series of plastic tabs that hold it down.
- It eventually connects to the (hidden) logic board.

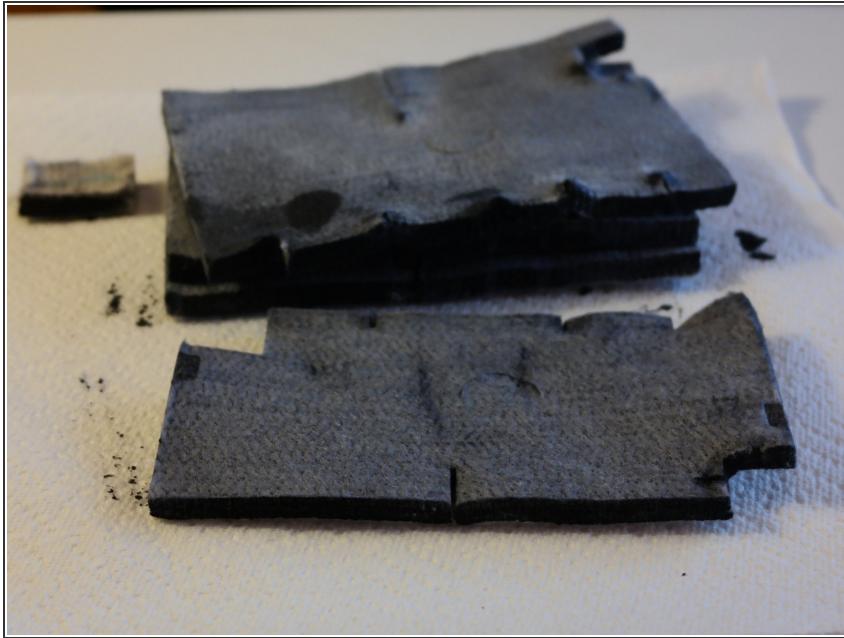
Step 15

- The object at the bottom of the last photo was 5 layers of absorbent padding to contain all the ink that the printer has wasted while cleaning its nozzles, in this case *almost 8 years* of ink.
-

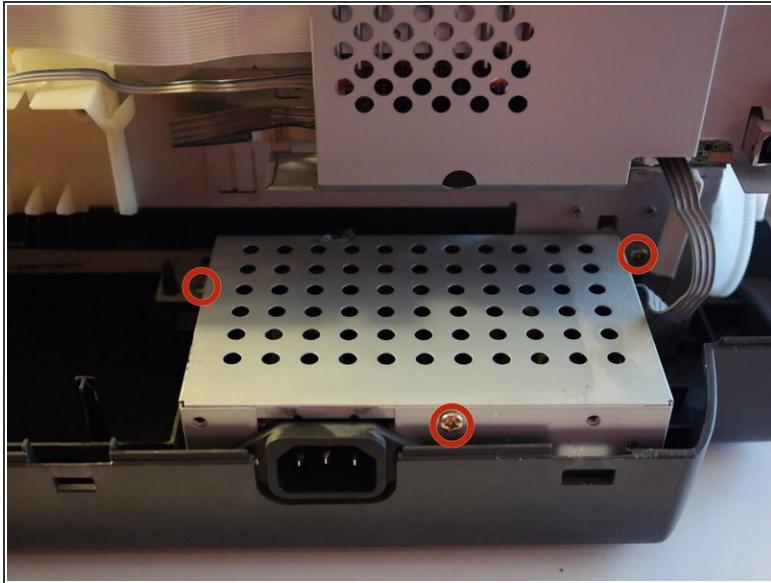
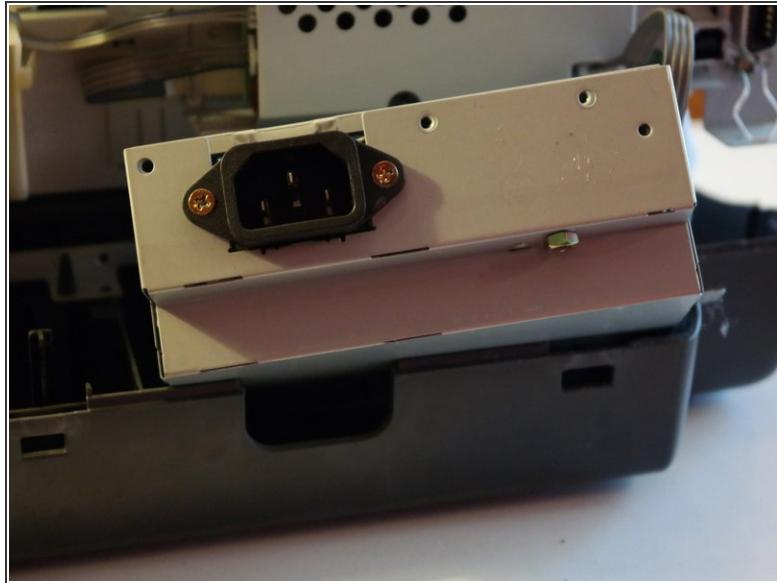
Step 16

- The power supply is held in place by 3 screws, but it seems to be missing two on the front.

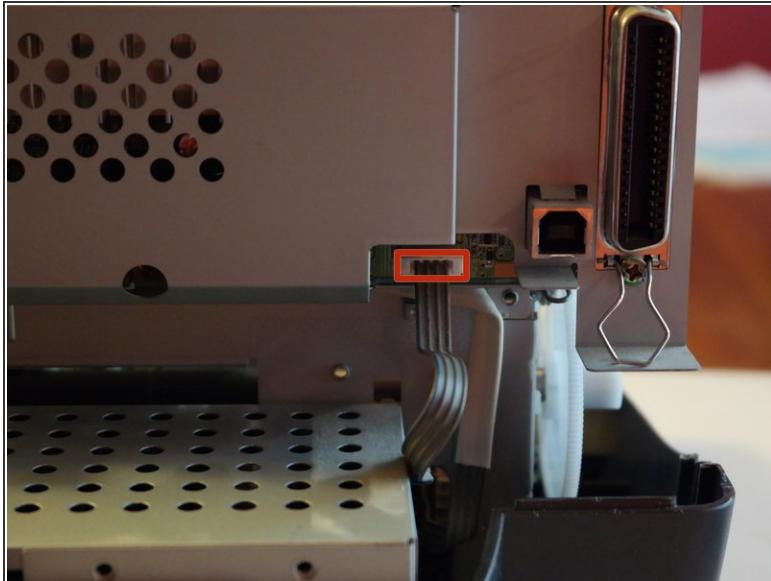
Step 17

- The power supply is connected to the main board by 4 surprisingly thin wires.

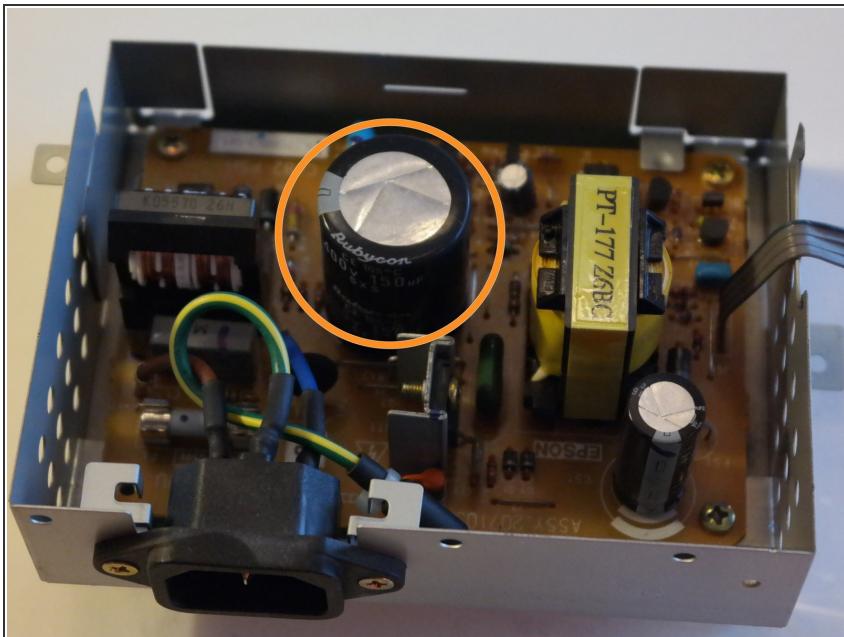
Step 18

- The inside of the power supply.

⚠ The large capacitor (circled in orange) can hold up to 400 volts, which will hurt if you touch it while plugged in.

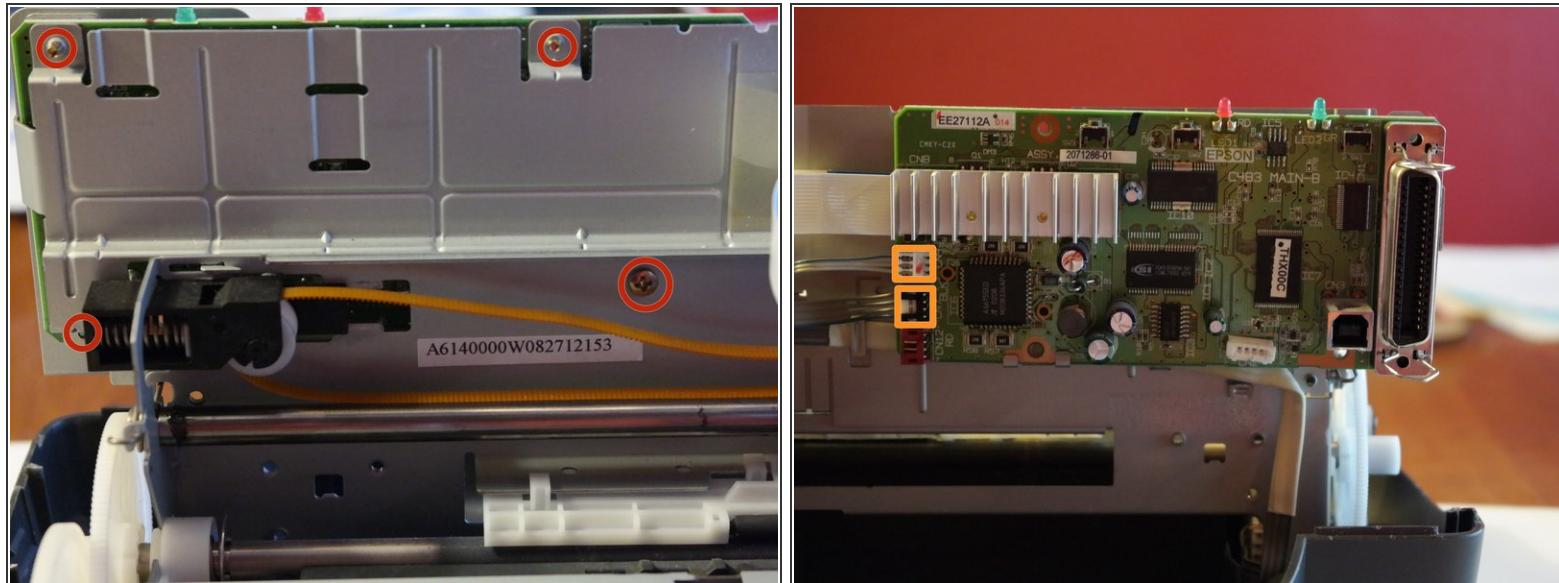
Step 19

- The logic board's shielding is held in place with 4 screws.
- Two cables remain connected to the logic board.

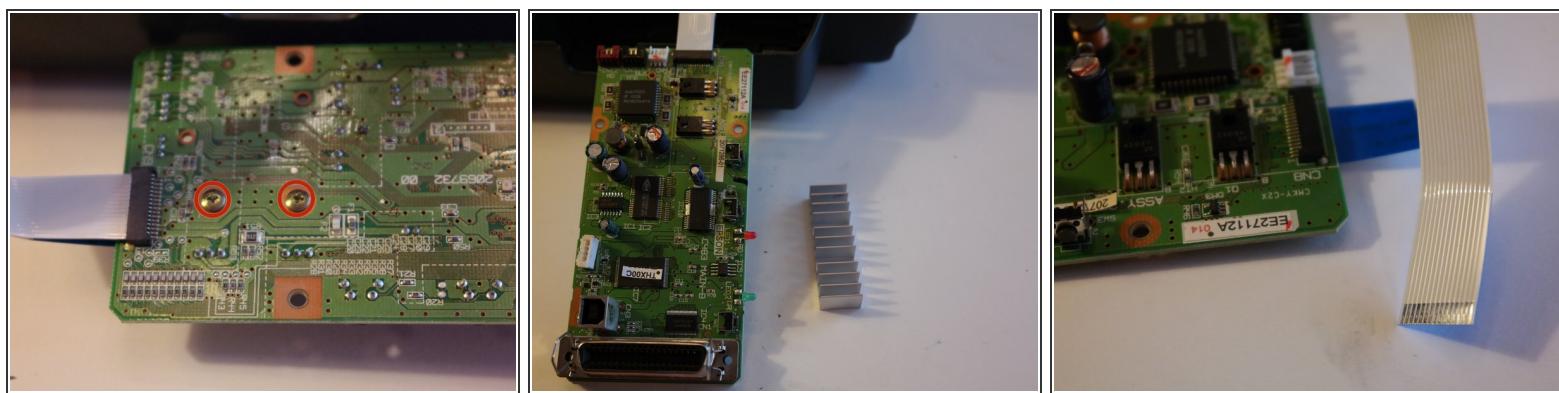
Step 20

- The heatsink is attached to the logic board by these screws.
- The large dual ribbon cable for the printhead attaches to two connectors on the logic board, one on each side.

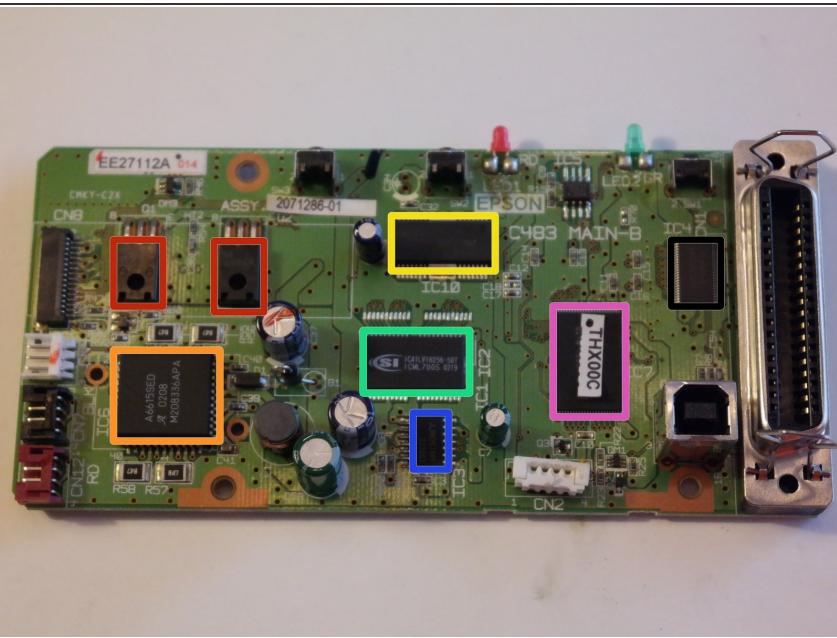
Step 21

- The chips on the logic board.
- A2037 and C5694 transistors
- A6615SED stepper motor driver
- 219A254UN proprietary EPSON chip
- IC41LV16256 256K x 16 bit dynamic RAM
- M62510FP bus termination regulator
- 29LV400TC 8 mBit CMOS flash memory
- LVCZ161284A high speed IEEE 1284 transceiver

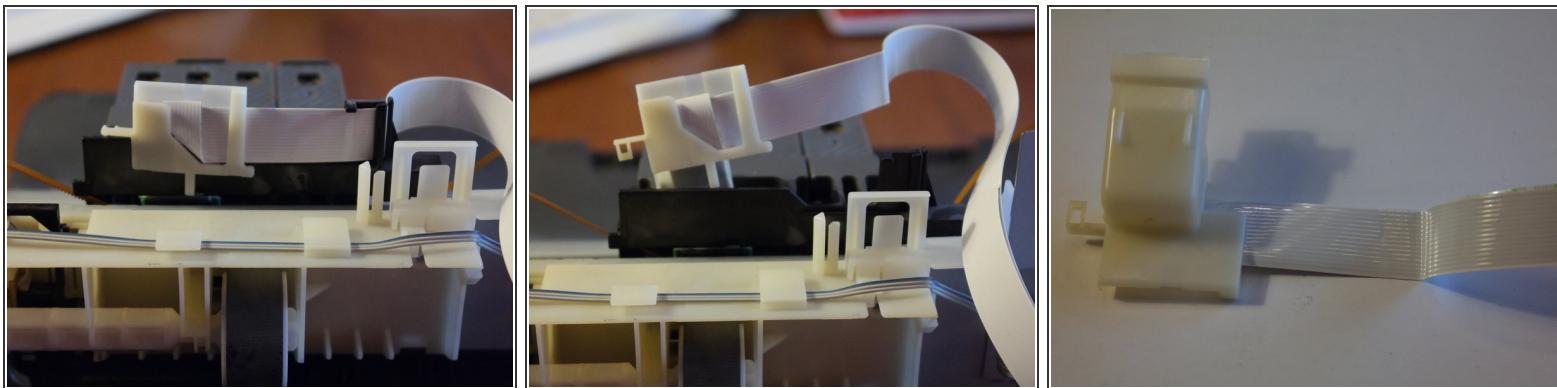
Step 22

- The plastic clip that holds the dual ribbon cable in a folded position.

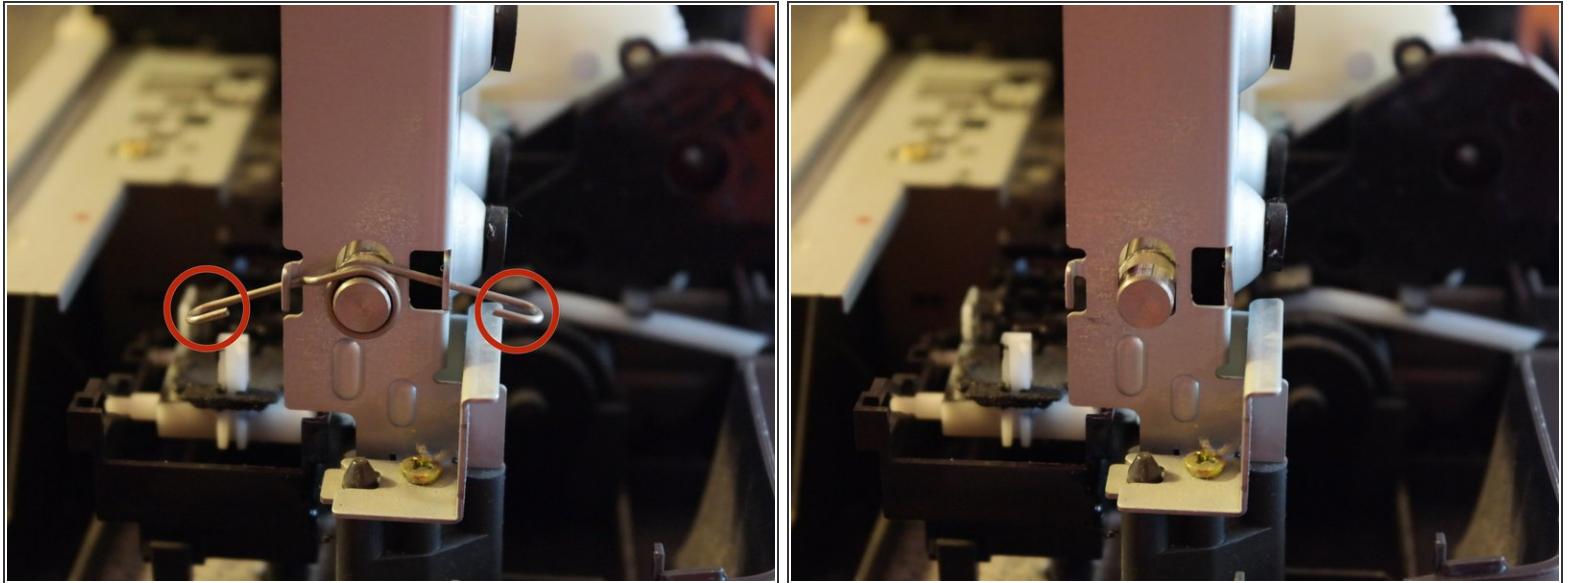
Step 23

- The main axle/rod/shaft/round metal thingy is held in by spring clips.

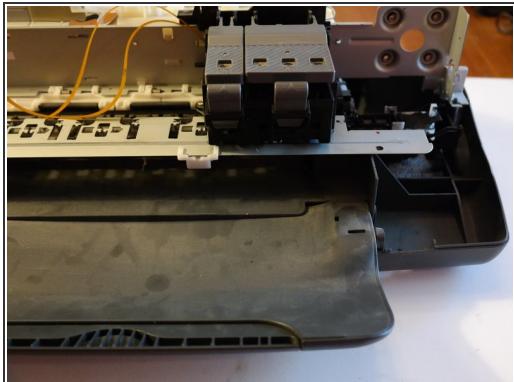
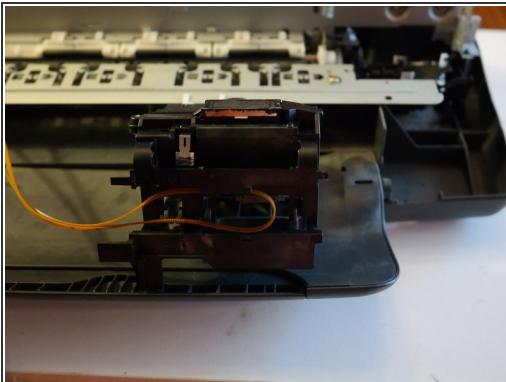
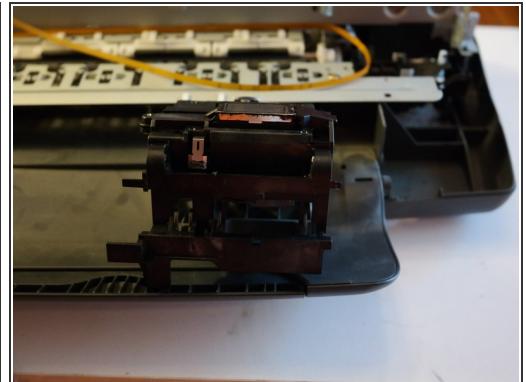
Step 26

- Now that the rod has been removed, the print head can be unhooked from the drive belt.

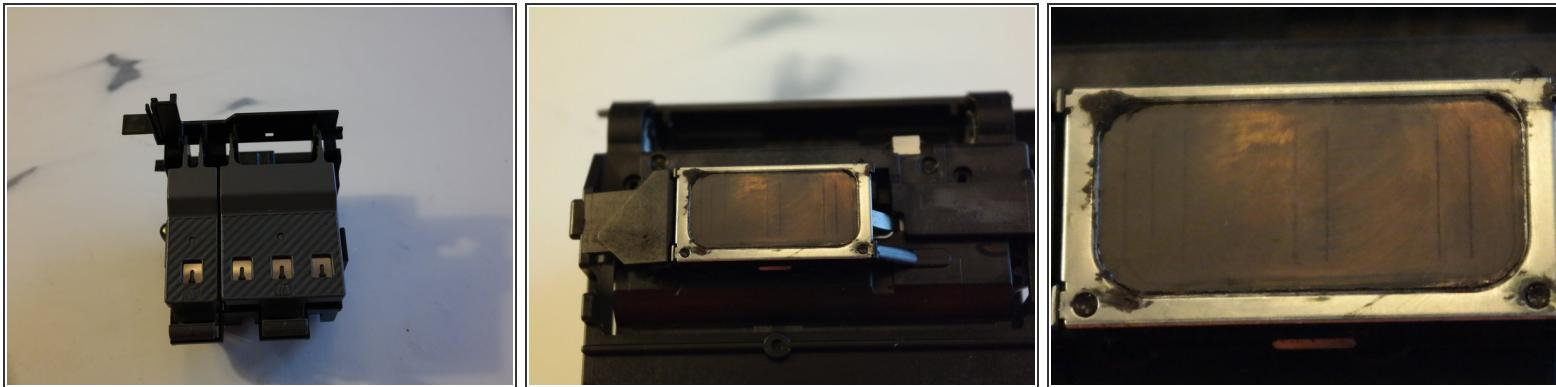
Step 27

- The print head
- The six lines on the print head visible in the second and third pictures are actually rows of microscopic ink nozzles.

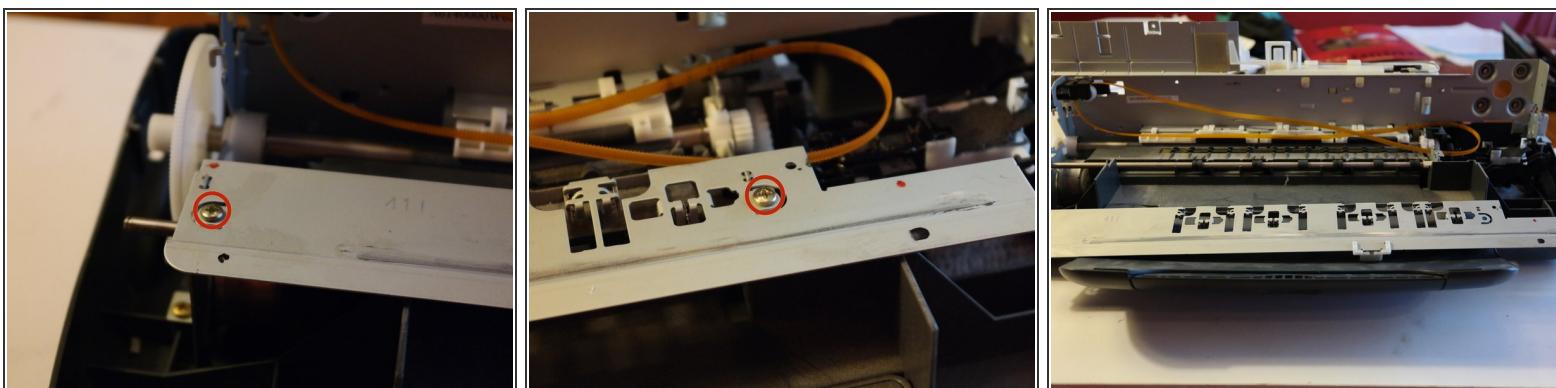
Step 28

- An unusual metal bar in the paper feed path is held in by two screws.

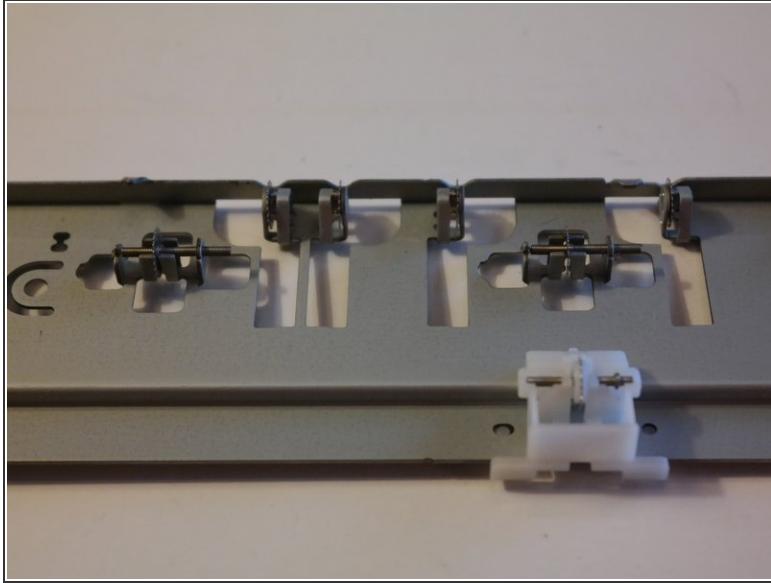
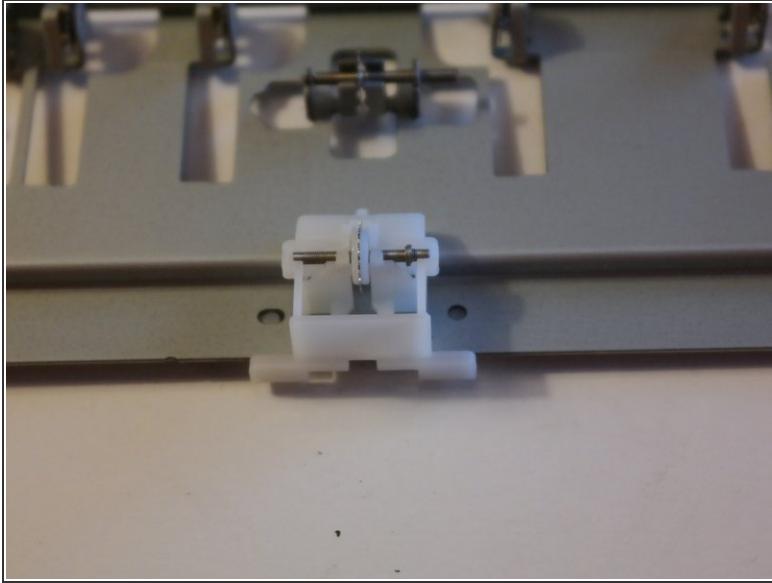
Step 29

- The metal strip contains many spiked wheels rotating on springs which allow them to be pushed out of the feed path.

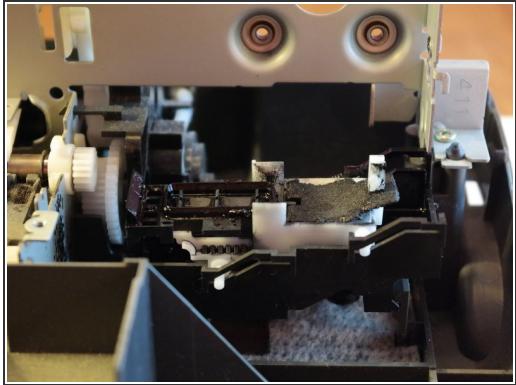
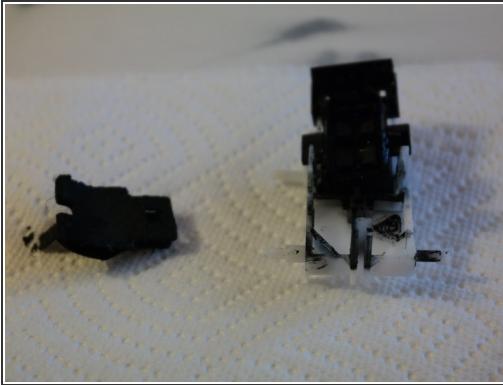
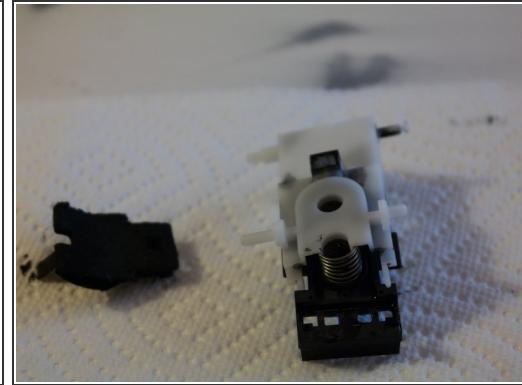
Step 30

- This inky mess is the nozzle cleaner.
- The assembly is spring loaded so the nozzles can be pushed into a pad to collect ink, which is then somehow transferred into the large absorbent ink pad.

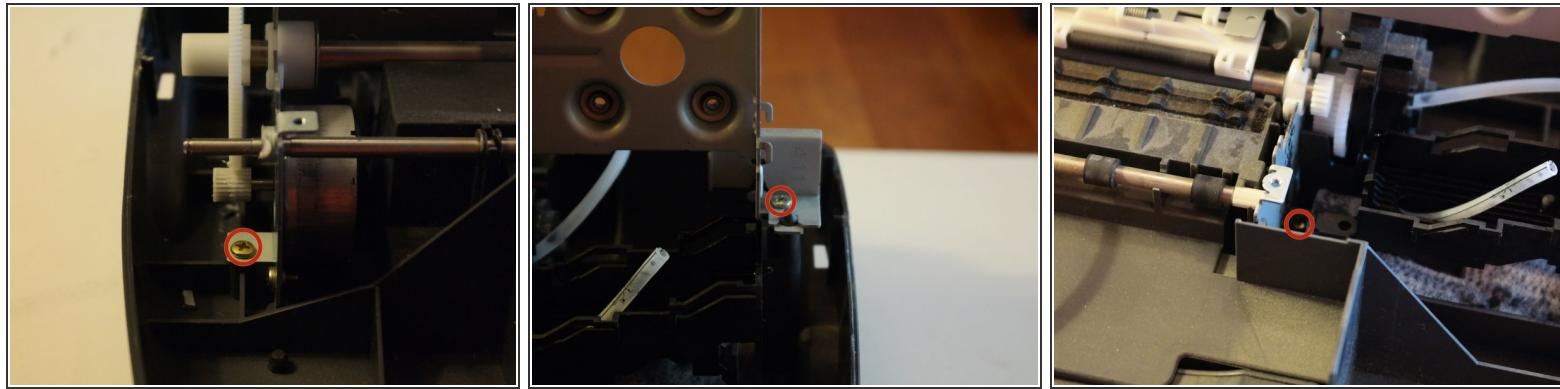
Step 31

- To remove the metal midframe of the printer, three screws must be removed.

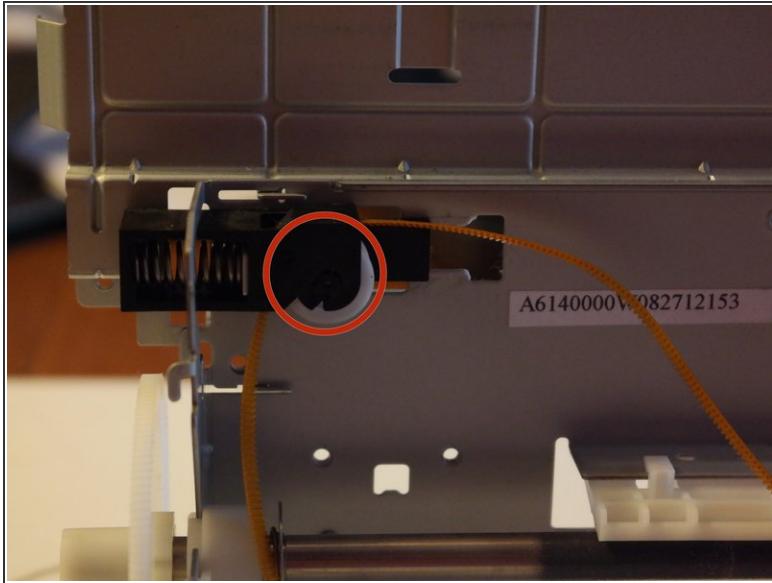
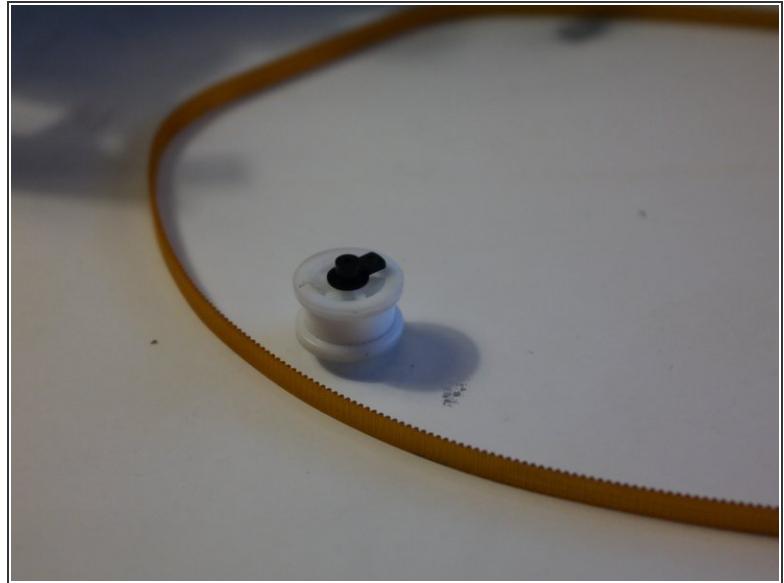
Step 35

- The tensioner wheel and drive belt can be removed by pushing it down out of the tensioner.

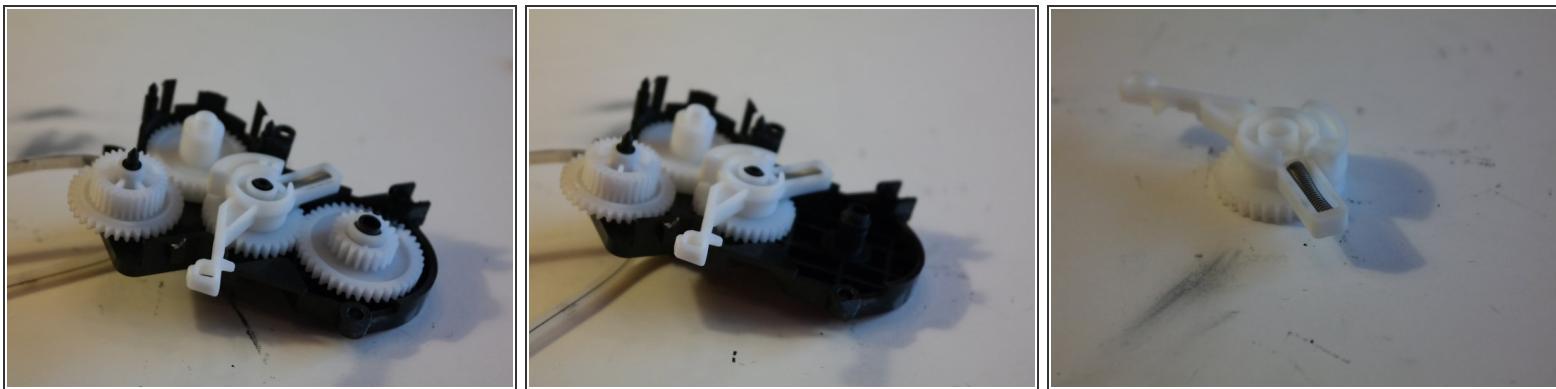
Step 37

- The gearbox drives the paper feed and the nozzle cleaning processes all from one motor.

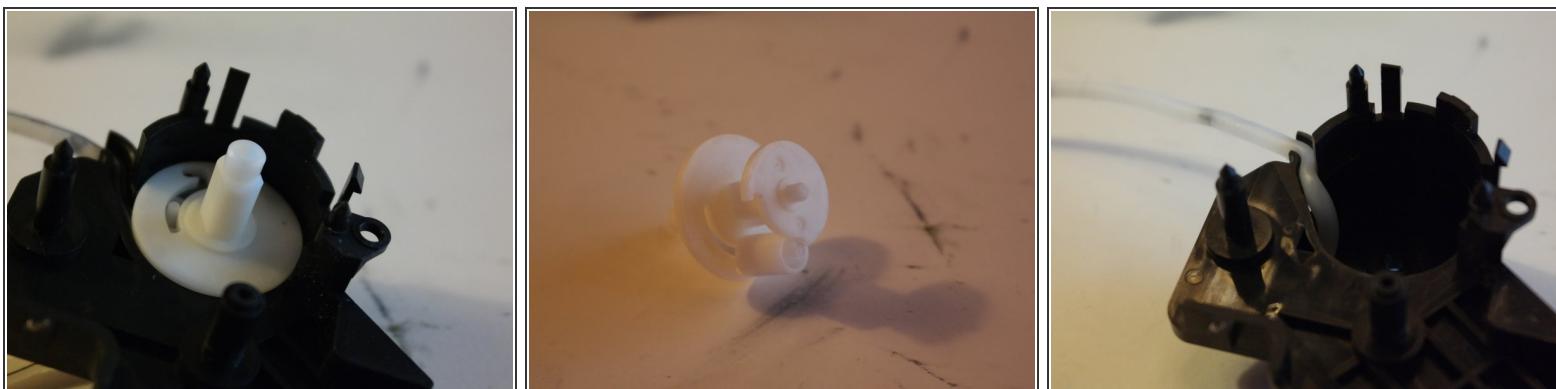
Step 38

- A close look at the peristaltic pump used to move ink from the nozzle cleaner to the large absorbent pads.

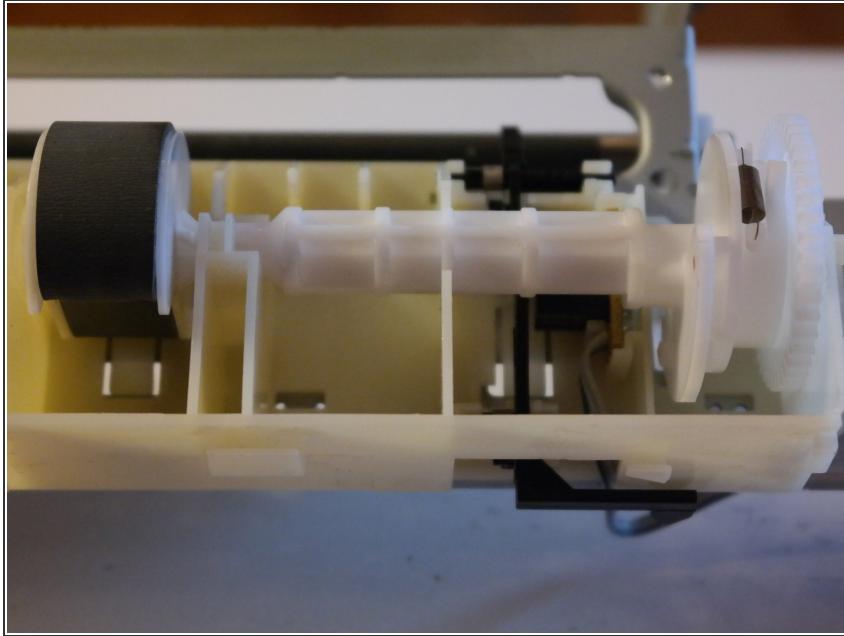
Step 39

- This is what is left of the paper feed mechanism. The circuit board contains two microswitches to detect if there is paper present.

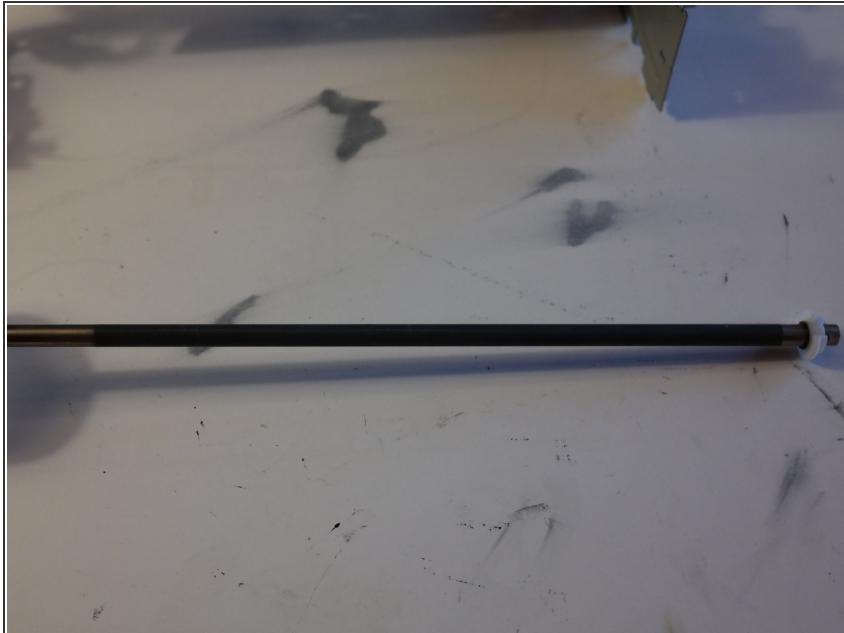
Step 40

- Another rod is removed from the printer.
- This rod is coated in something that helps it grip onto the paper better.

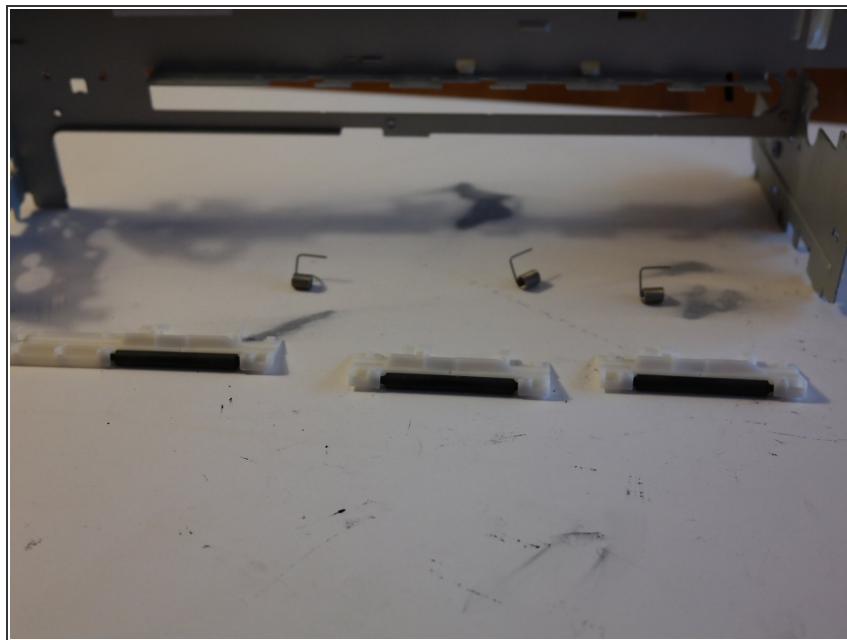
Step 41

- Lastly, here are the three spring-loaded rollers removed from the paper feed mechanism.

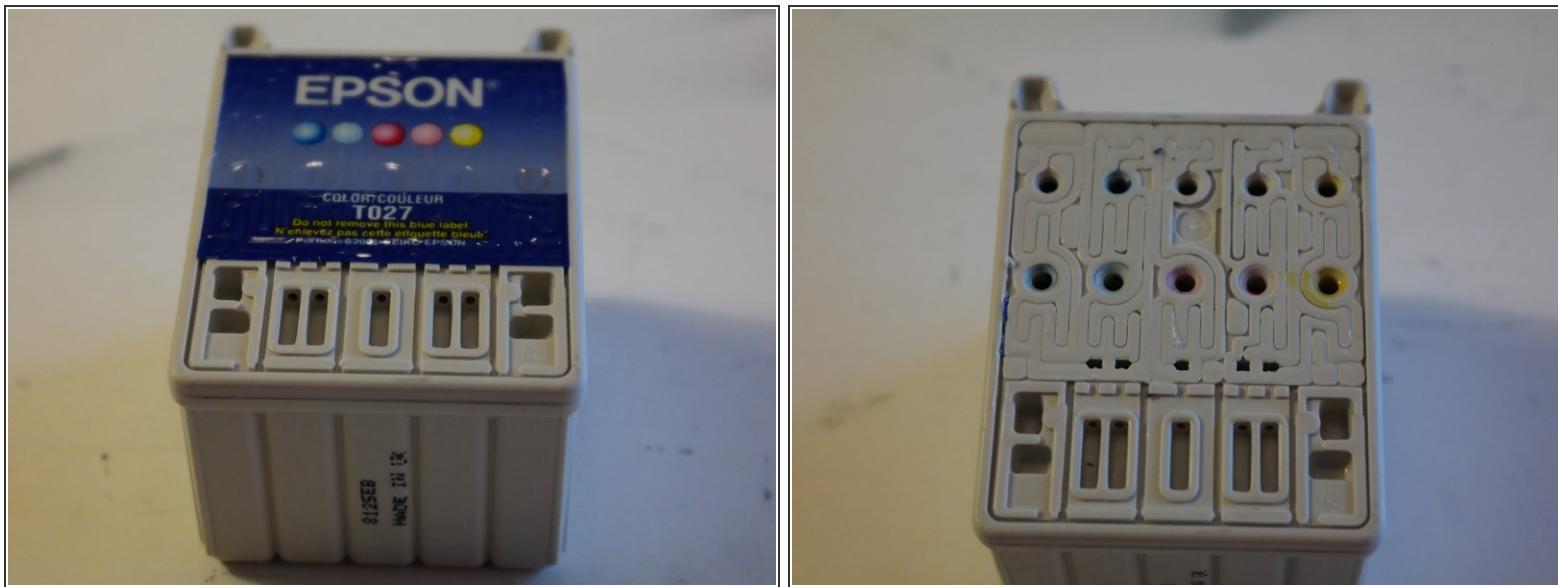
Step 43

- **Bonus Teardown Time!**
- Time to see what is underneath the 'Do not remove' sticker located on the ink cartridge.
- What is this network of labyrinthine passageways?
- The answer is a capillary tunnel to reduce ink pressure. The lower row of holes leads into the cartridge itself, while the top row leads to the ink nozzles.
