# Escort Passport 9500IX Button Board Replacement

This guide will help you with replacing your Escort Passport 9500IX button board.

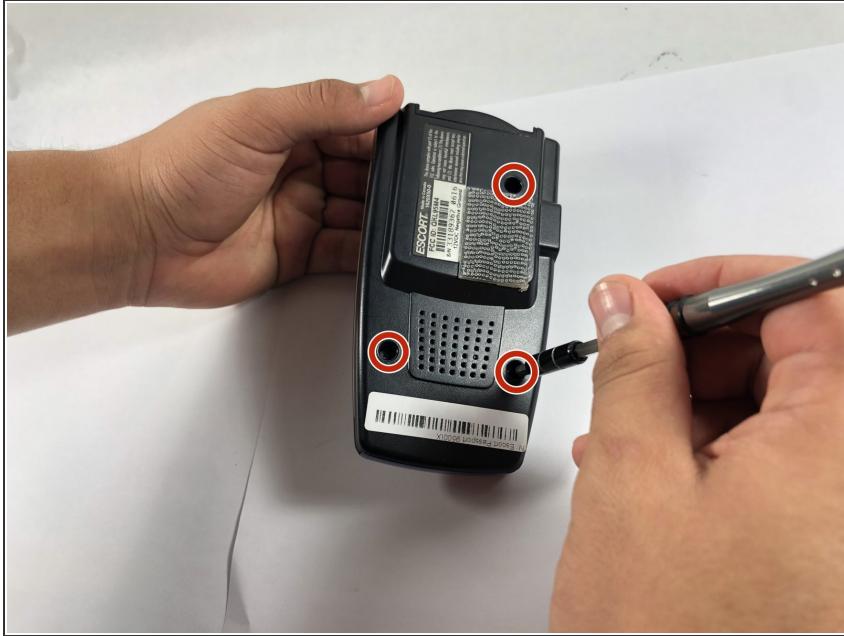
## Step 1 — Back Panel

- Remove the three 1.2 mm Phillips #1 screws on the back of the device.

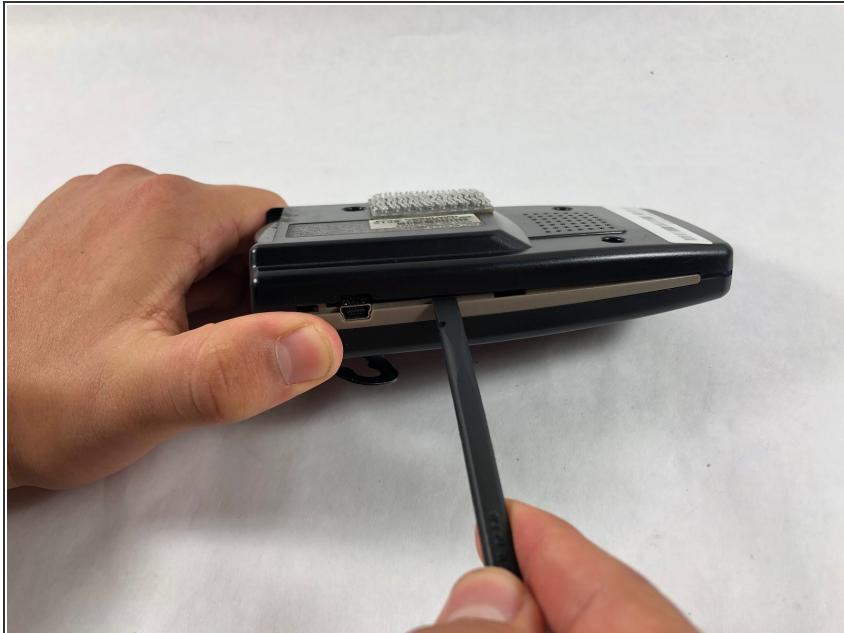
## Step 2

- Pry off the back panel of the radar using the nylon spudger.

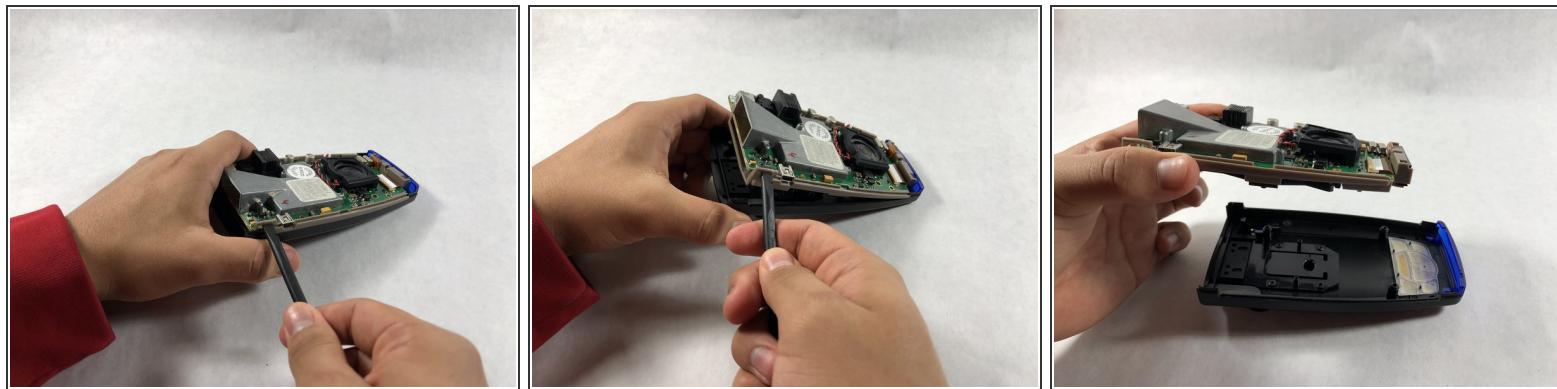
## Step 3 — Buttons

- Carefully pry the grey frame off the black plastic covering using the nylon spudger.

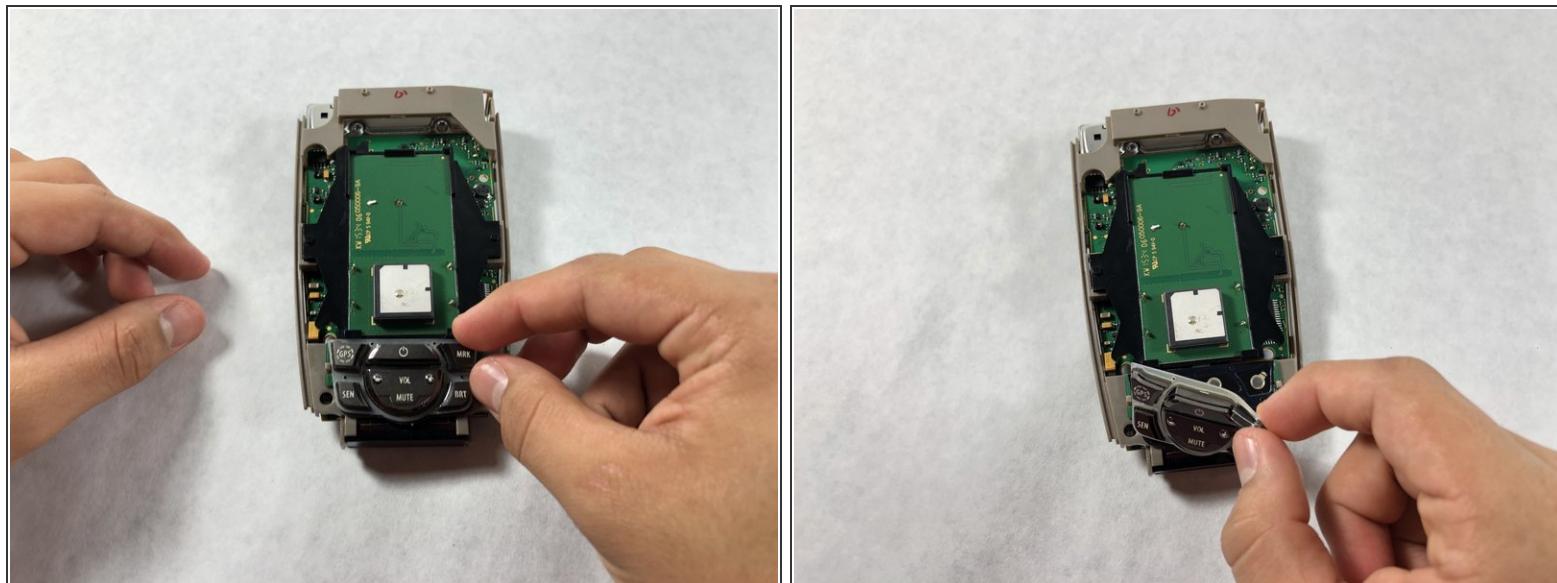
## Step 4

- Slowly peel the buttons off the button board.

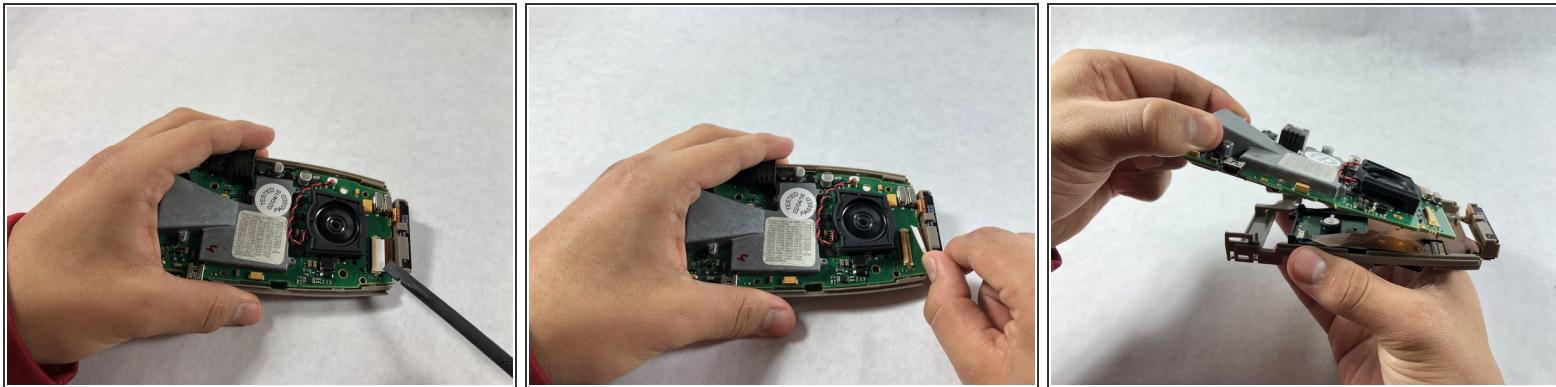
## Step 5 — Button Board

- Detach the orange flap on the motherboard.
- Carefully remove the motherboard from the grey plastic frame.

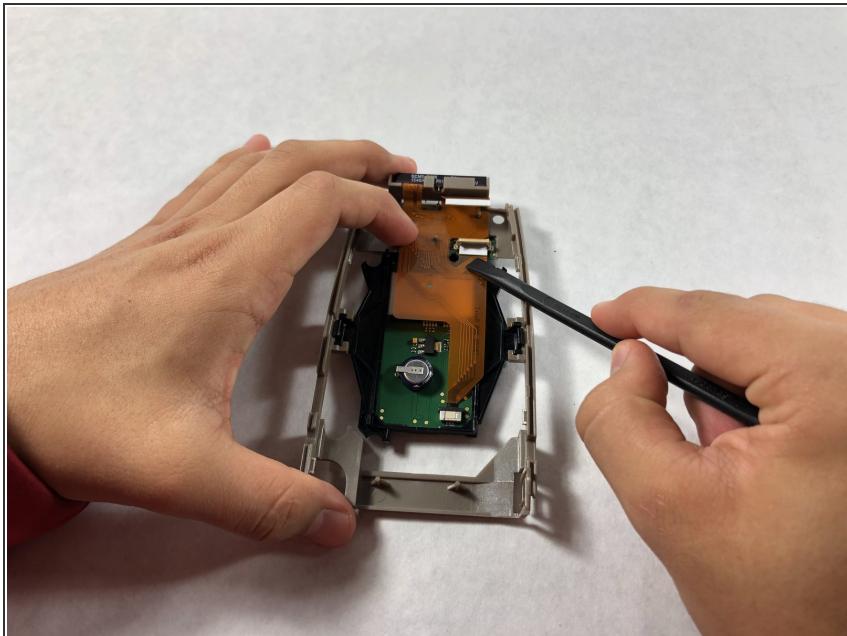
## Step 6

- Detach the orange flap directly behind the button board.

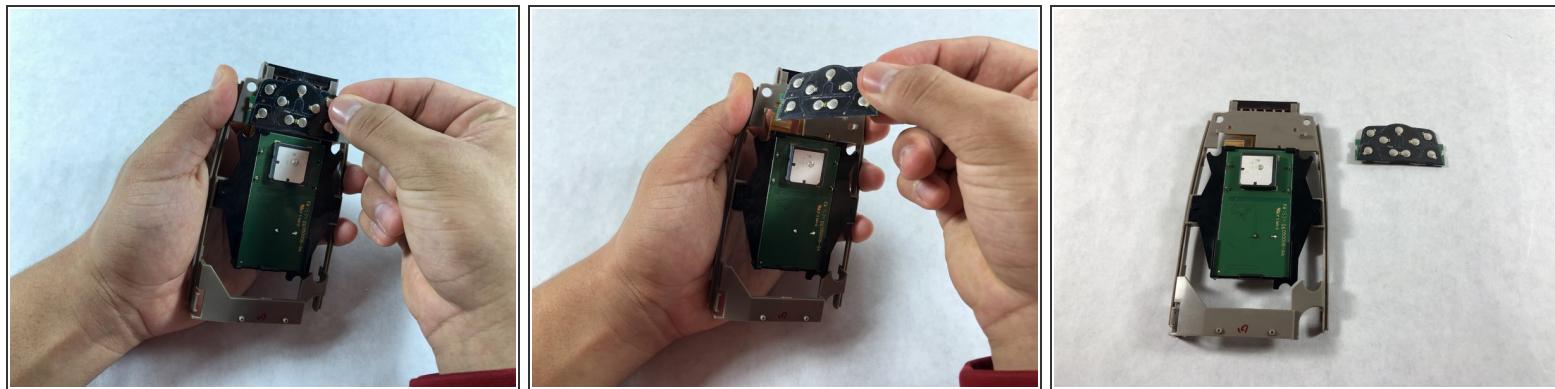
## Step 7

- Carefully pull out the button board from the grey frame.

To reassemble your device, follow these instructions in reverse order.
