# Face ID Teardown

Face ID System Teardown

## INTRODUCTION

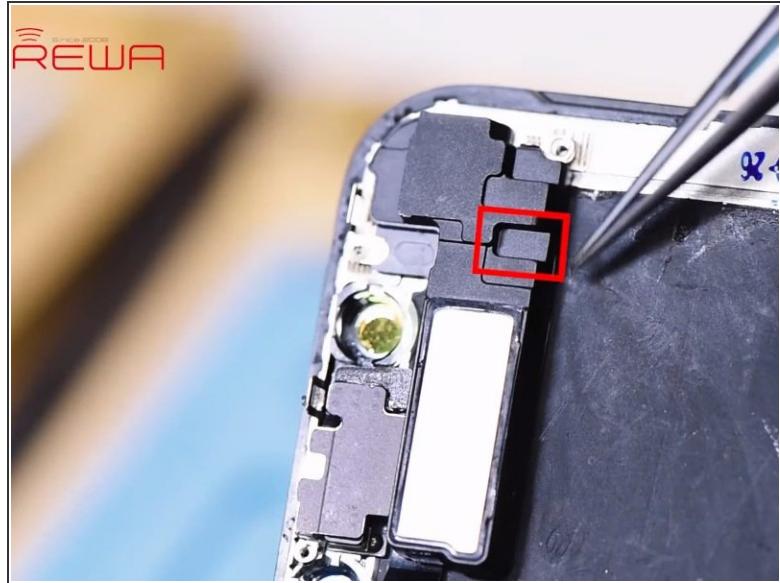
## Step 1 — Face ID System

- There are 8 components packed into the front of the phone. Infrared Camera; Flood Illuminator; Proximity Sensor; Ambient Light Sensor; Speaker; Microphone; Front Camera; Dot Projector;
- The infrared camera, the dot projector and the front camera are located on the back glass assembly.
- The flood illuminator, the proximity sensor, the ambient light sensor, the speaker and the microphone are located on the display assembly.

**⚠** Please be careful when disassembling or repairing the phone. Damage of any component will cause Face ID failure.

**⚠** Please be noted that there is a slot on the display assembly. When assembling the phone, the fold of the speaker flex cable should be placed correspondingly in the slot to prevent the cable from getting broken. Which will also result in the failure of Face ID.
