# Ford Taurus Air Re-Circulation Door Motor Replacement

This guide will show you how to replace the Air Re-Circulation Door Motor in your 2008 Ford Taurus.

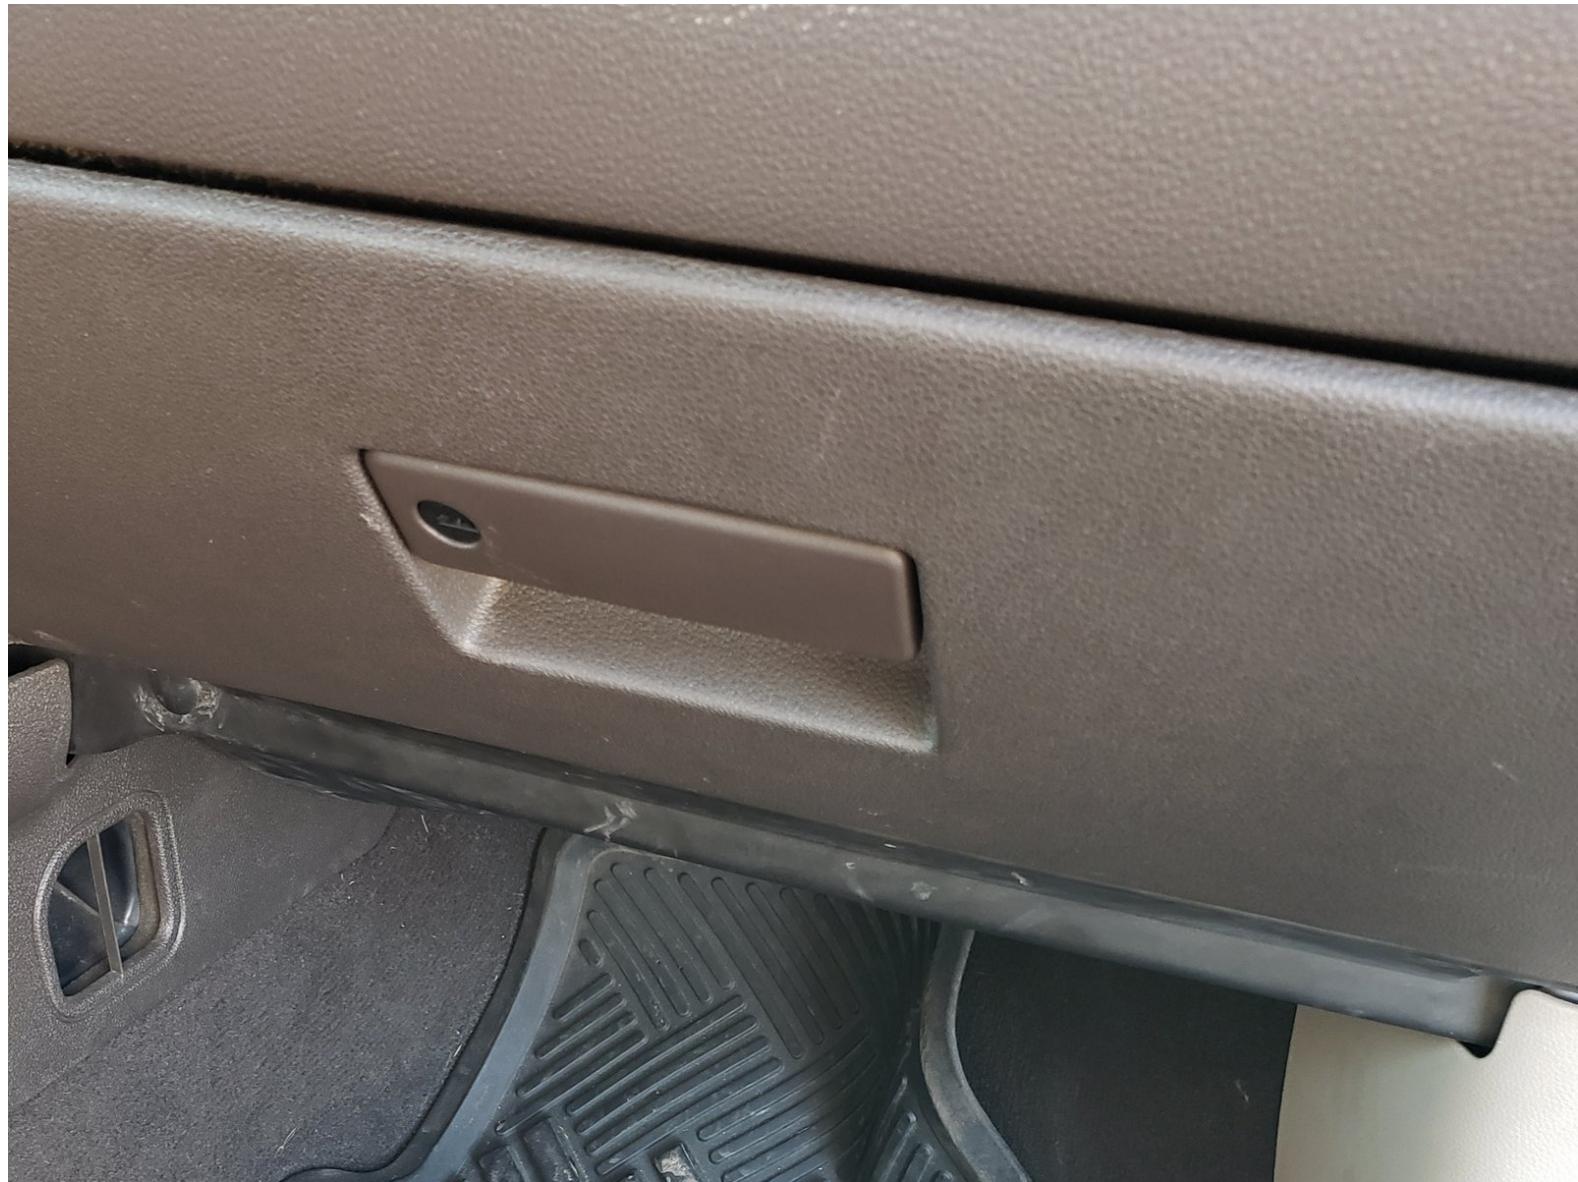
If your Taurus is making a loud clicking/grinding sound when using both the A/C and heat while using the air recirculation feature, the motor is bad.

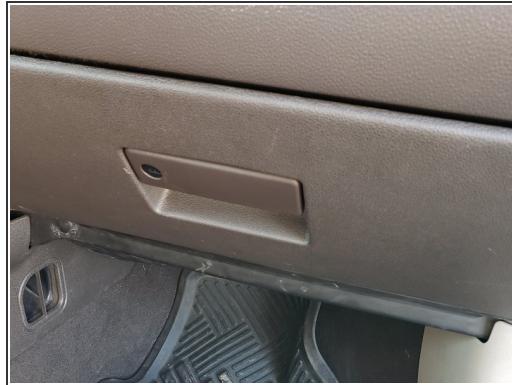
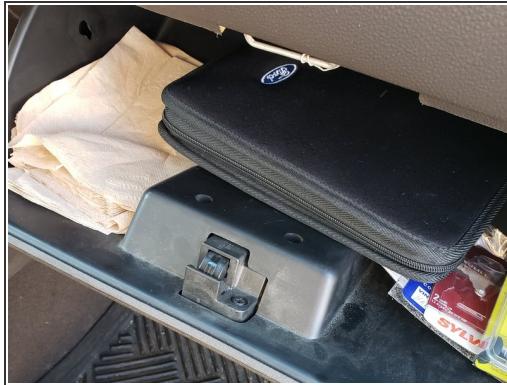
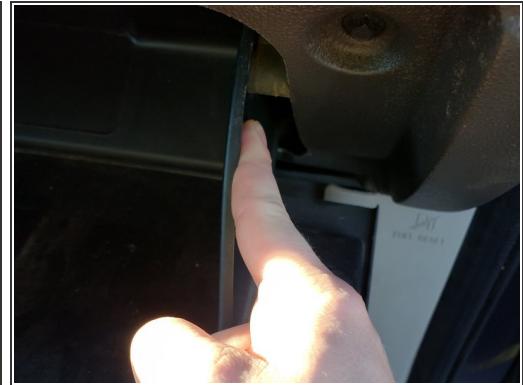
## Step 1 — Time to drop the glovebox (Not literally)

- Tired of the clicking/grinding when using the air re-circulation feature in your Taurus? Follow this guide, and there will be no more of it.
- Make sure to empty out your glovebox, so when you drop it down, all of your stuff doesn't fall out.
- Once your glovebox is empty, gently press in on both sides to release the latch, and the glovebox will fold down towards the floor.

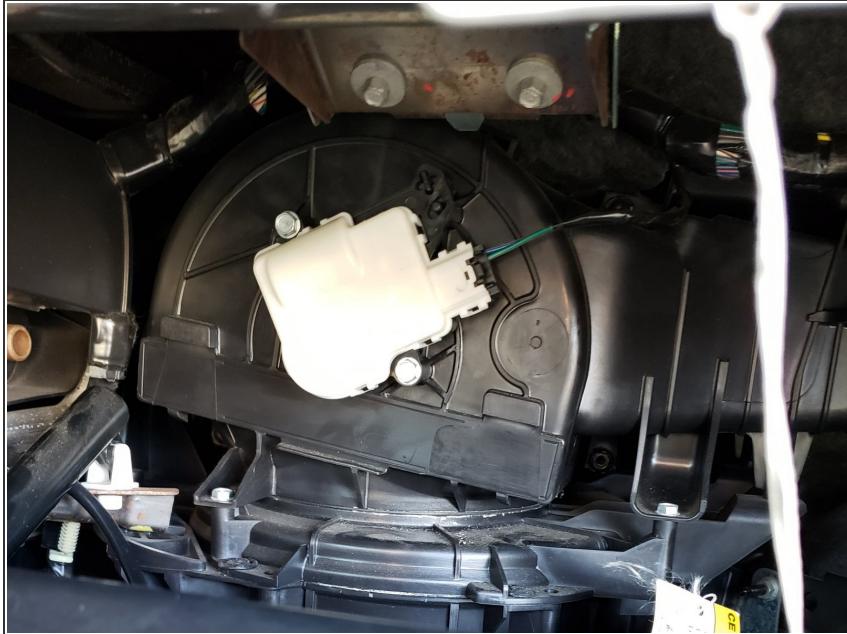
## Step 2

- Looking ahead, you'll see the white motor with two 11mm mounting screws.
- First pull the wire connector from the harness by pressing the harness clip, and gently pull the wire out. Now it is disconnected, and you can let it dangle. (Don't worry it won't run off)

- Now you can use an 11mm socket attached to a ratchet to quickly unscrew the two screws. Once the screws are free, gently pull the motor out.
- Replace with Motorcraft YH-1779 Motor Assy.

- When installing the new motor, ensure the teeth on the spindle match up to the direction they are in on the connector. Don't worry about lining it up perfectly with the screw holes when installing it, as you can make the adjustment when it pops in.

- Lastly, tighten down the two 11mm screws, but be careful not to crack the plastic by tightening them too tightly. Now connect the electric wire into the harness, and you can gently push both sides of the glovebox back in, and lift it back into place. Good job, no more grinding!
