# Garmin Nüvi 52LM USB Charge Port Replacement

This guide will show you how to replace the USB charge port on your Garmin Nüvi 52LM.

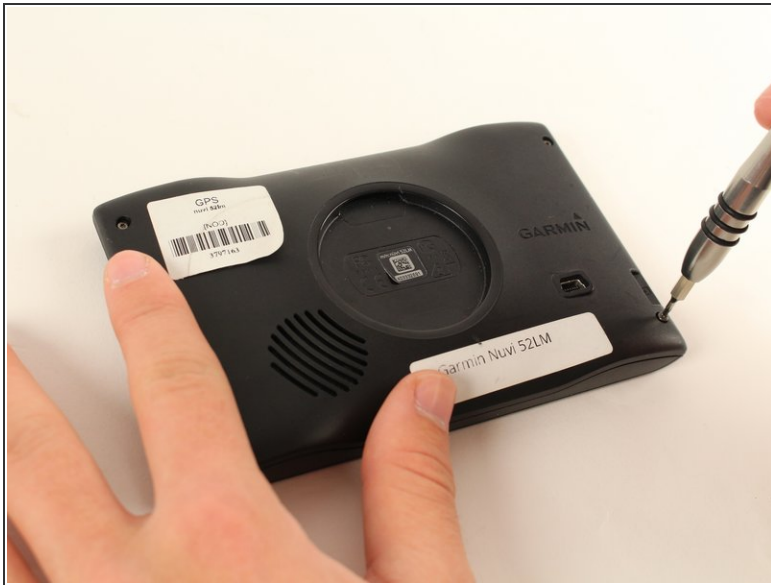
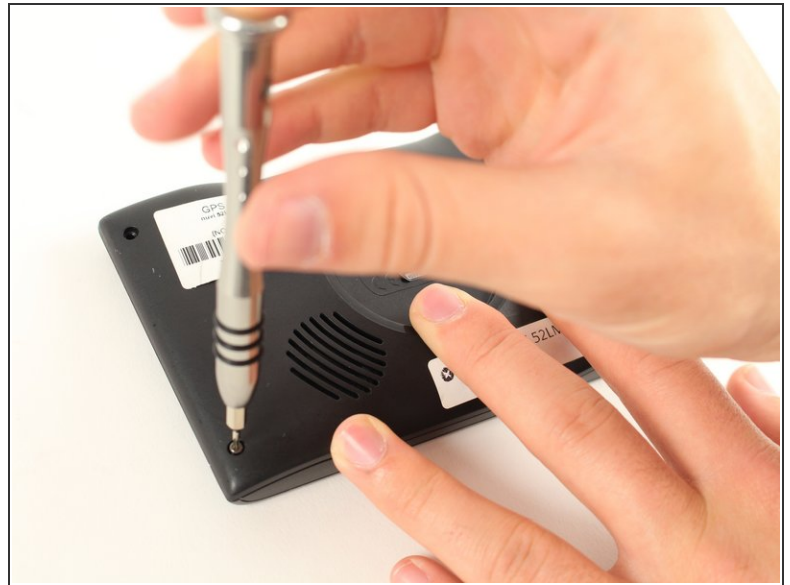
## Step 1 — Garmin Nüvi 52LM Disassembly

- Place the device face-down, with the screen facing the surface. There are **8.7mm** screws located in each of the back 4 corners of the device. Using a T5 Torx screw bit, unscrew all four screws and leave them aside.

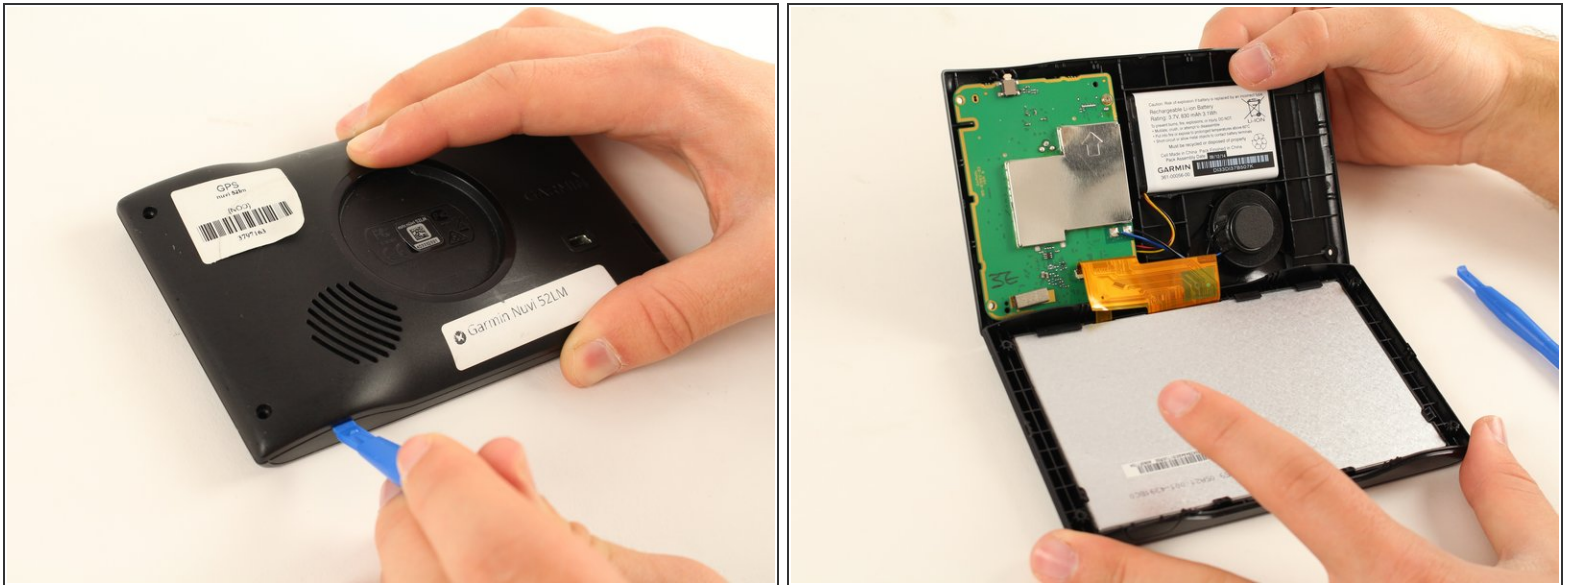
## Step 2

- Place a plastic opening tool in the seam between the back and front plates of the device. Using constant pressure, slowly and continuously slide the tool along the seam. The tool should disable each of the hooks holding the two plates together. If unsuccessful, apply slightly more pressure and try again.
- Once all hooks are disabled, slowly separate the two plates, being careful not to damage the ribbon wire still connecting the two.

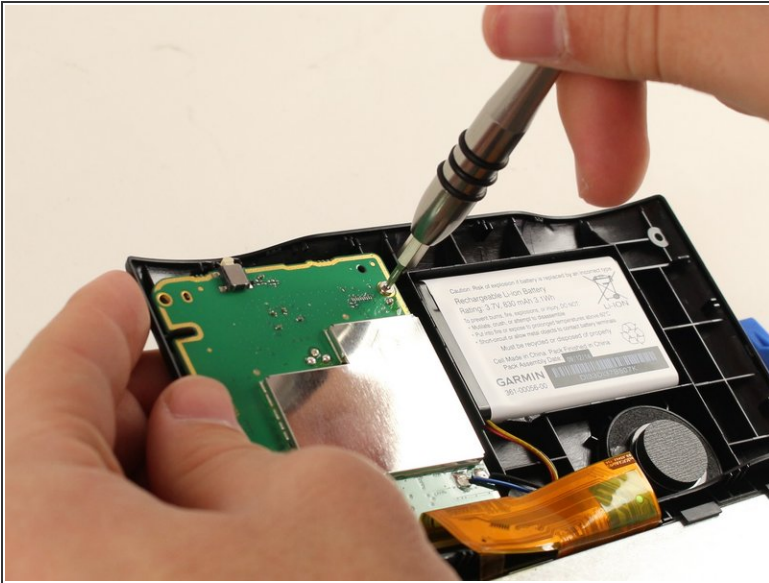
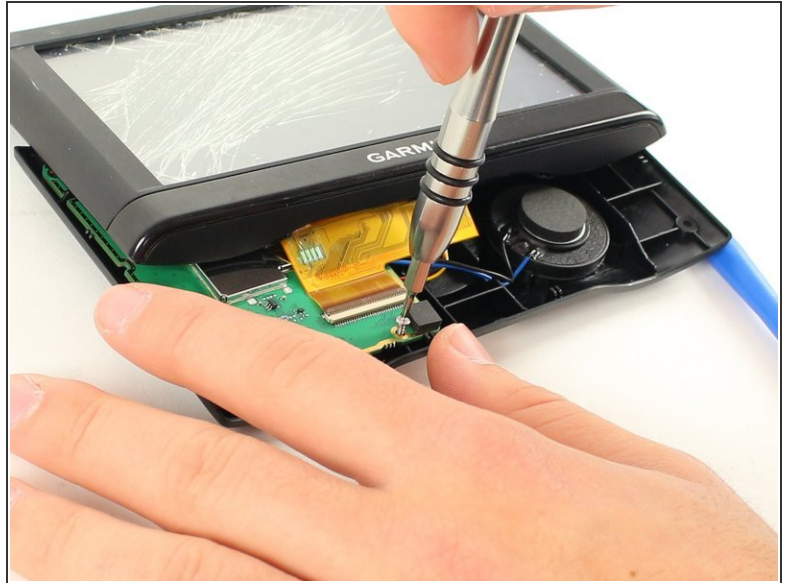
## Step 3 — Battery

- Using the T5 Torx screwdriver, unscrew the two **5.6mm** screws at the top right and bottom right corners of the motherboard.

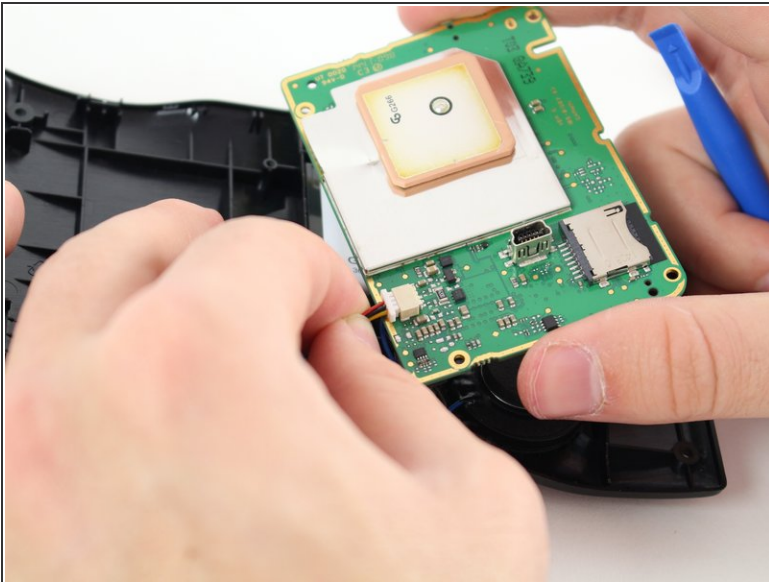
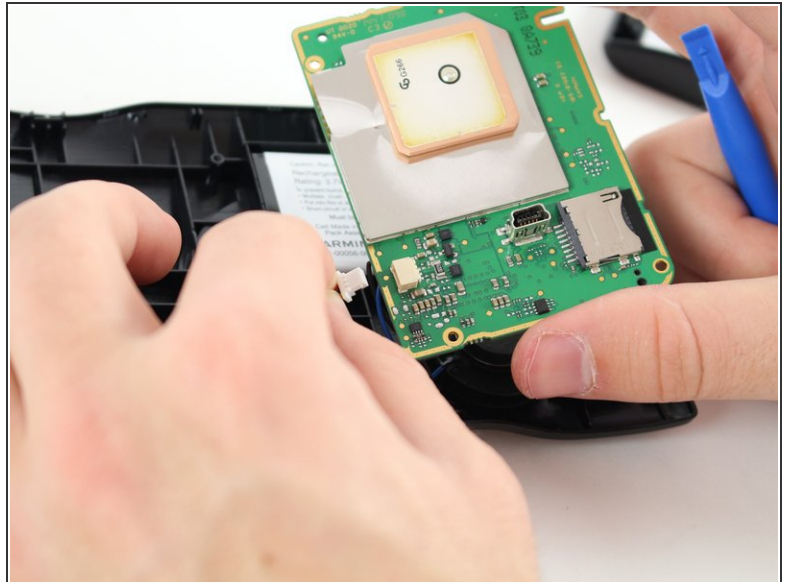
## Step 4

- Gently unplug the wire connecting the battery to the small socket on the back of the motherboard.

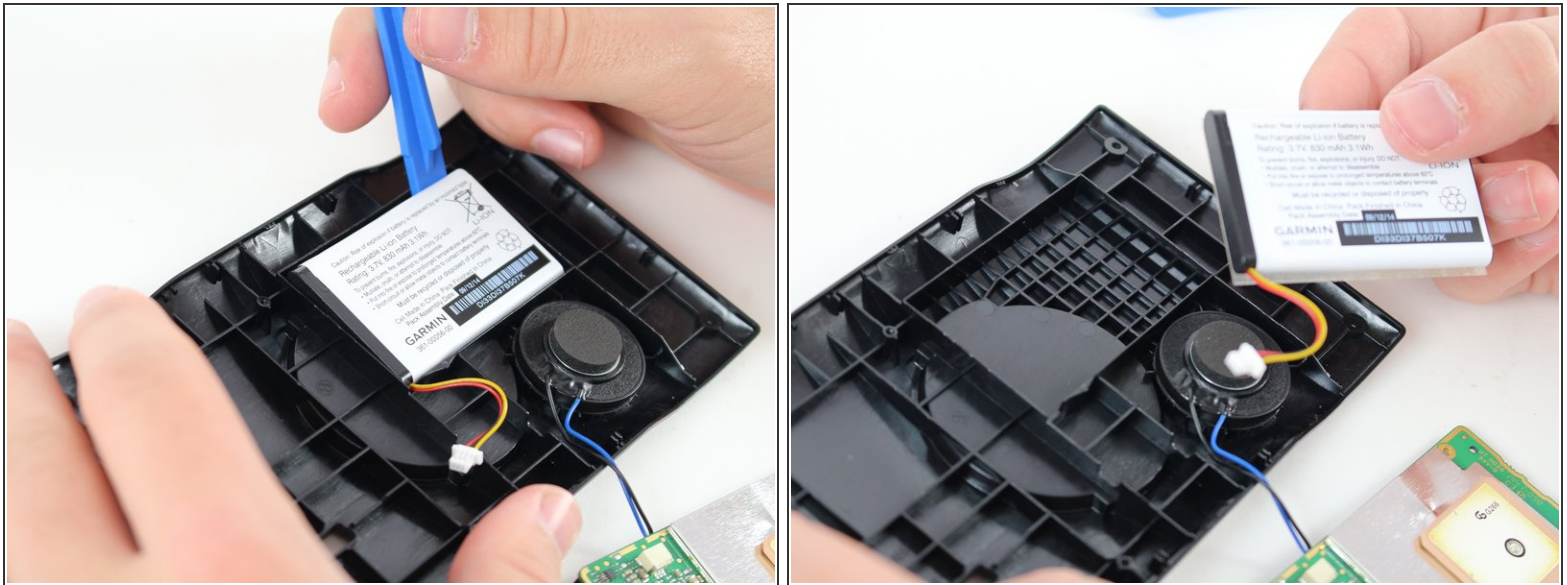
## Step 5

- Using a plastic opening tool, pry the battery from the back cover of the device. There may be an adhesive sticker keeping it in place, so you may need to apply some force.
- The battery should now be completely detached from the other parts.

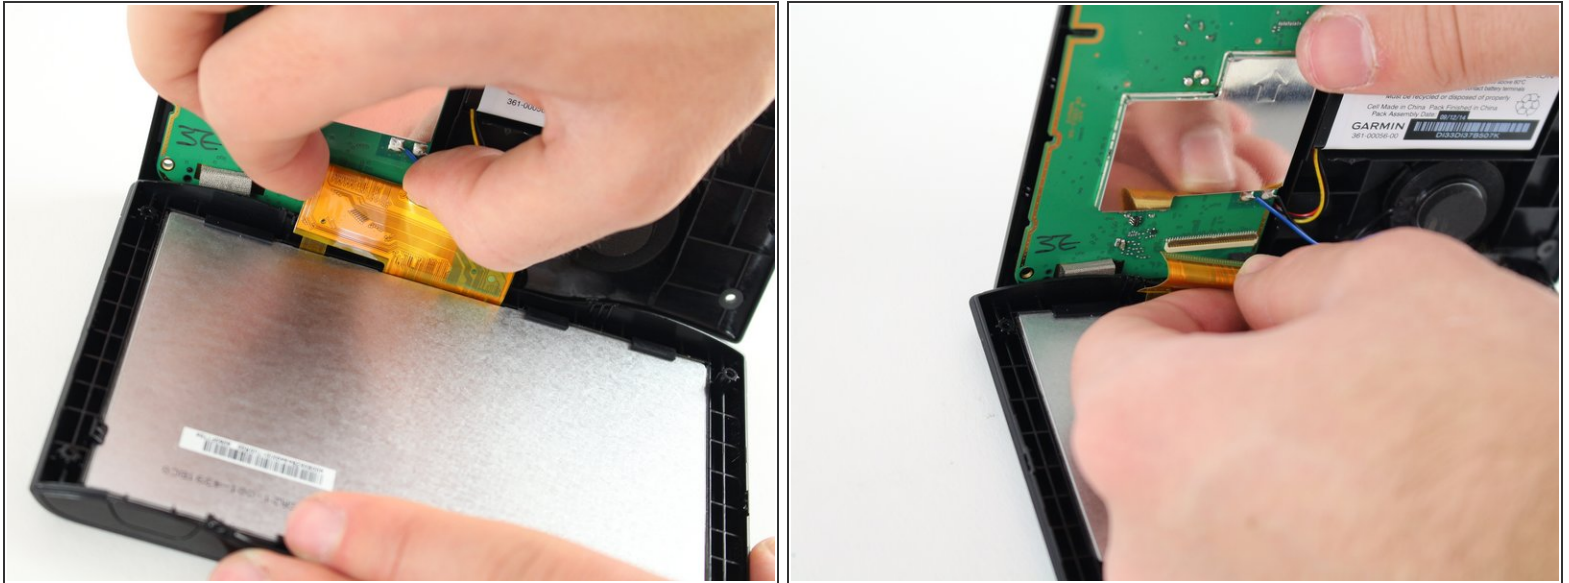
## Step 6 — USB Charge Port

- On the motherboard, lift the small plate that holds the orange ribbon wire in place.
- Gently disconnect the ribbon wire from its connection to the motherboard.

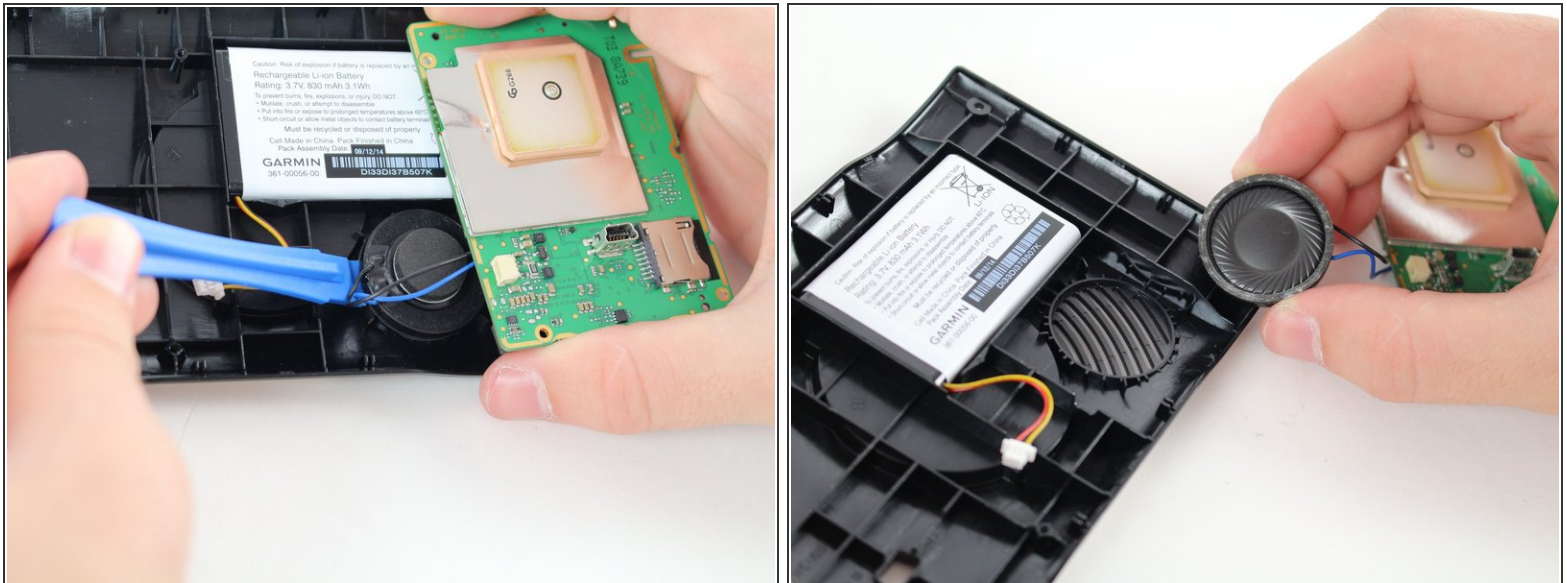
## Step 7

- Using a plastic opening tool, pry the speaker from the back plate of the device. There may be a small amount of adhesive connecting the two, so you may need to use a small amount of force.
- The motherboard and USB charge port should now be completely detached from the other parts of the device, and a new one can now be placed.
