# Garmin Nuvi 2589LMT Microphone Replacement

A simple guide to replace your Garmin Nuvi 2589LMT Microphone.

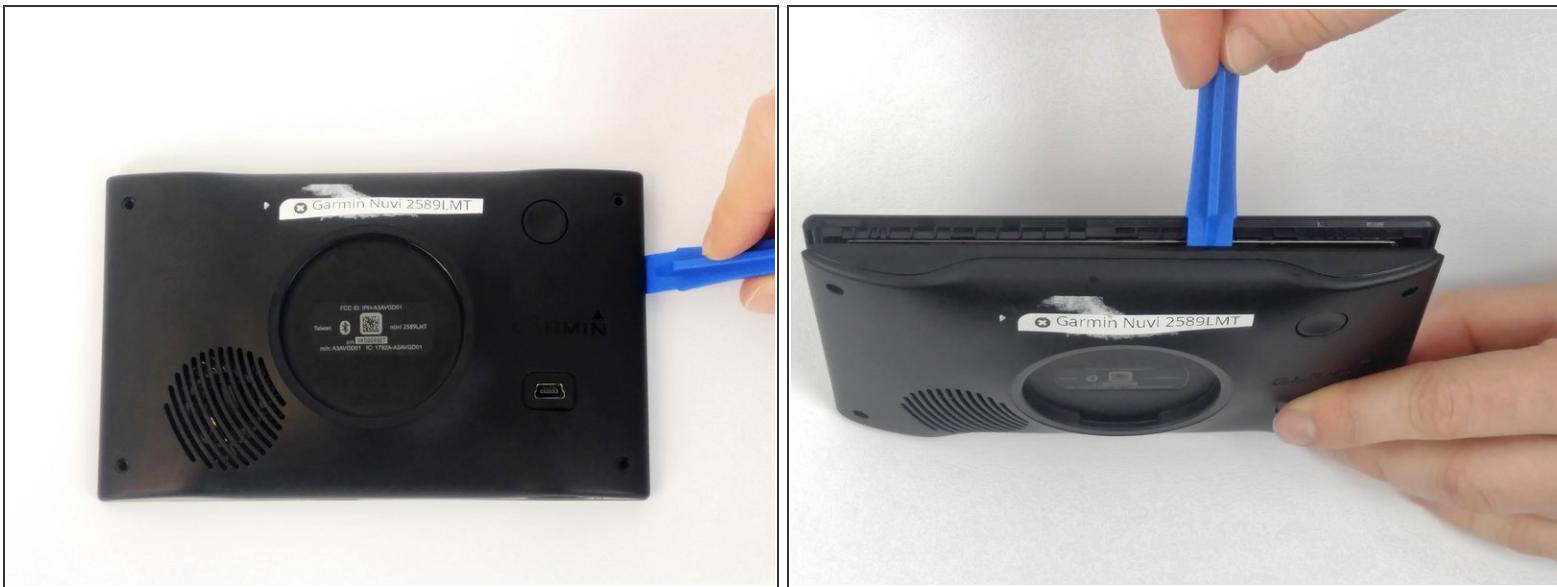
## Step 2

**⚠** Do not disconnect or tear the ribbon wiring, located at the bottom of the motherboard, when removing the back of the device.

- Using the plastic opening tools, pry the shorter sides of the device apart.
- Once a gap has formed at the top of the device, insert the opening tool into the gap and slide it along the top of the device. Repeat for the bottom edge of the device to separate the LCD screen from the back.
