Garmin Nuvi 2589LMT Motherboard Replacement

A simple guide to replace your Garmin Nuvi 2589LMT motherboard.

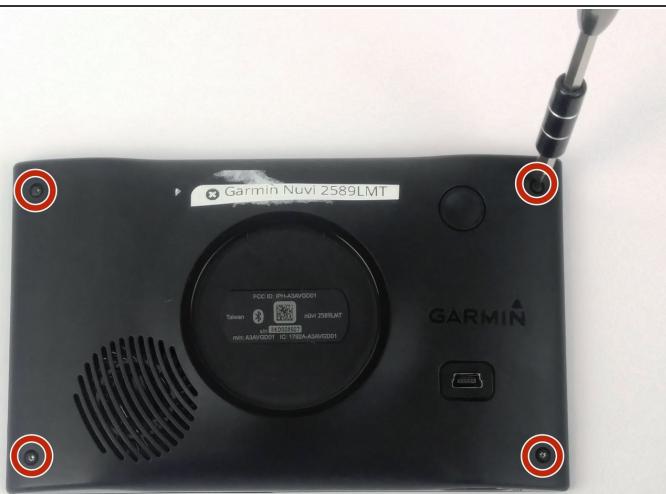
Step 1 — Back Panel Assembly

- Using the T5 Torx Screwdriver, remove all 4 of the 5.7mm screws from the back of the device.

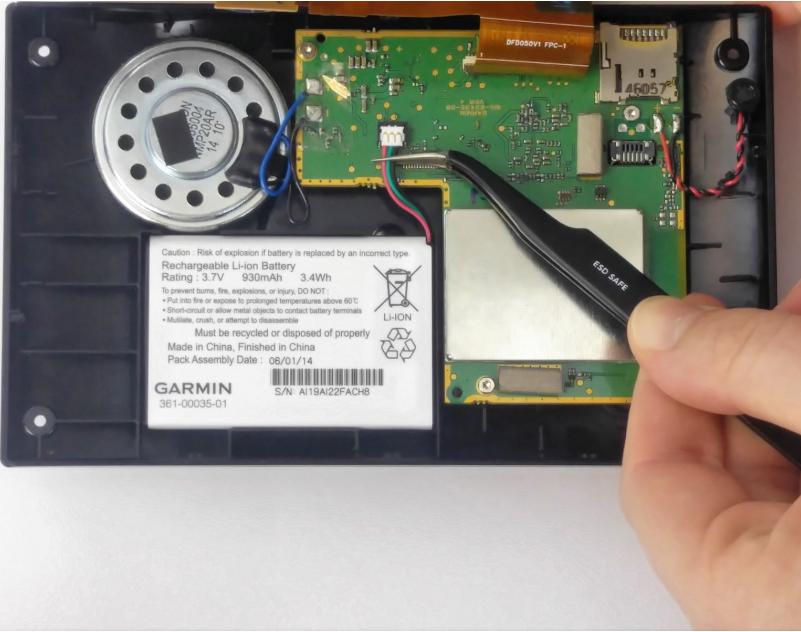
Step 3 — Motherboard

- Using the angled tweezers, grip the red, black, and green wires connecting the battery to the motherboard, then gently lift away from the motherboard.

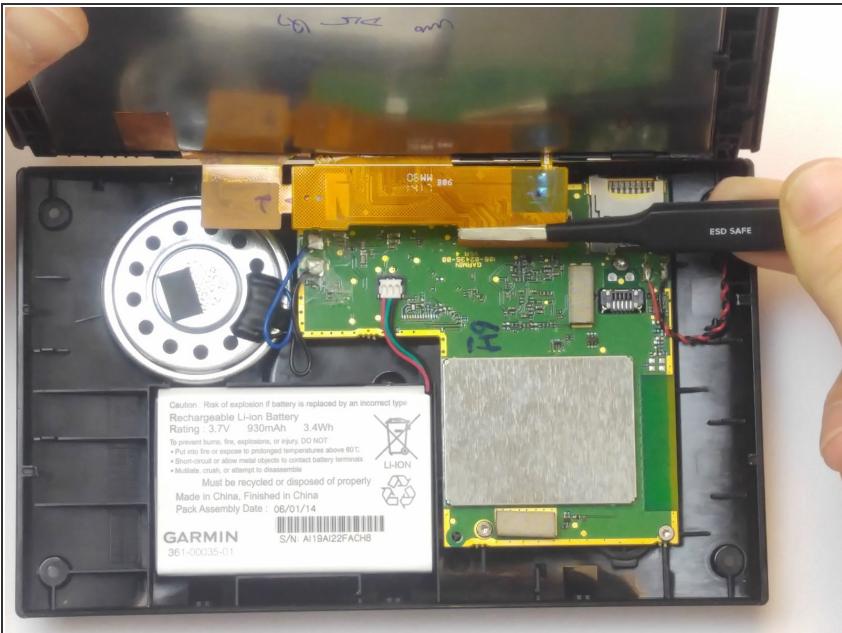
Step 4

- Using the tweezers, gently pull the ribbon wiring near where it connects to the motherboard to disconnect it from the motherboard.

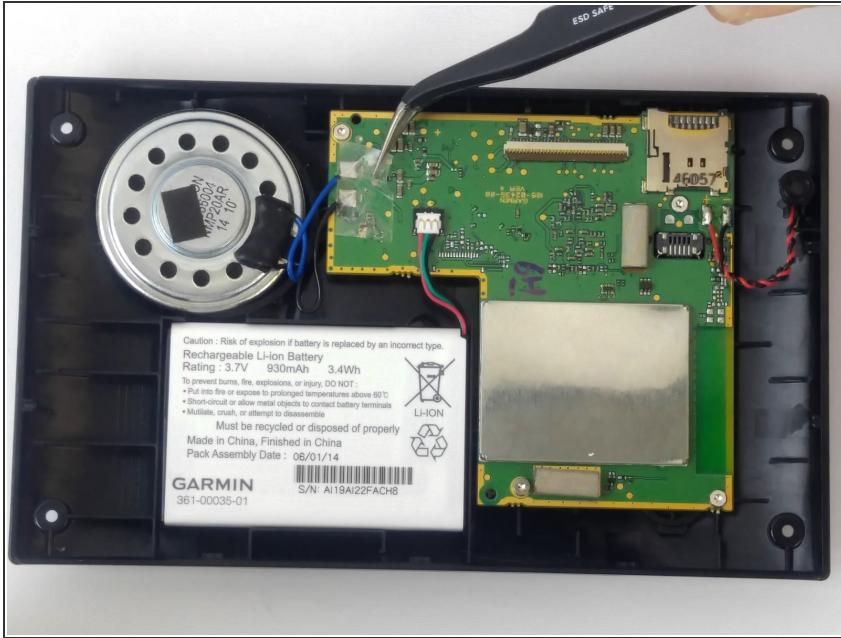
Step 5

- Using tweezers, remove the tape covering the speaker connection to the motherboard.

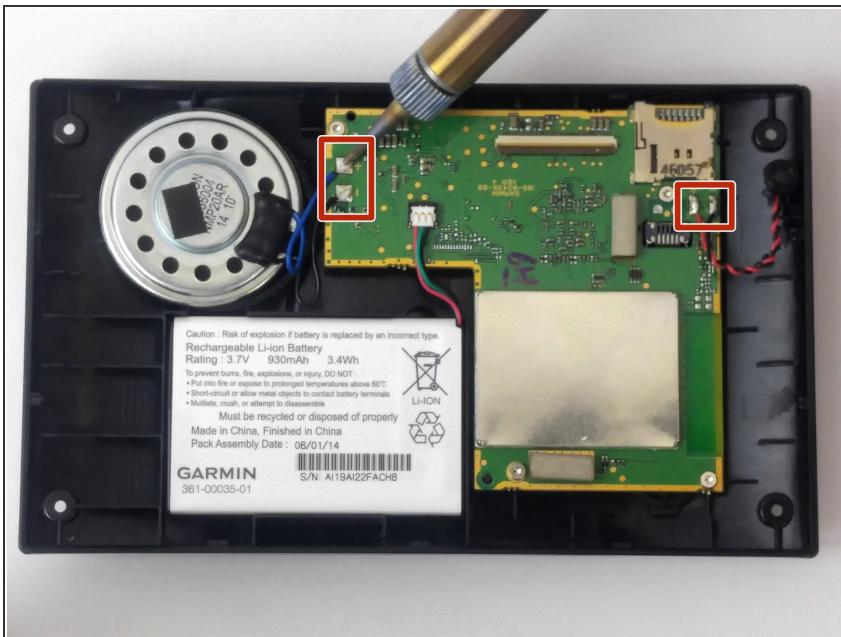
Step 6

- Using a soldering iron, desolder all connections to the motherboard.

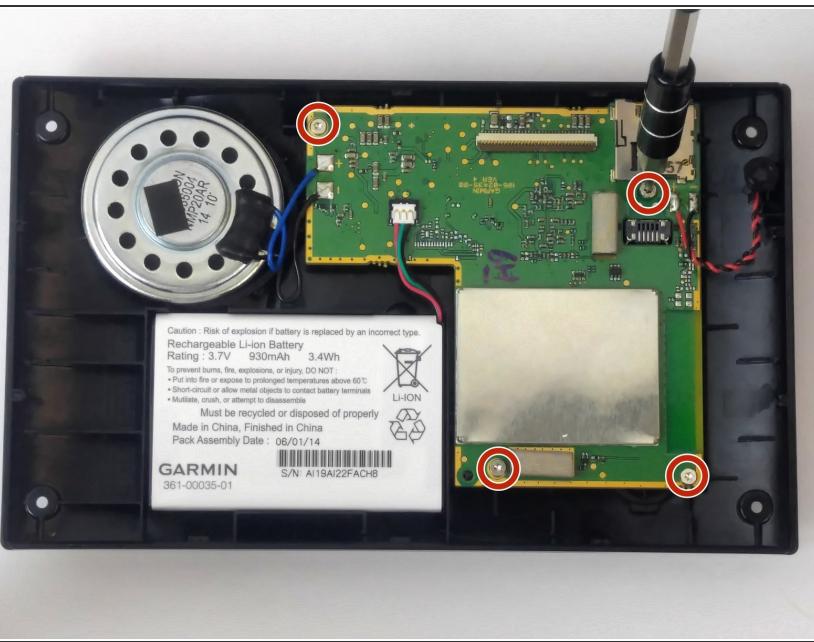
Step 7

- Using the T5 Torx Screwdriver, remove all 4 of the 4.0 mm screws from the motherboard.

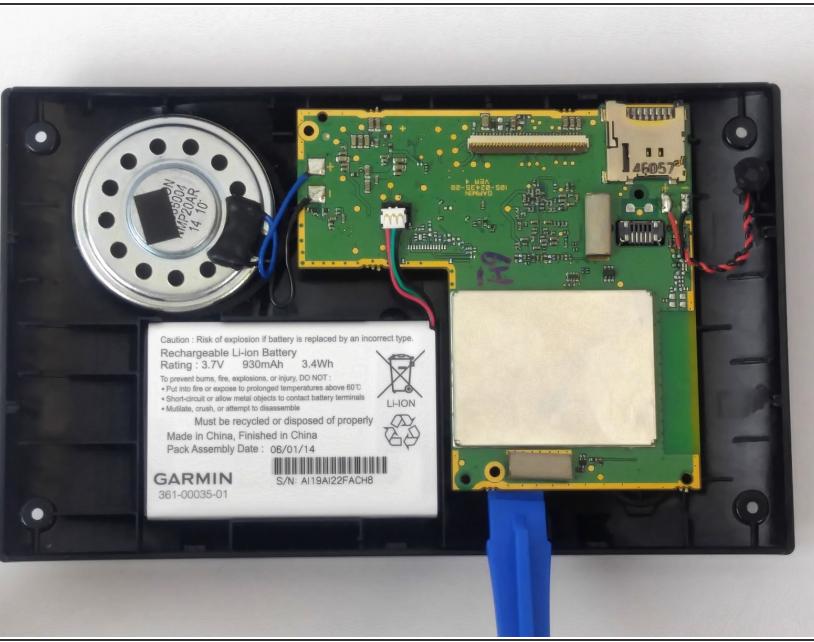
Step 8

- Using the plastic opening tools gently pry the motherboard away from the case.
