Garmin Nuvi 2589LMT Speaker Replacement

A simple guide to replace your Garmin Nuvi 2589LMT speaker.

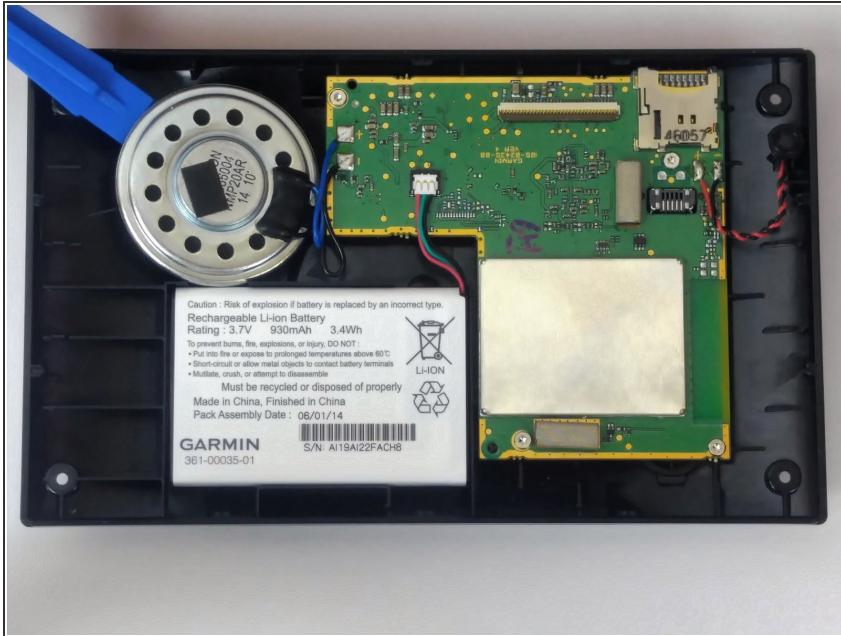
Step 3 — Speaker

- Wedge the speaker from the device, using the small plastic opening tool.

(i) The speaker is held in place by adhesive tape on the outer rim. Because the speaker is still connected to the motherboard, pry the speaker away from the device gently.

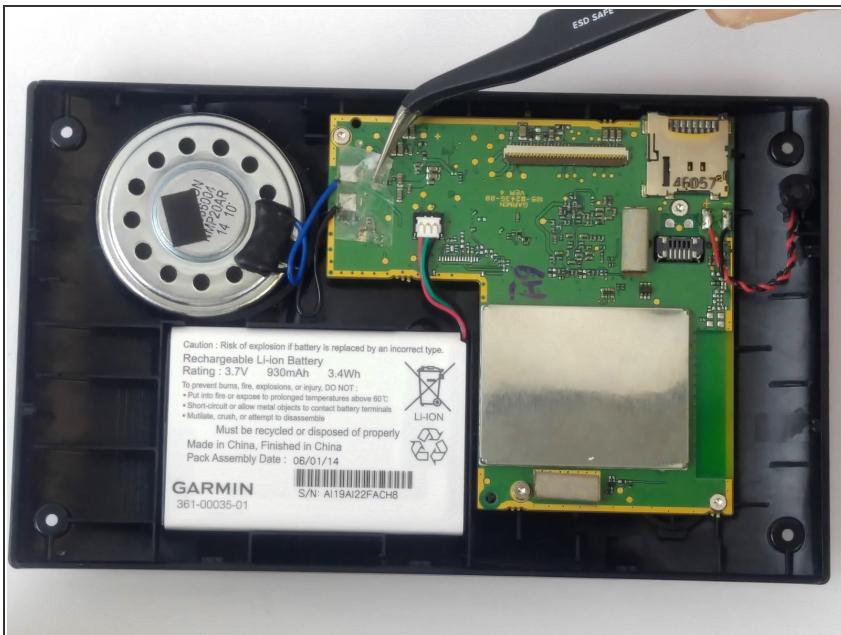
Step 4

- Using tweezers, remove the tape covering the speaker connection to the motherboard.

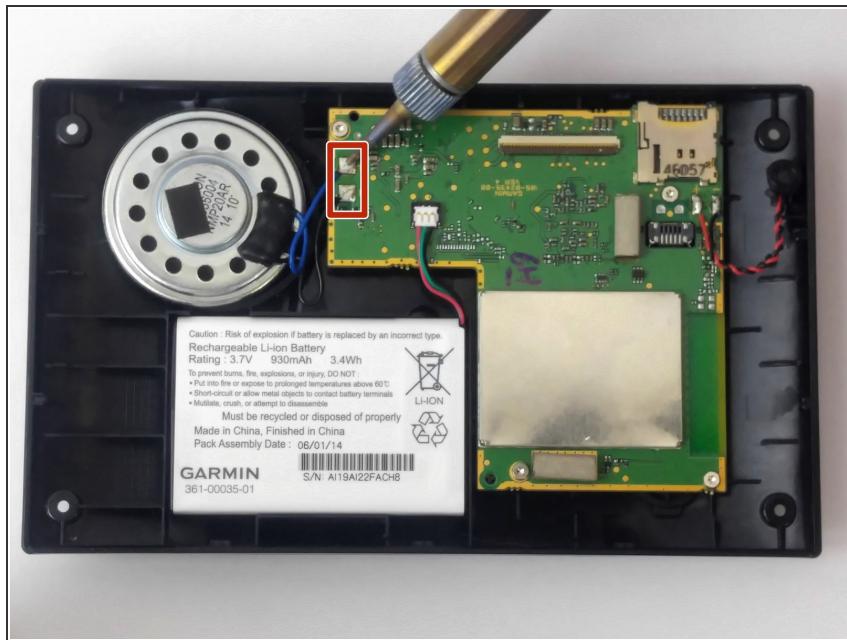
Step 5

- Using a soldering iron, desolder the wire connection at the soldering points between the speaker and the motherboard to remove.
- Learn more about soldering and desoldering connections [here](#).*
