HP 310-1037 Hard Drive Replacement

Very straight forward repair with only a few common tools.

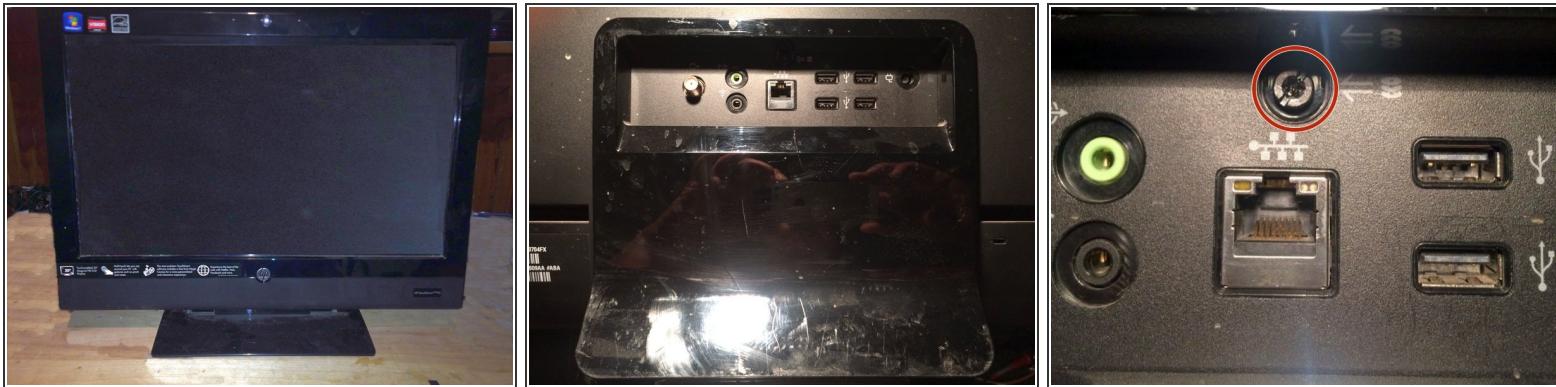
Step 1 — Hard Drive

- HP310-1037 Touchsmart PC with a dead hard drive. The hard drive is located behind the stand cover.
- Lay the PC flat on the front to gain access to the stand cover
- Remove the single screw that holds the stand cover to the chassis with a flat tip screwdriver

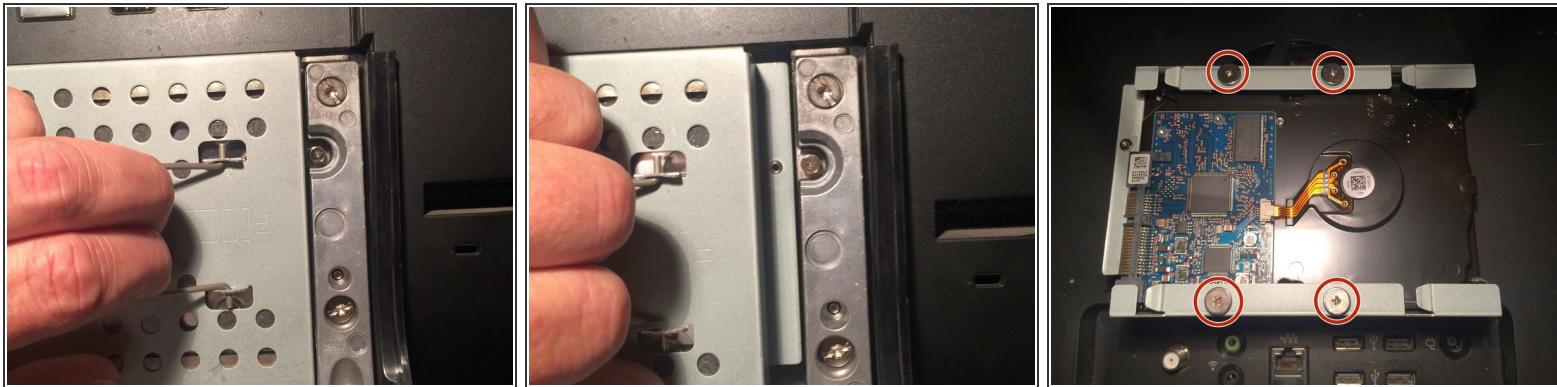
Step 3

- Lift the handle on the hard drive caddy
- and pull it to the backside. This will remove the hard drive caddy from the computer.
- To remove the hard drive from the caddy, turn it over. There are four Phillips screws that hold the hard drive in place.
