HP Chromebook CB2L Audio Port Replacement

This guide helps one remove and replace the Audio port of the HP Chromebook CB2L.

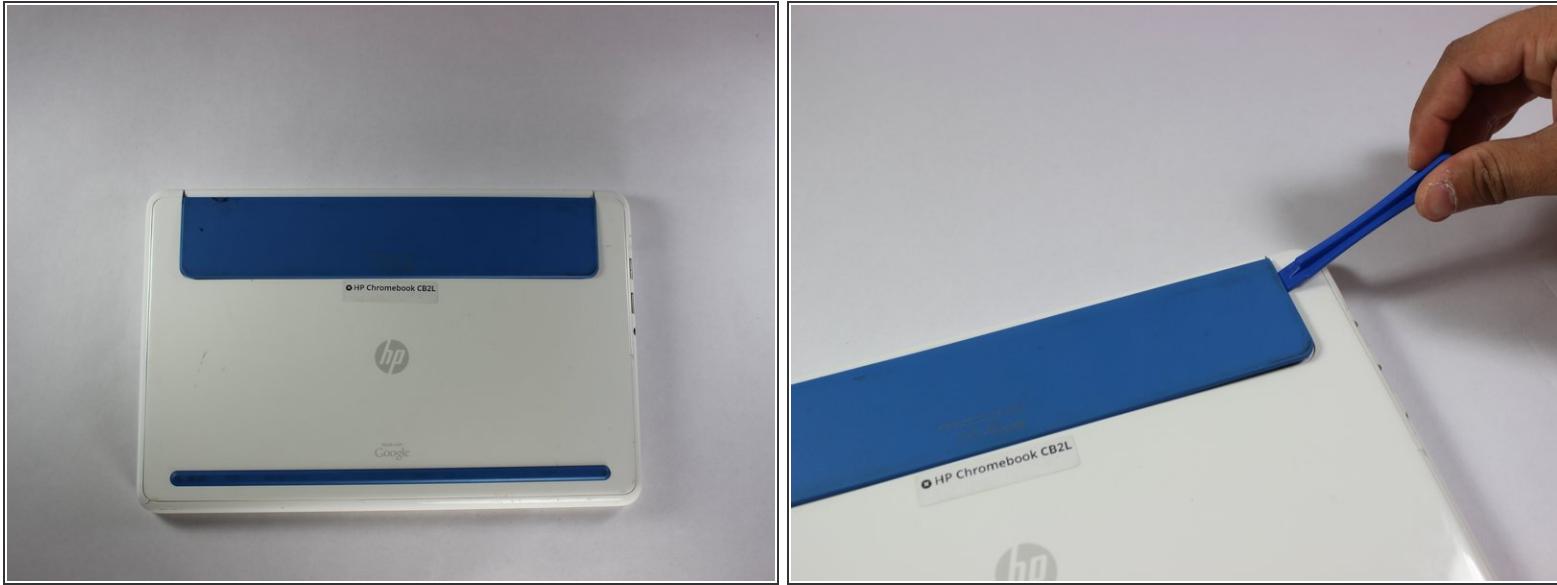
Step 1 — Audio Port

- Flip Chromebook over so that the bottom panel is facing upward.
- Use the plastic opening tool to remove the blue panel.

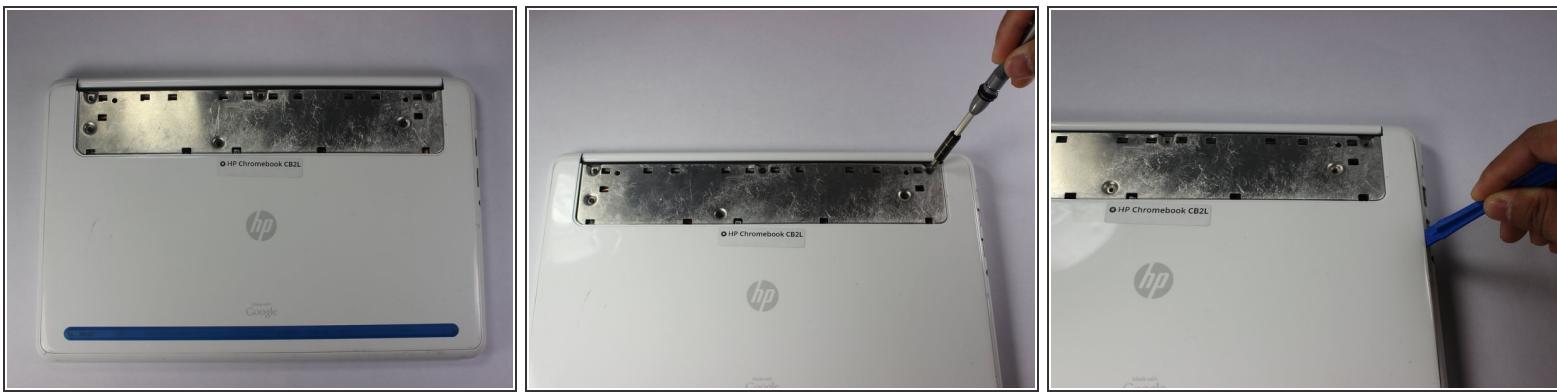
Step 2

- Unscrew the six 1.2mm screws on the metal plate using Phillips #1 screwdriver.
- Lift the white panel by gently prying around the edges using the plastic opening tool.

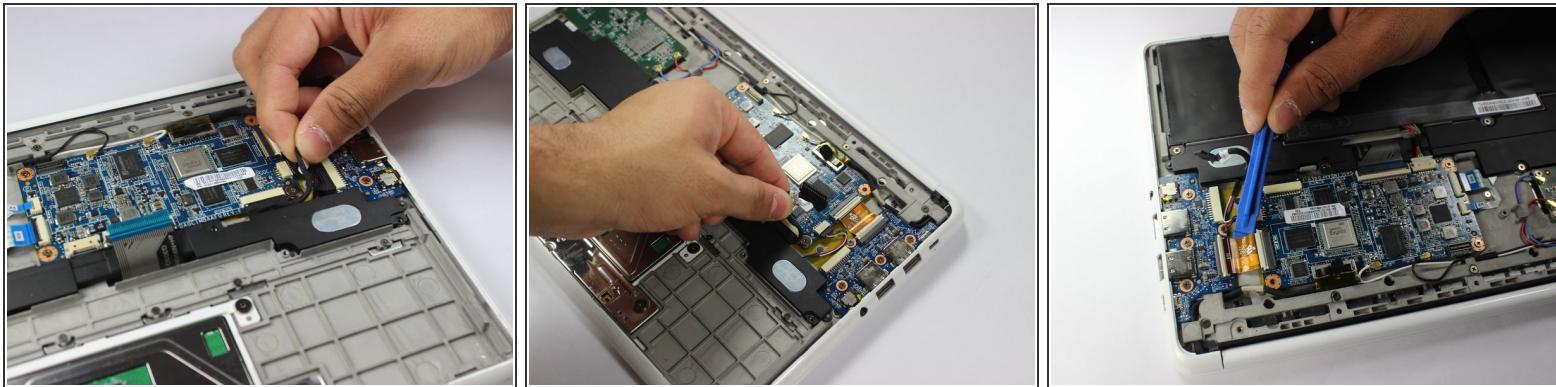
Step 3

- Disconnect the black wire which connects the audio port to motherboard.
- Disconnect the gold strip connecting the audio port to motherboard

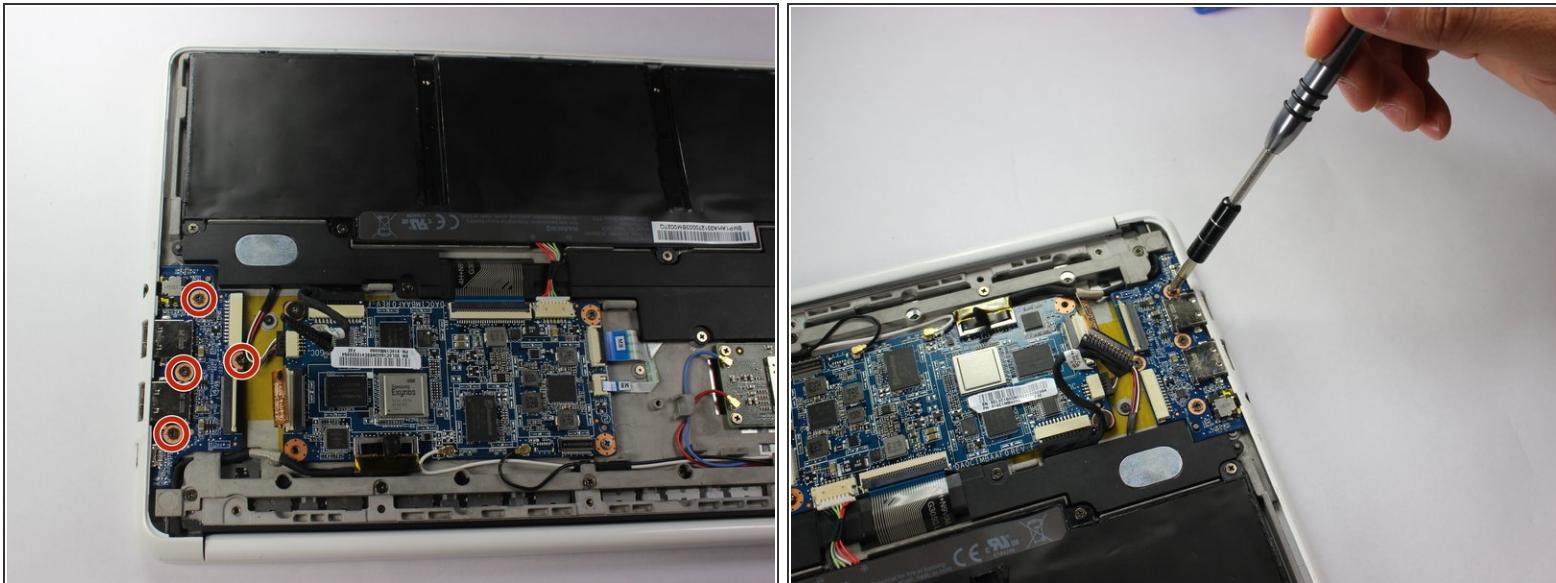
Step 4

- Unscrew four 1.2mm Phillips screws using Phillips #1 screwdriver.

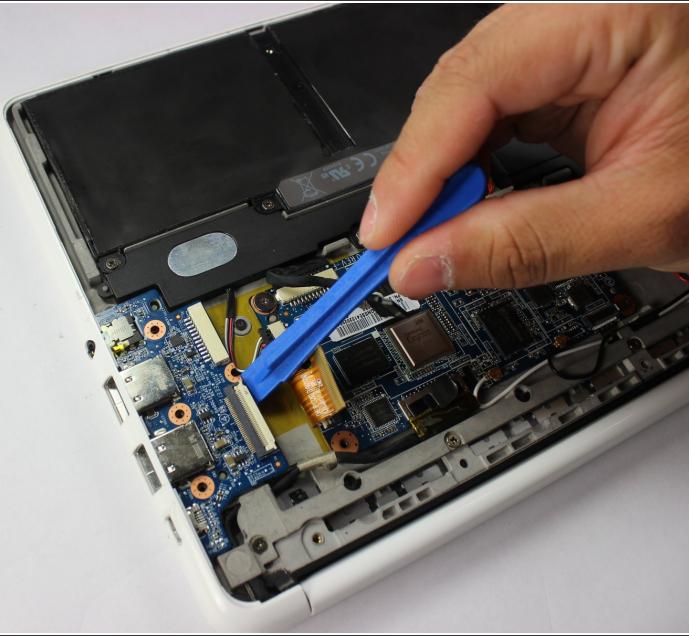
Step 5

- Using the plastic opening tool remove the audio port from the back panel.

To reassemble your device, follow these instructions in reverse order.
