# HP Compaq Presario CQ56-110US CD Drive Replacement

This guide will detail the process of replacing a CD Drive from the HP Compaq Presario CQ56-110US laptop.

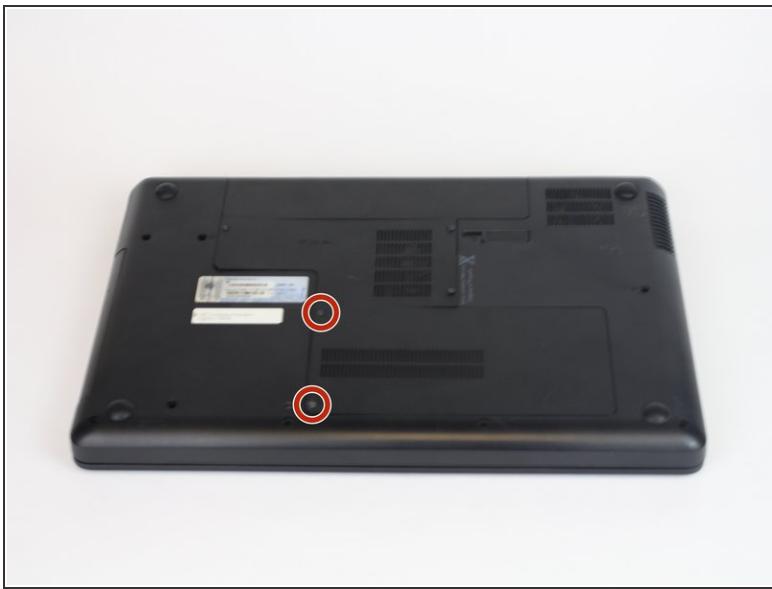
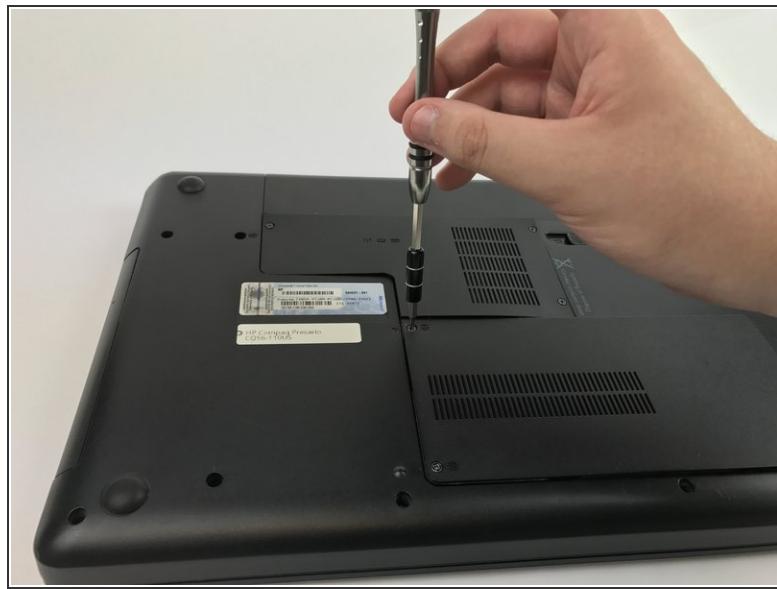
## Step 1 — CD Drive

- Loosen the two indicated screws on the panel using a Phillips screwdriver with a PH1 head size.

*(i)* The screws do not come free from the panel. They only need to be loosened enough so that the panel can be lifted/pried using a plastic opening tool.

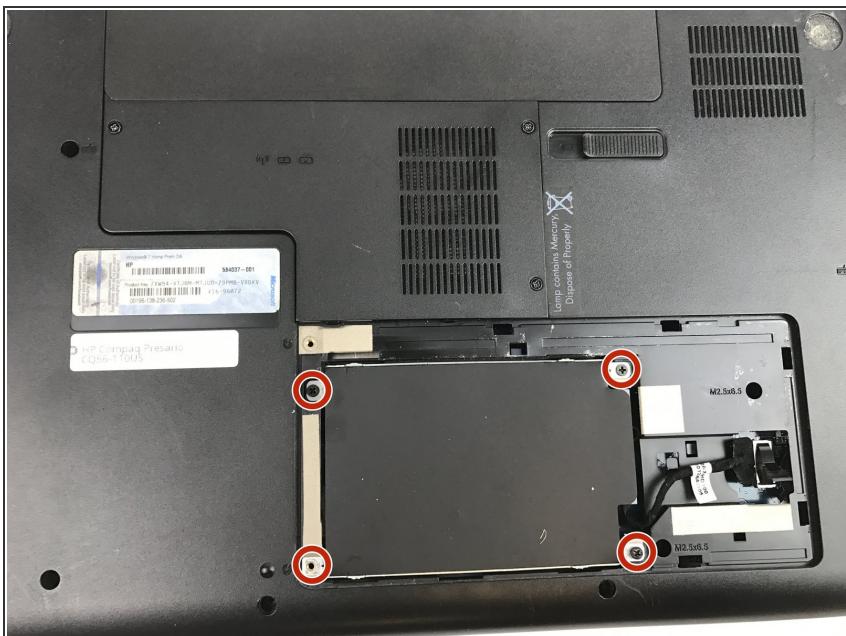
## Step 2

- Use the screwdriver to unscrew the four 5mm screws holding down the hard drive.

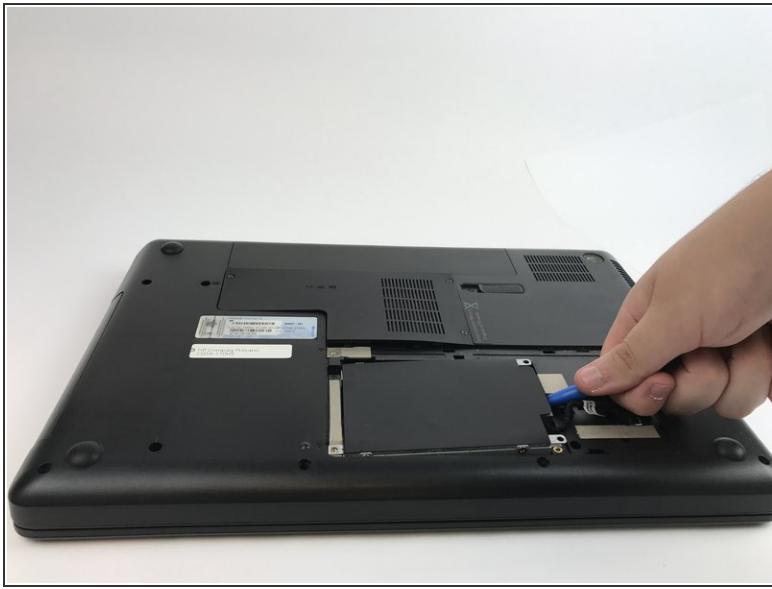
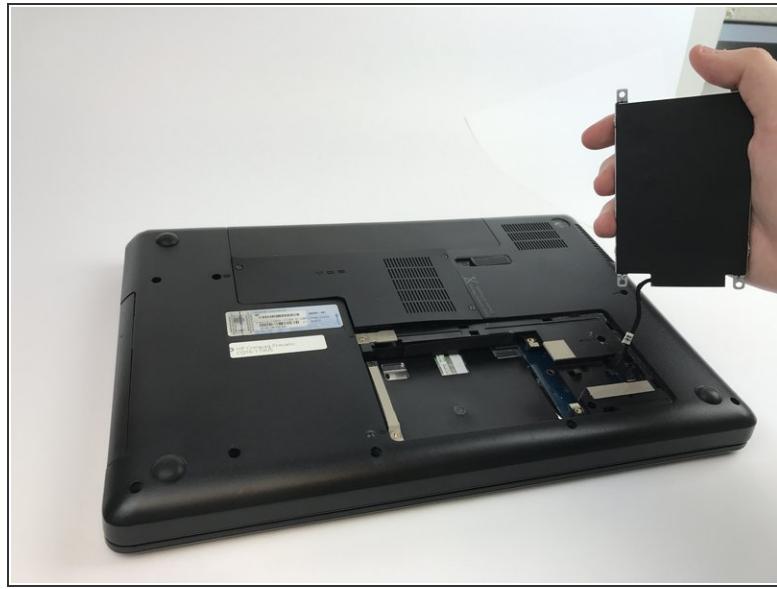
## Step 3

- Use plastic opening tools to lift up the hard drive. Set aside the hard drive without disconnecting the wire.

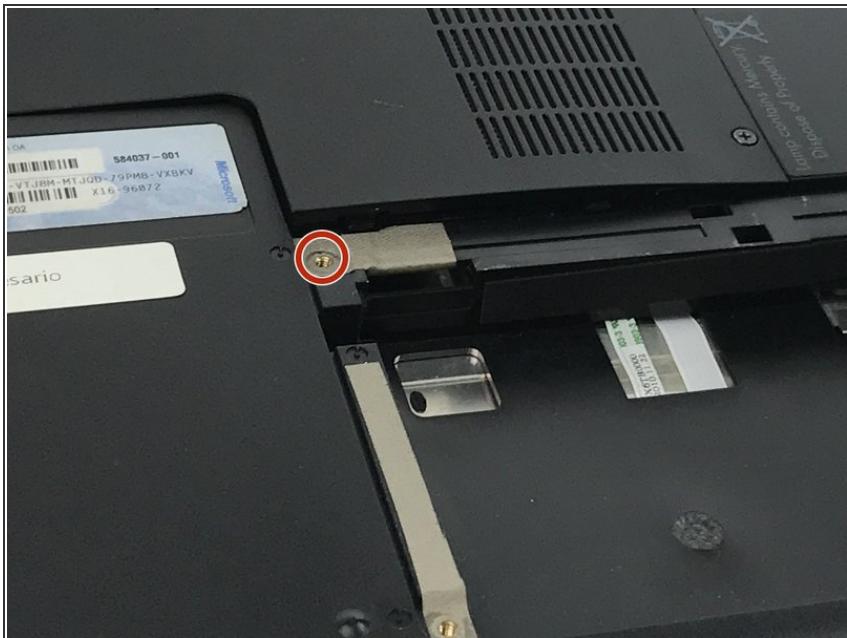
## Step 4

- Use a Phillips screwdriver with a PH0 head type to unscrew the indicated 5.5mm screw.

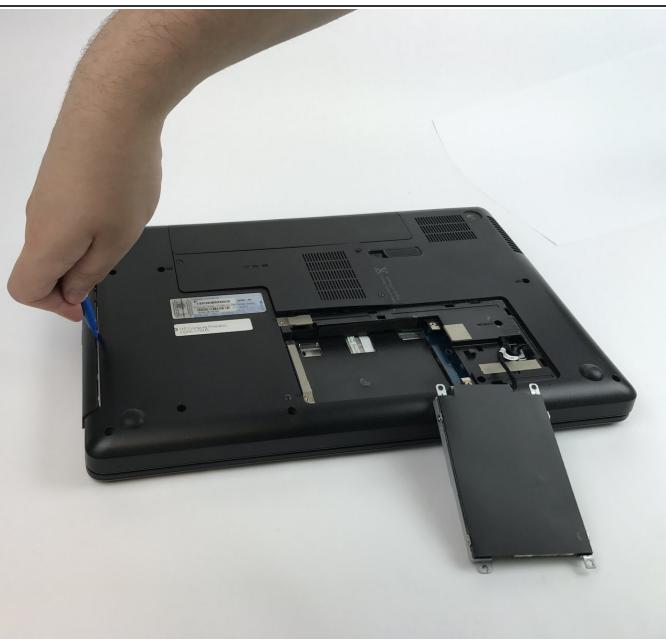
## Step 5

- Use plastic opening tools to pry open the CD Drive.

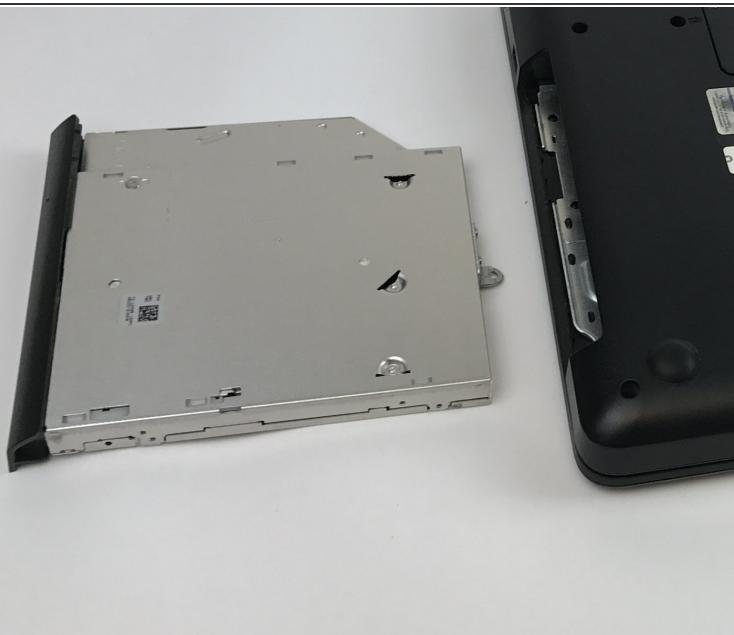
## Step 6

- Use your hands to pull the CD drive out and remove it from the laptop.
