# HP Compaq Presario CQ56-110US Repair Wi-Fi Card Replacement

Use this guide to fix wireless connectivity issues by replacing the defective wifi card on the HP Compaq Presario CQ56-110US laptop.

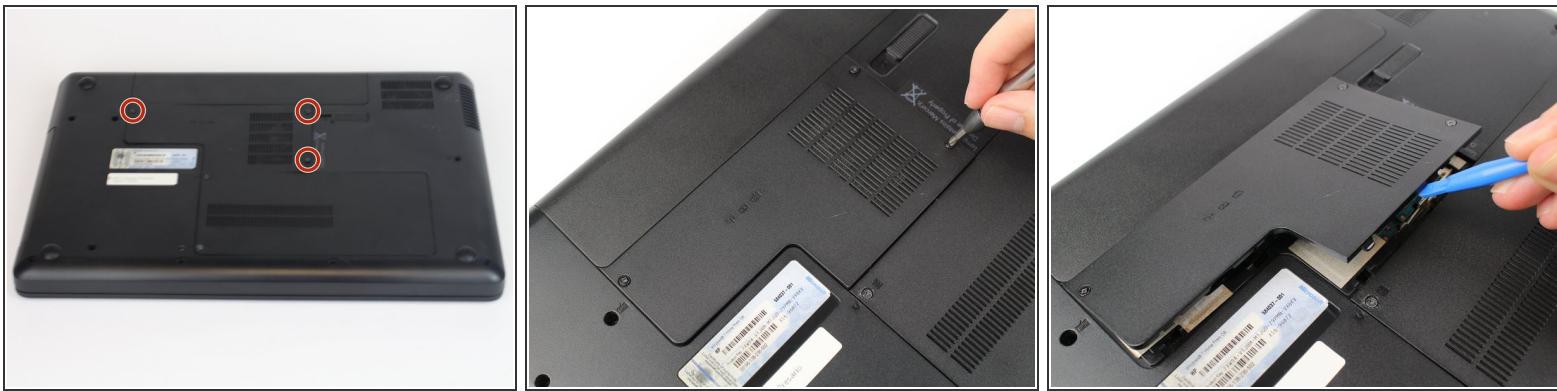
## Step 1 — Wi-Fi Card

- Use a Phillips screwdriver with a PH1 bit to loosen the three indicated screws.
- ⓘ The screws do not come free from the panel. They only need to be loosened enough so that the panel can be lifted/pried using a plastic opening tool.

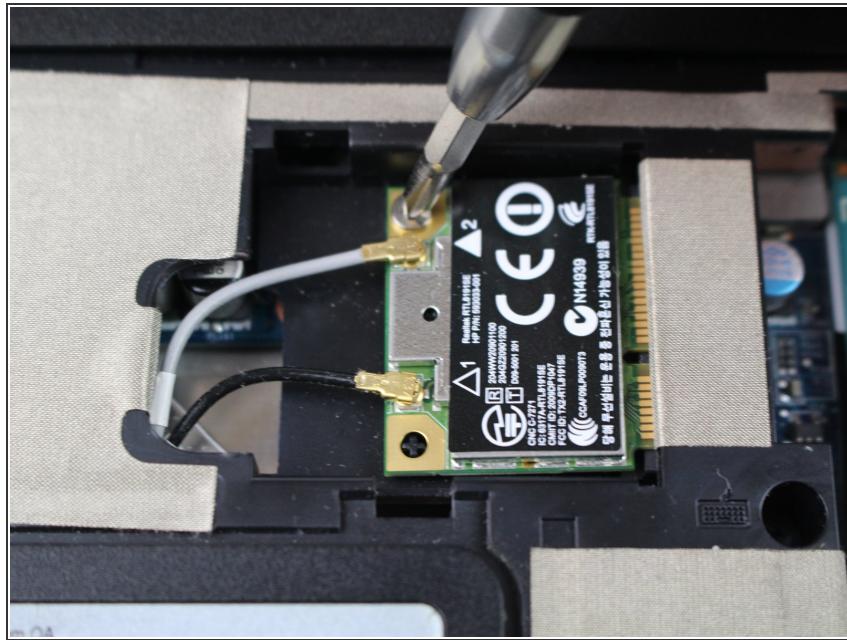
## Step 3

- Use the same screwdriver to remove the two 3 mm screws holding the card in place.
