HP Elitebook x360 1040 G5 Speakers Replacement

If your issues cannot be fixed with other troubleshooting methods, this guide will help you replace the speaker for the HP Elitebook x360 1040 G5.

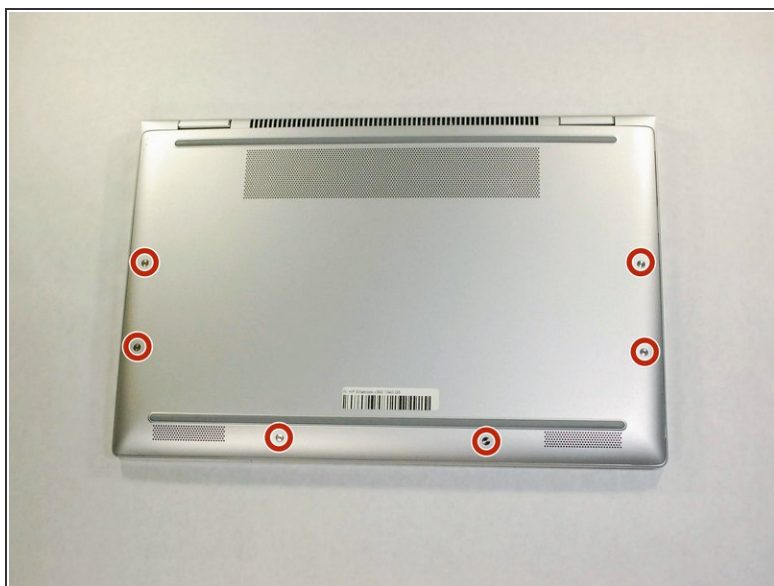
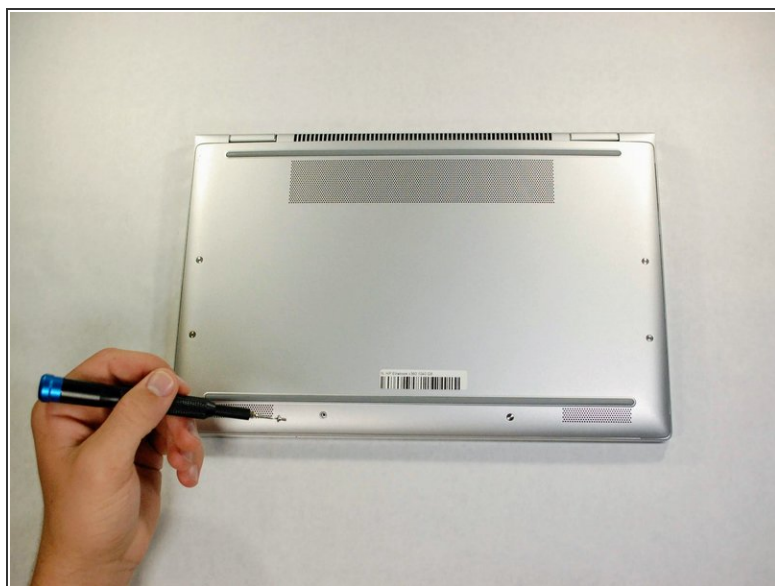
Step 1 — Lower Case

- Use the T5 Torx screwdriver to remove the six 4 mm screws from the underside of the laptop using iFixit's 64 Bit Driver Handle and a T5 Torx screwdriver head.

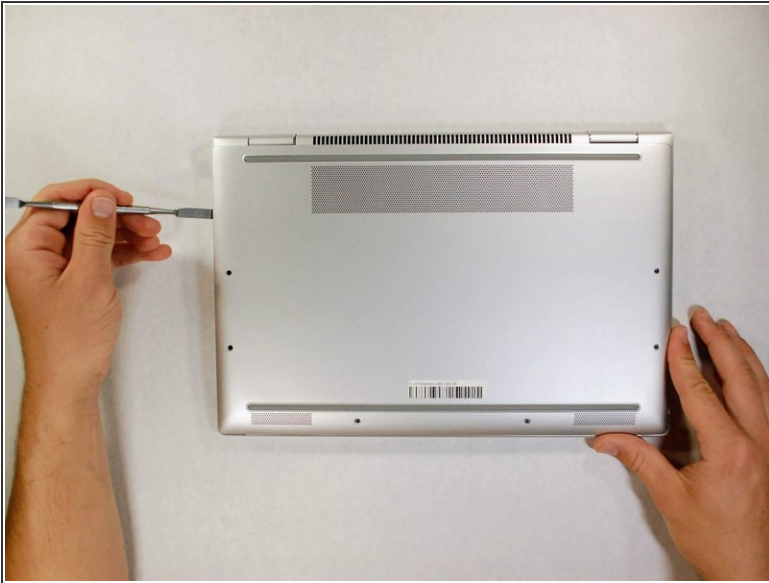
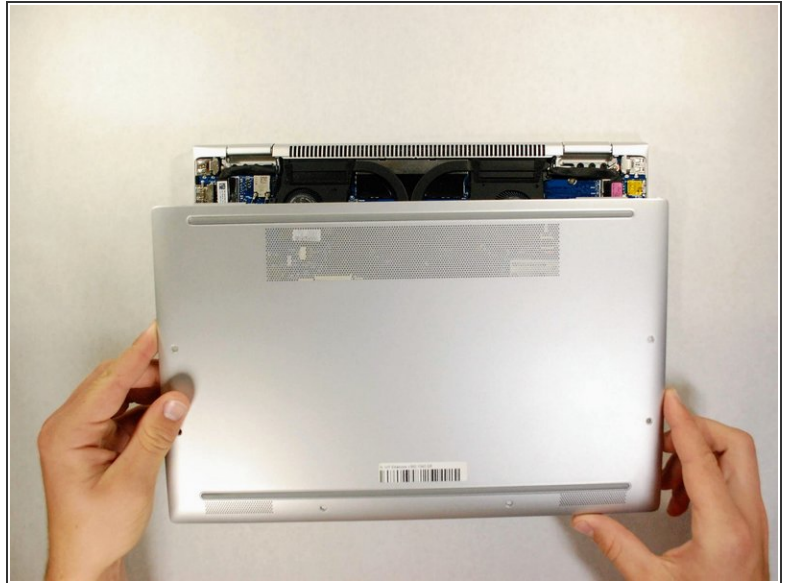
Step 2

- Pry open the lower case from where it meets the laptop base using iFixit's Metal Spudger.
- Remove the lower case from the work area.

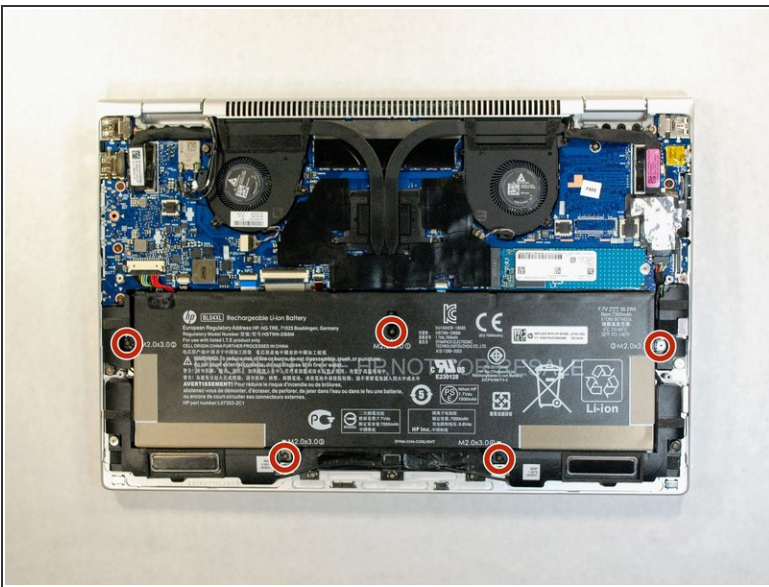
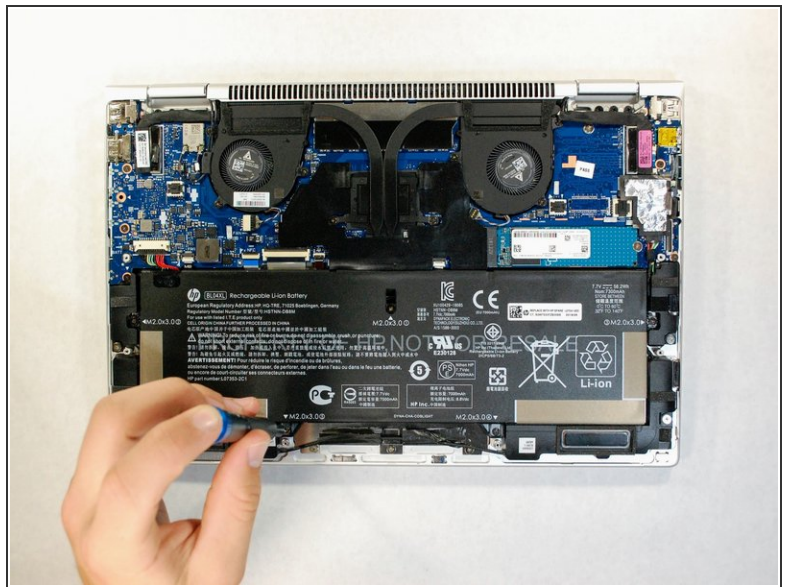
Step 3 — Battery

- Use the Phillips 1 screwdriver to remove the five 3mm Phillips screws from the battery assembly.

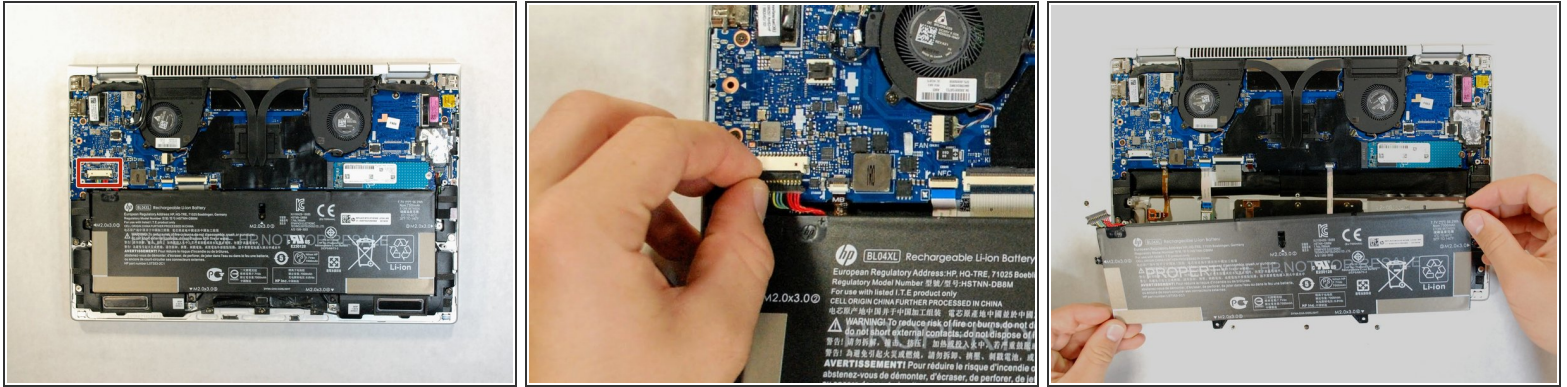
Step 4

- Carefully remove the power supply connector by pulling on both sides of its head.
- ⚠ Do not tug on the wires as they may become damaged.
- Lift the battery from its position, removing it from the device.

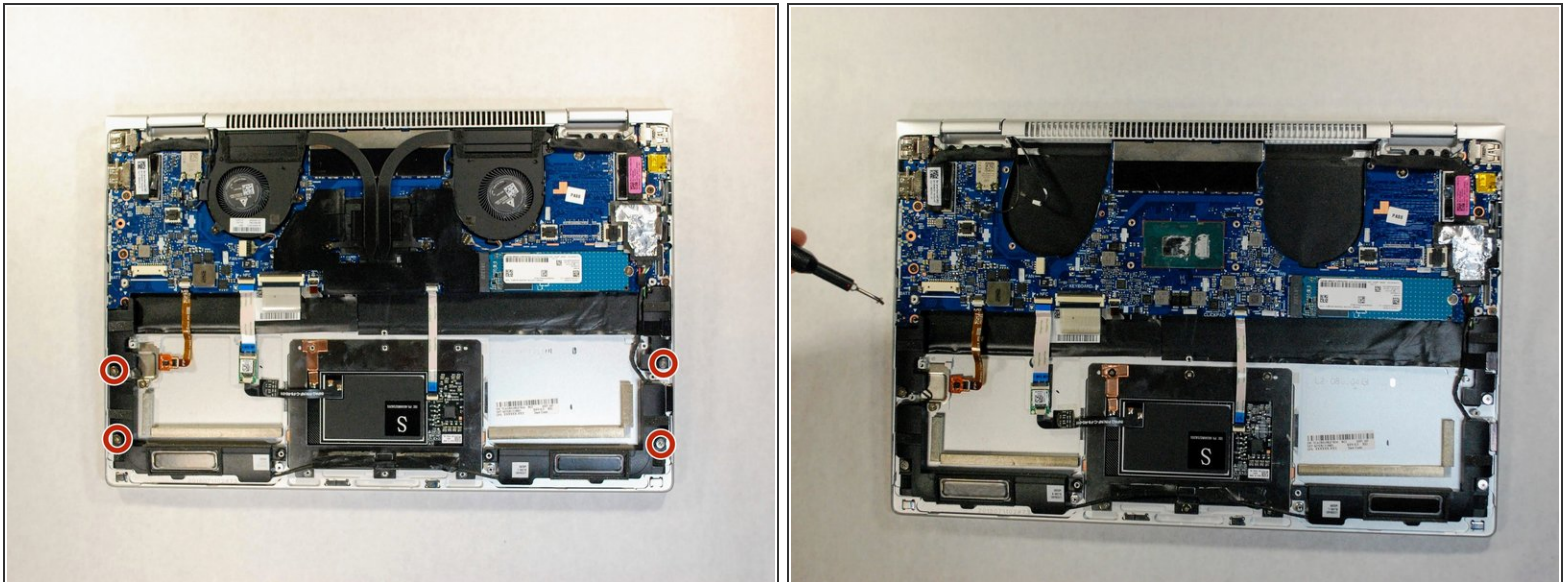
Step 5 — Speakers

- Use the Phillips 0 screwdriver to remove the four 3mm Phillips screws from the speaker assembly.

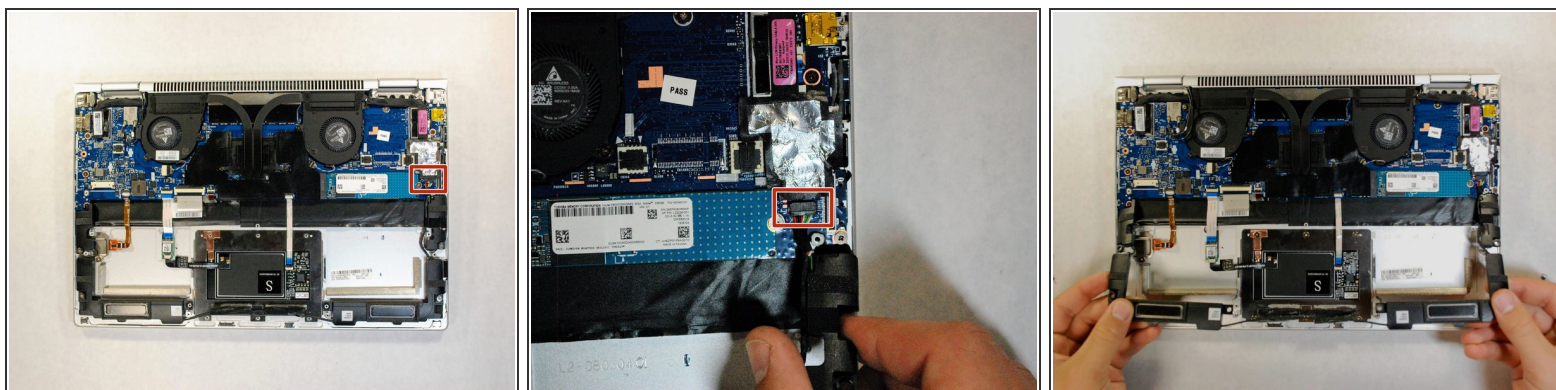
Step 6

- Carefully remove the plug, connecting the speaker assembly to the motherboard on the right hand side, by pulling on either side of its head.
