# HP Pavilion 15-au123cl CD Drive Replacement

Incase your CDs and DVDs aren't working, you can follow this guide to replace your CD Drive for the HP Pavilion 15-au123cl.

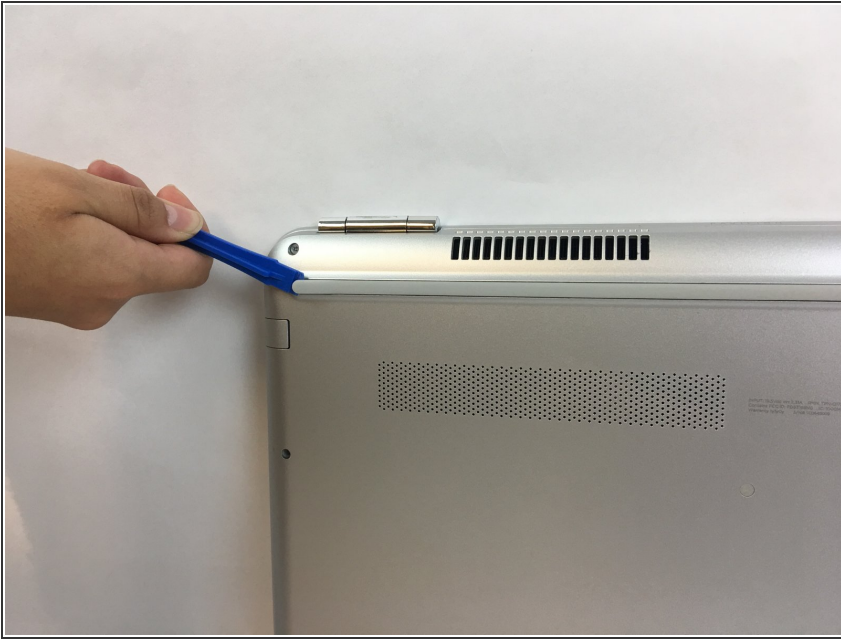
## Step 1 — Battery

- ★ Make sure the laptop is off and unplugged before starting.
- Using the plastic opening tool, remove the top rubber feet on the back panel as it hides one of the screws we will be removing.

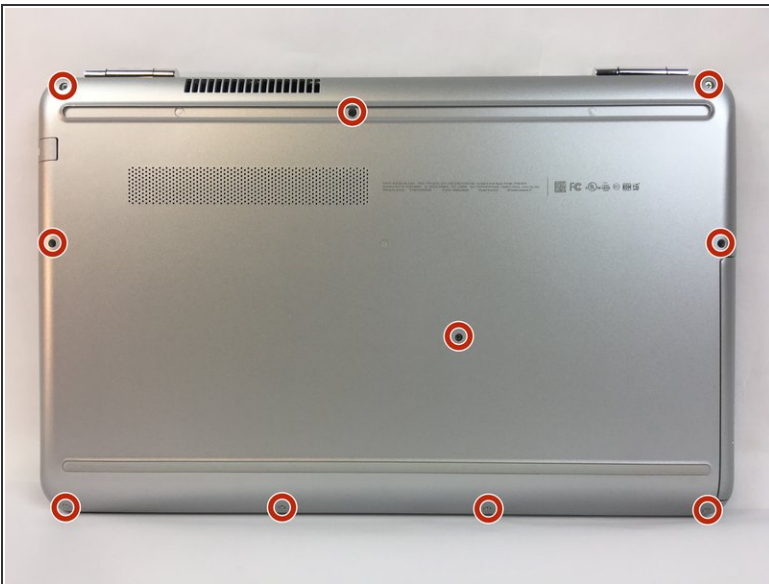
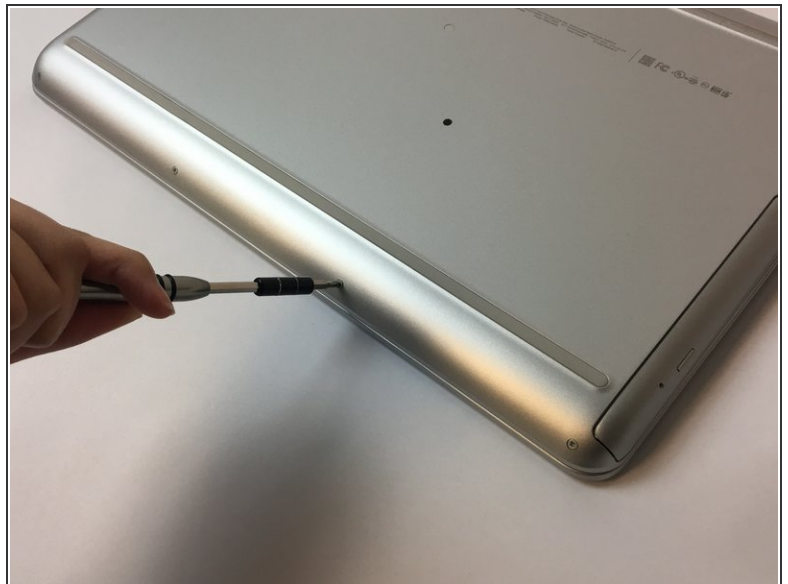
## Step 2

- Using a PH0 screwdriver, unscrew the ten 4.4mm Phillips head screws located on the back panel.

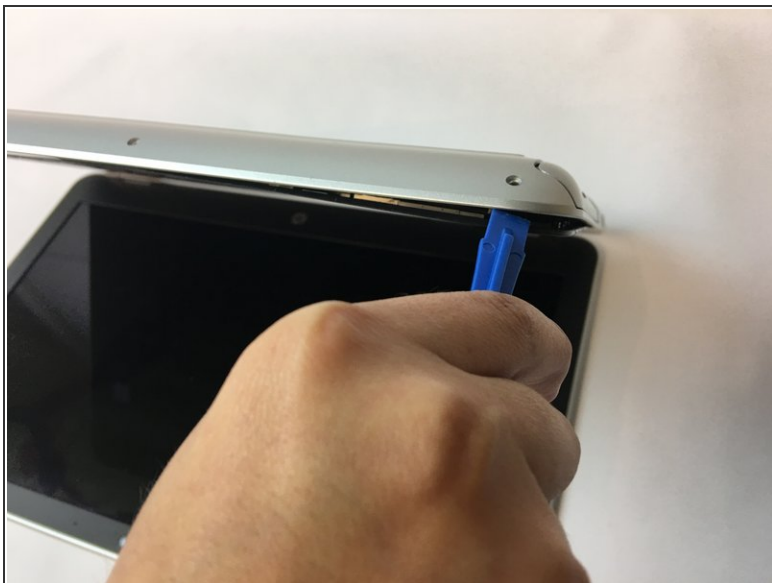
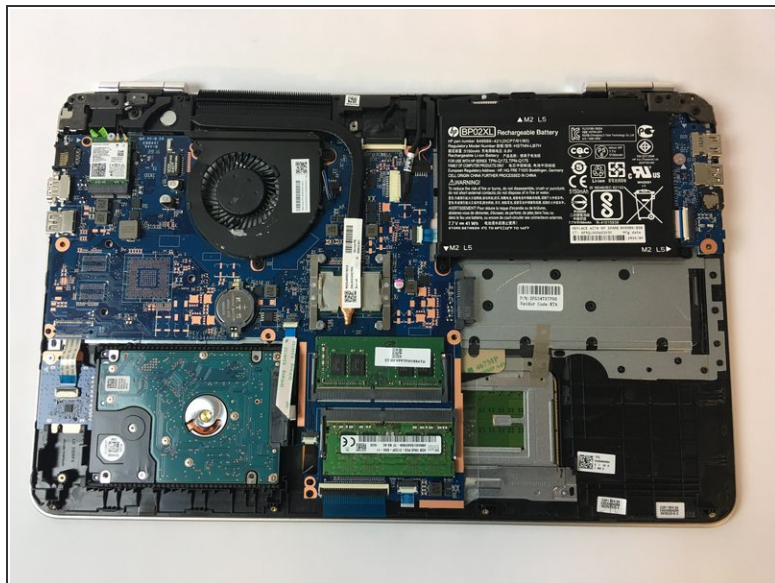
## Step 3

- Using the plastic opening tool, remove the back cover of the laptop.
- ⓘ It is recommended that you start with a corner and run the tool throughout the edges of the cover.
- ⚠ Be sure not to bend the cover by applying too much force.

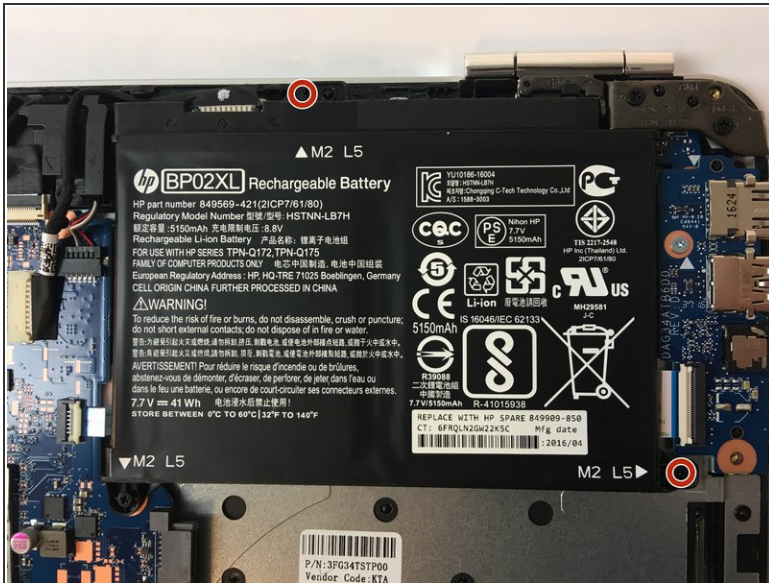
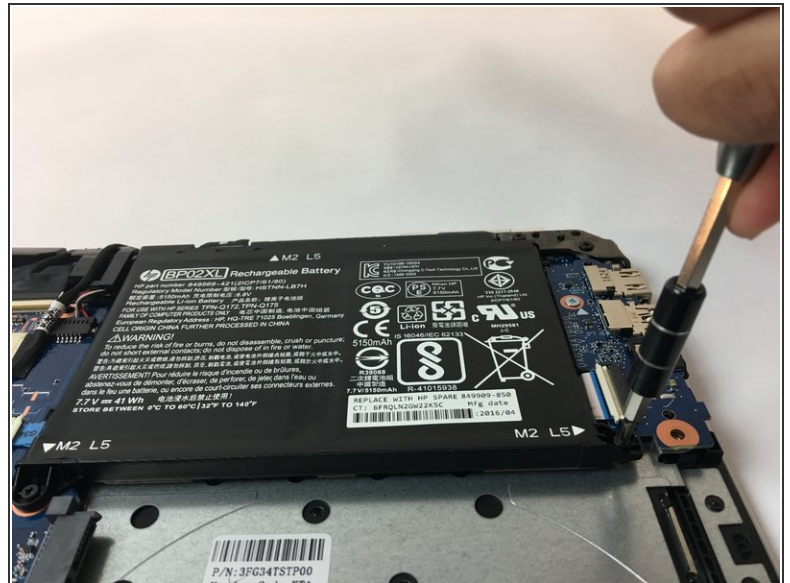
## Step 4

- Using a PH0 screwdriver, unscrew the two 3.8mm PH0 Phillips head screws that hold the battery in place.

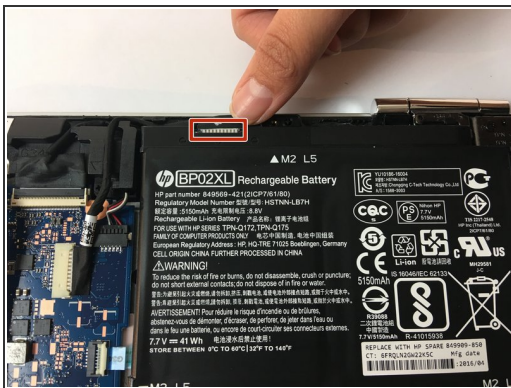
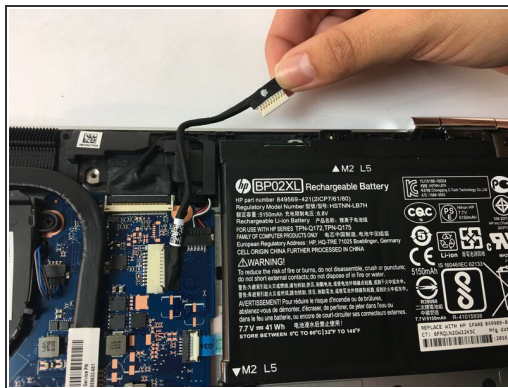
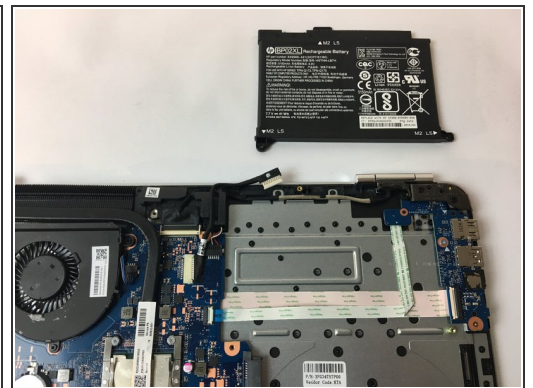
## Step 5

- Carefully disconnect the cable connecting the top of the battery and remove the battery.

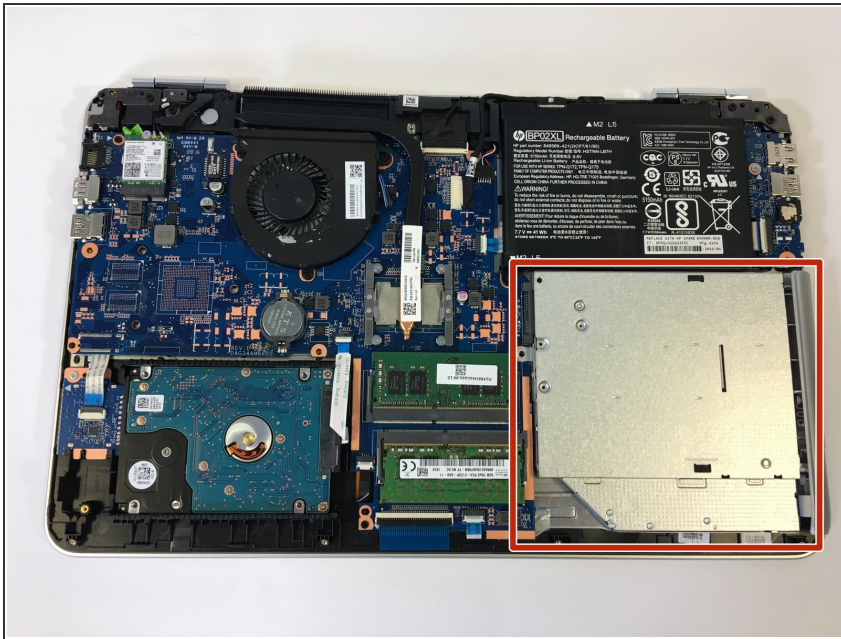
## Step 6 — CD Drive

- The CD Drive is located at the bottom right area of the motherboard.

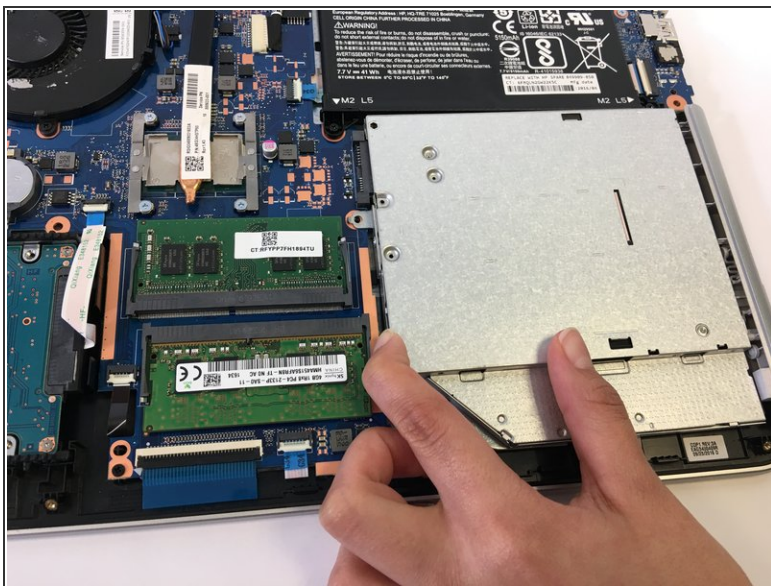
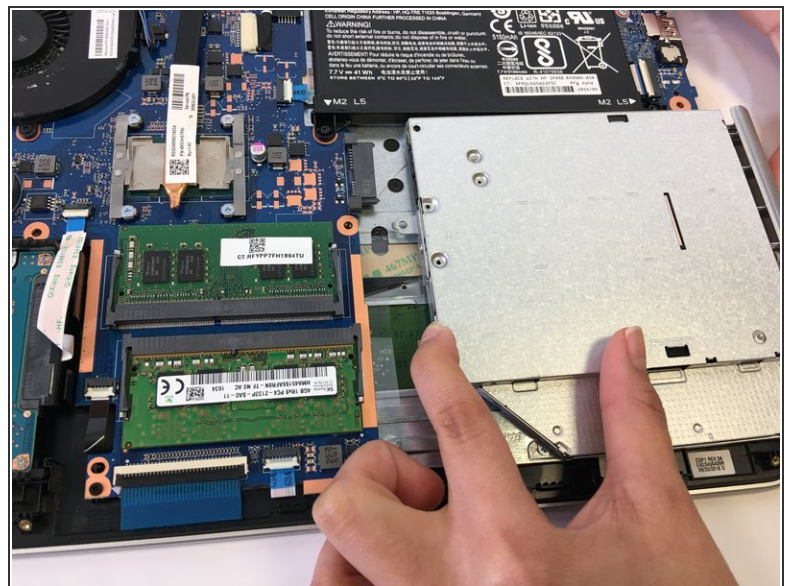
## Step 7

- Disconnect the CD drive from the motherboard connector on the left.

To reassemble your device, follow these instructions in reverse order.
