# HP Pavilion dv7-6178us CD Drive Replacement

This guide will show you how to remove and replace the CD Drive for an HP Pavilion dv7-6178us.

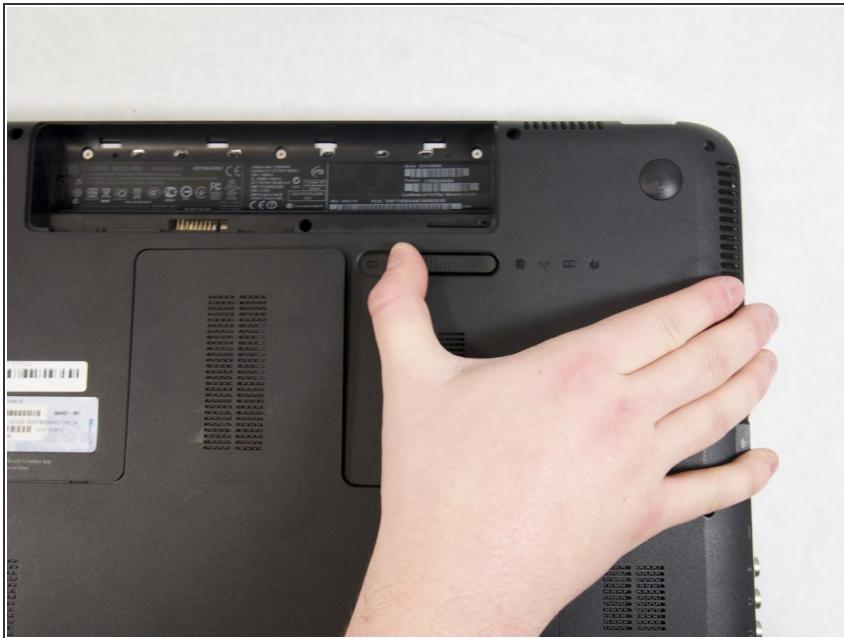
## Step 1 — CD Drive

Make sure the device is turned off.

- Remove the panel on the bottom of the laptop by sliding the switch to the right.

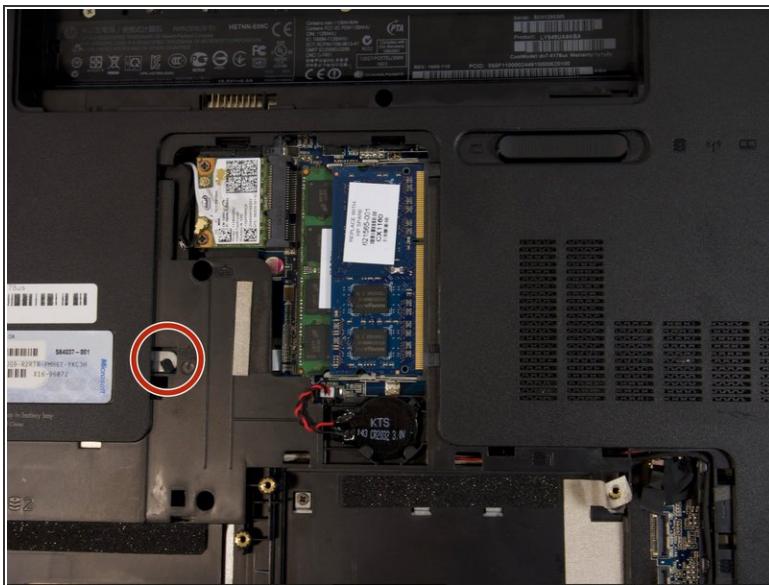
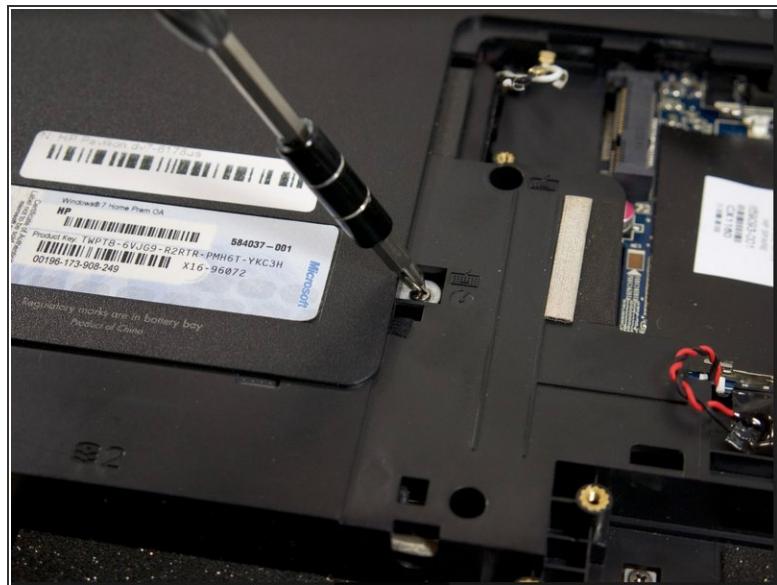
## Step 2

- Locate the screw that keeps the CD drive attached, and remove it with a Phillips head screwdriver.

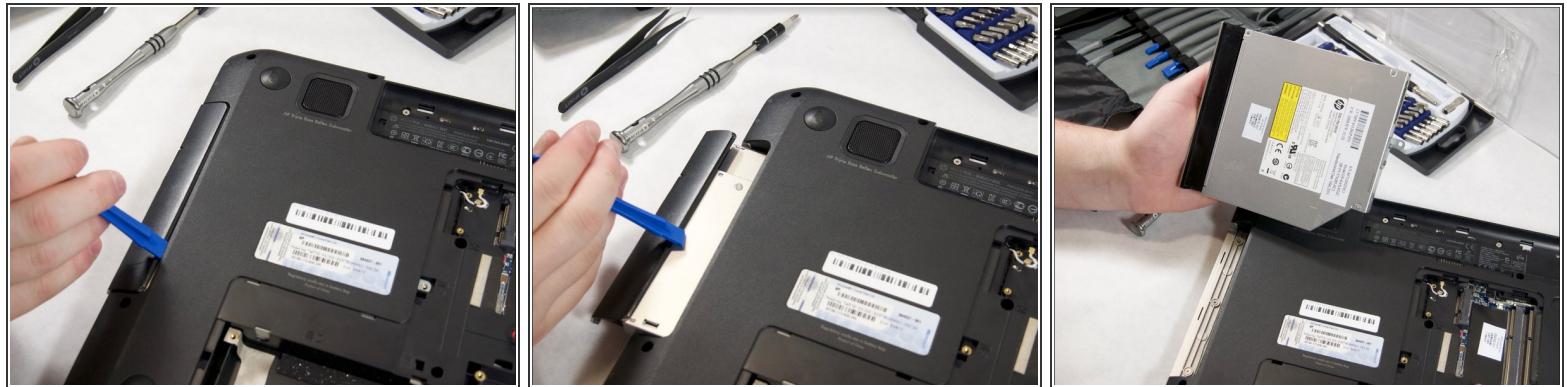
## Step 3

- After the screw is removed, pry the CD drive out of the laptop until you can grip and remove it.

To reassemble your device, follow these instructions in reverse order.
