# HP Pavilion x360 15t-br000 Hard Drive Replacement

Use this guide to replace the hard drive in your HP Pavilion x360 15t-br000.

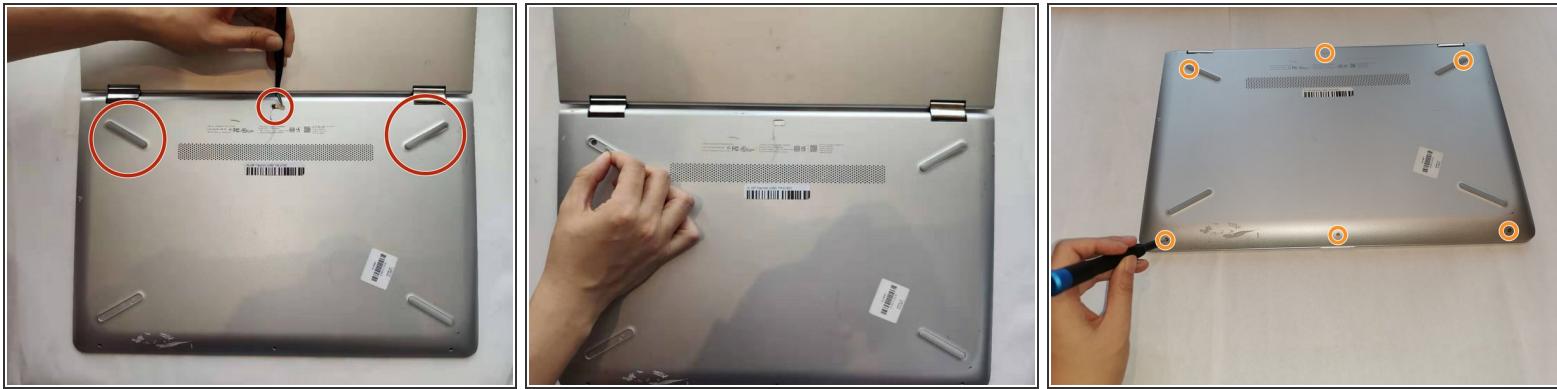
## Step 1 — Keyboard Panel

- Remove the covers to access the screws attached to the back cover of the device.
- Remove six 3mm screws using the Phillips #0 screwdriver.

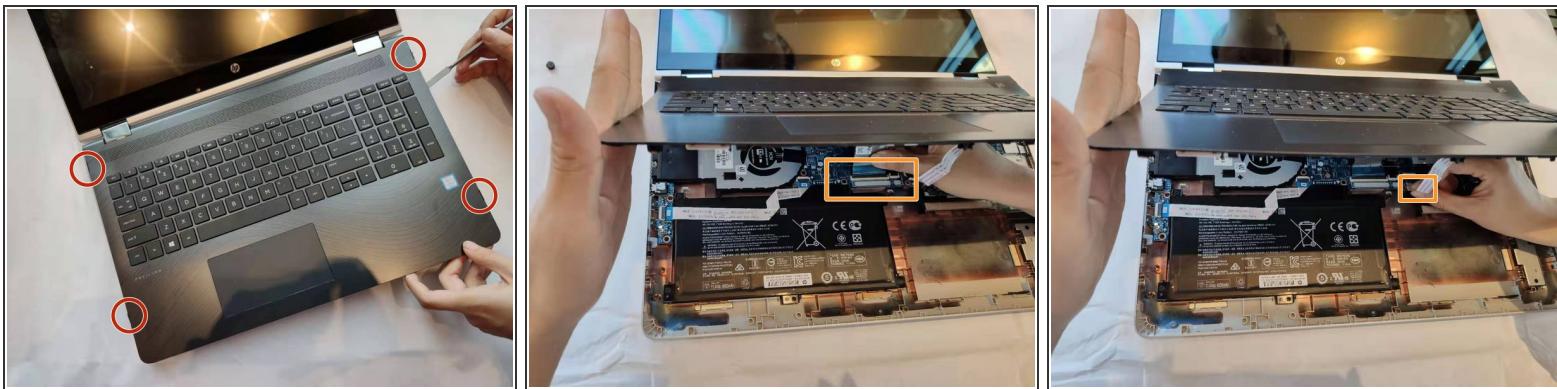
## Step 2

- Use a metal spudger to loose the four corners of the keyboard panel. The corner is circled red shown in the first image.
- Disconnect the keyboard panel cables under the upper case.
- Remove the keyboard panel from the device.

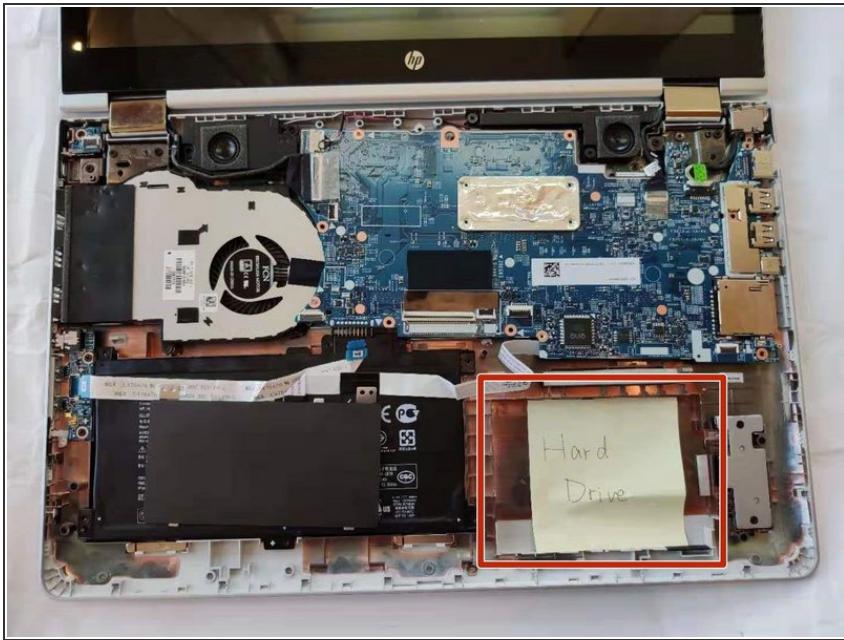
## Step 3 — Hard Drive

- Use the Phillips #0 screwdriver to remove four screws from the hard drive.
- Remove the hard drive from the device.

*(i)* At the time of creating this guide, the hard drive was not present in the device.
