HP Pavilion ze4530US CD Rom Replacement

Replace a CD Rom that is not capable of reading discs.

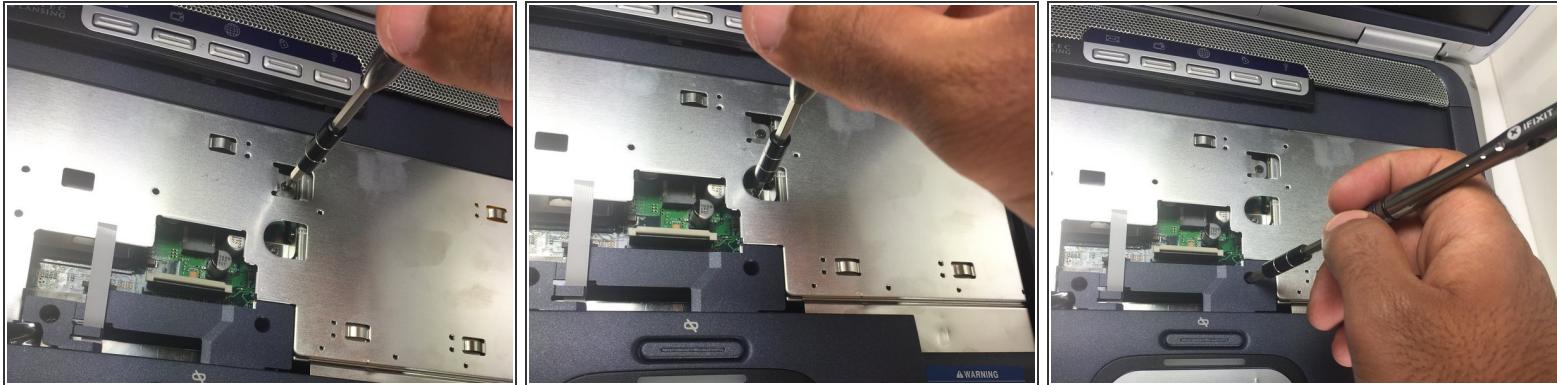
Step 1 — CD Rom

- Unscrew three screws from under the keyboard. The keyboard must be removed for this process.

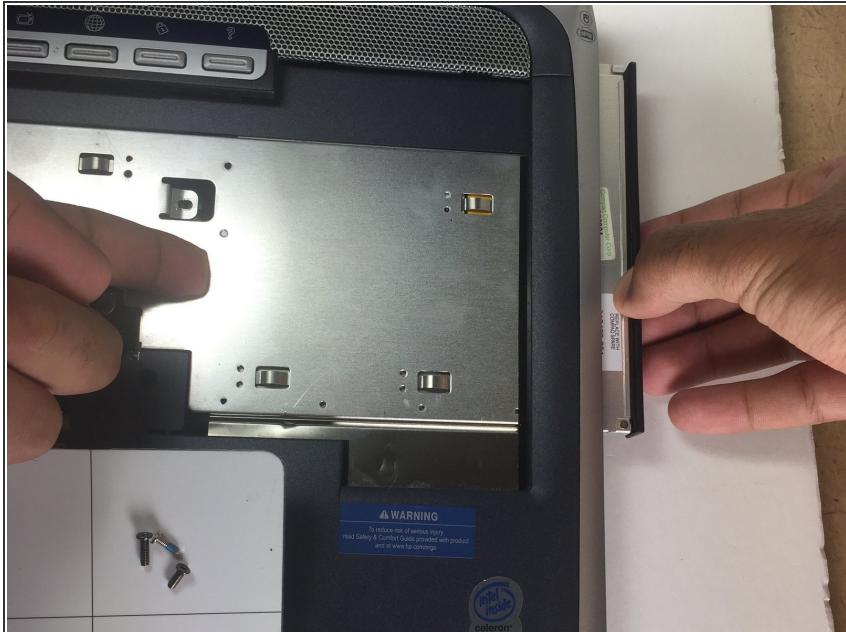
Step 2

- After the screws have been removed, use one finger to push the CD Rom out while the other hand is simultaneously pulling the CD Rom out.

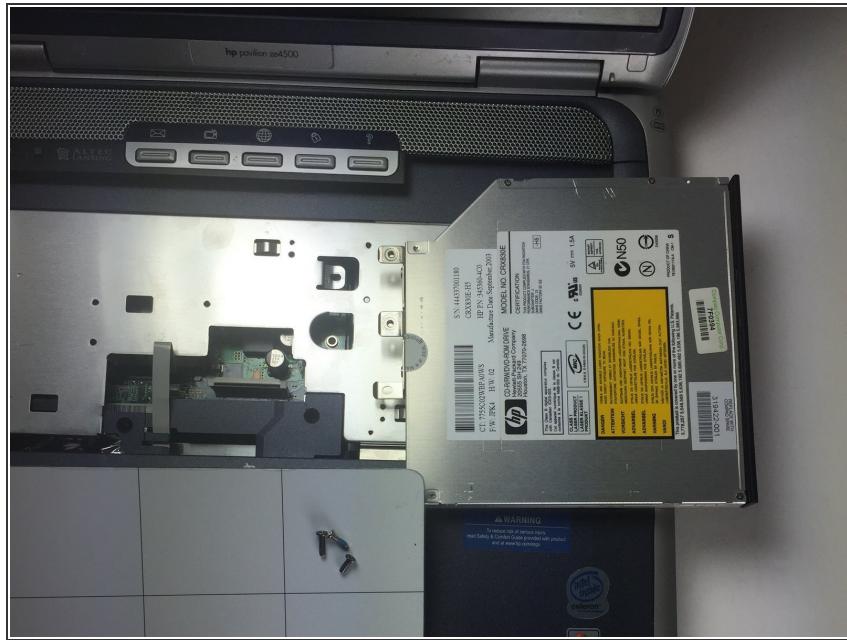
Step 3

- The CD Rom has been successfully taken out.

To reassemble your device, follow these instructions in reverse order.
