# HP Photosmart D5160 printer Disassembly

This guide covers disassembly in order to ease the cover-open linkage or to remove the main logic board for inspection or maintenance. Disassembly and maintenance of the print mechanism is not covered.

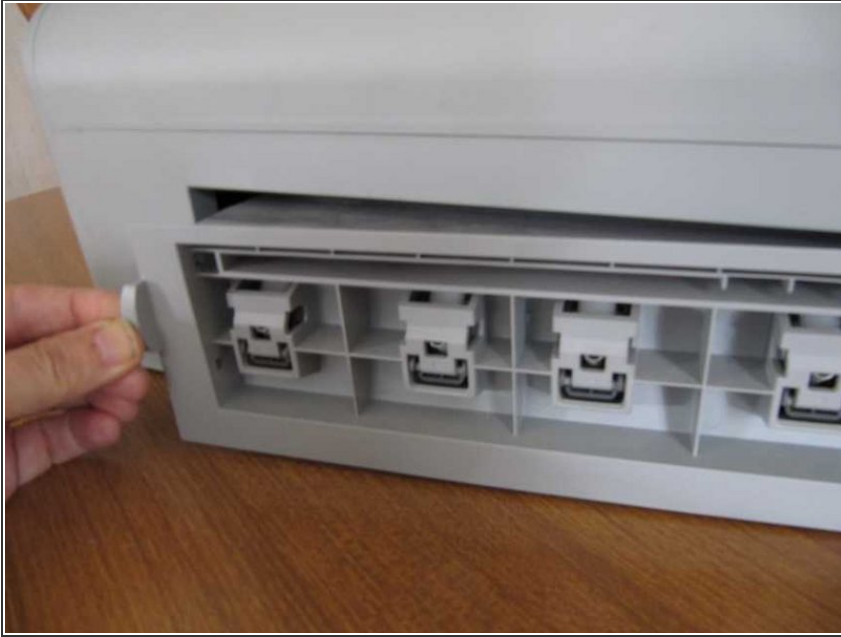
## Step 1 — HP Photosmart D5160 printer Disassembly

- Remove any paper from the paper tray.
- Remove the paper guide from the rear of the printer. Check for any jammed paper or torn paper fragments and gently remove them. Blow out any dust and clean the rollers.

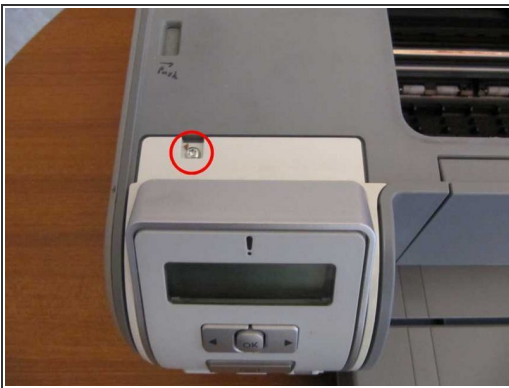
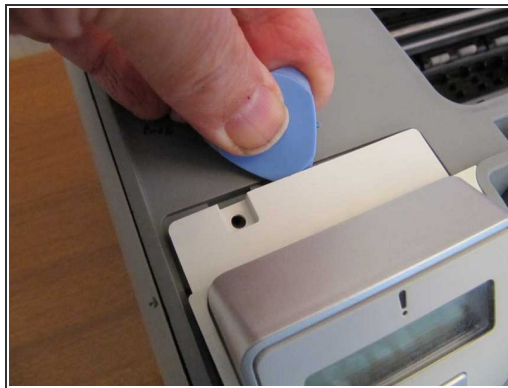
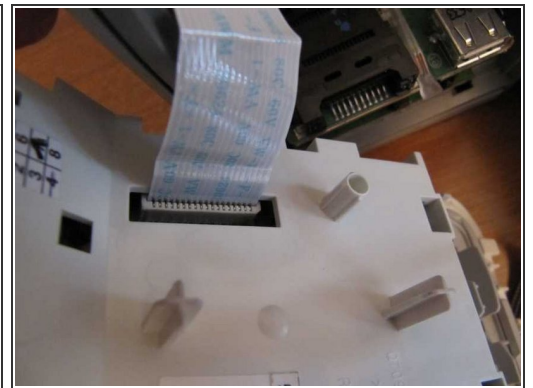
## Step 2

- Lift the lid. You will see a single screw at the top of the control panel. Remove this.
- Starting from the top, prise the control panel off.
- Release the ribbon cable from the control panel and put it aside.

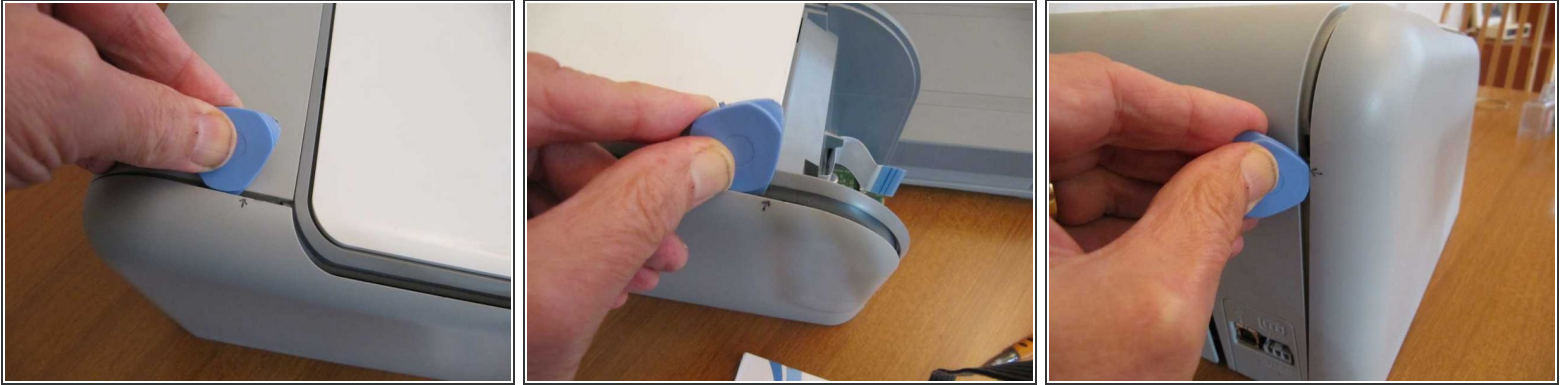
### Step 3

- Prise off the left hand side panel. First, release 2 clips at the top and one at the back.

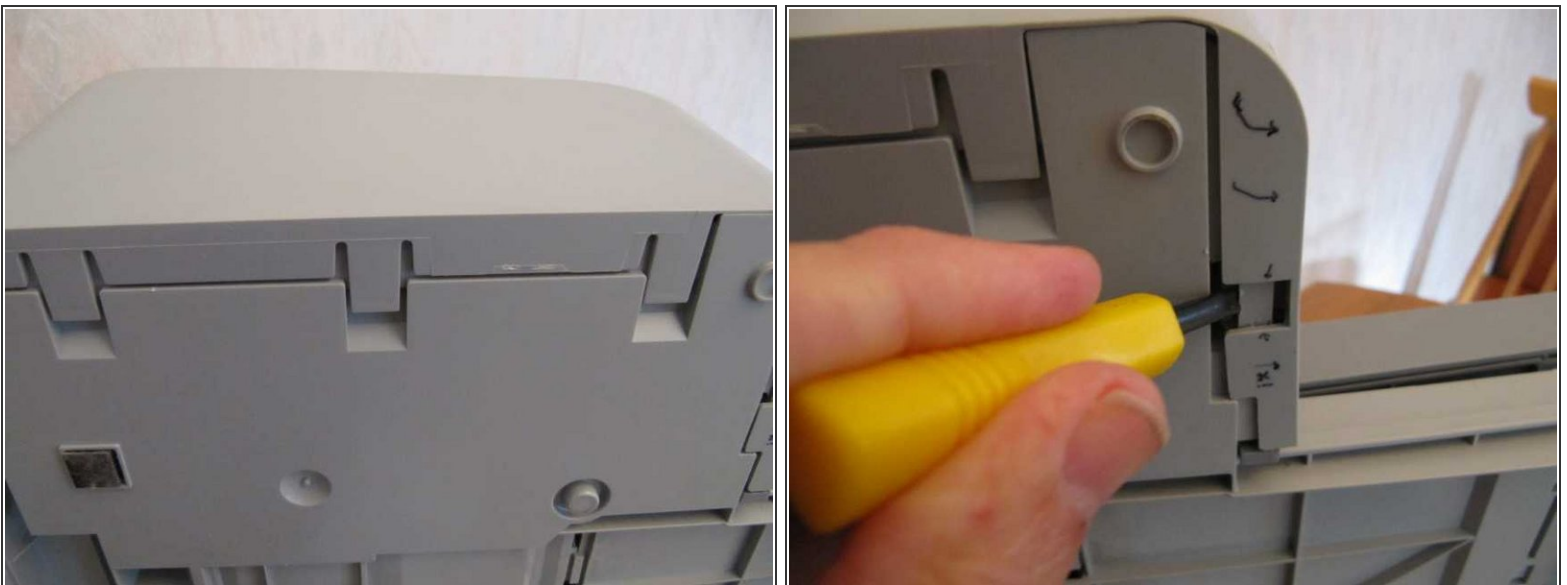
### Step 4

- There are 3 more clips underneath. Release these.
- The side panel is still held by a clip underneath where the control panel was. Press it from under the printer with a flat screwdriver. Ease this section of the side panel forwards, making sure it bends at the front corner, not by the clip, where it is relatively weak.
  - (In the photo you can see the arrows I marked to remind me where to bend it and where not to.)
- On reassembly, locate this latter clip before offering up the others.

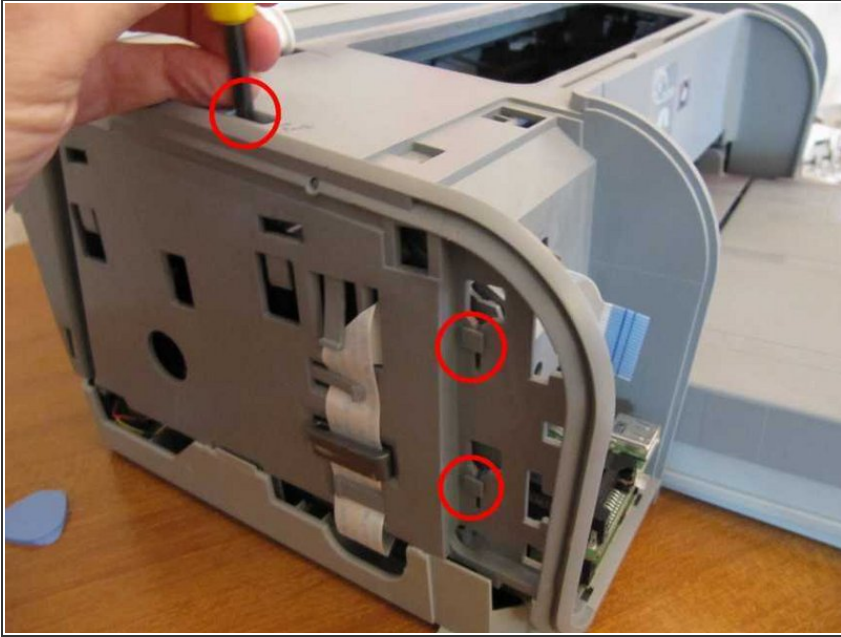
## Step 5

- You will now be able to see the linkage which is operated when you close the lid. The vertical section has 2 tabs which are a very loose fit in a vertical channel, causing it to jam all too easily.
- Clean off any existing lubrication or dirt, and apply a very thin smear of silicone grease to the tabs or the sides of the channel. Check for smooth operation.
- If this was the problem, you can now reassemble the printer, following the same procedure in reverse.
- If the linkage is still not satisfactory, further disassembly as described in the following steps will gain you better access to it and the possibility of a more complete cure.

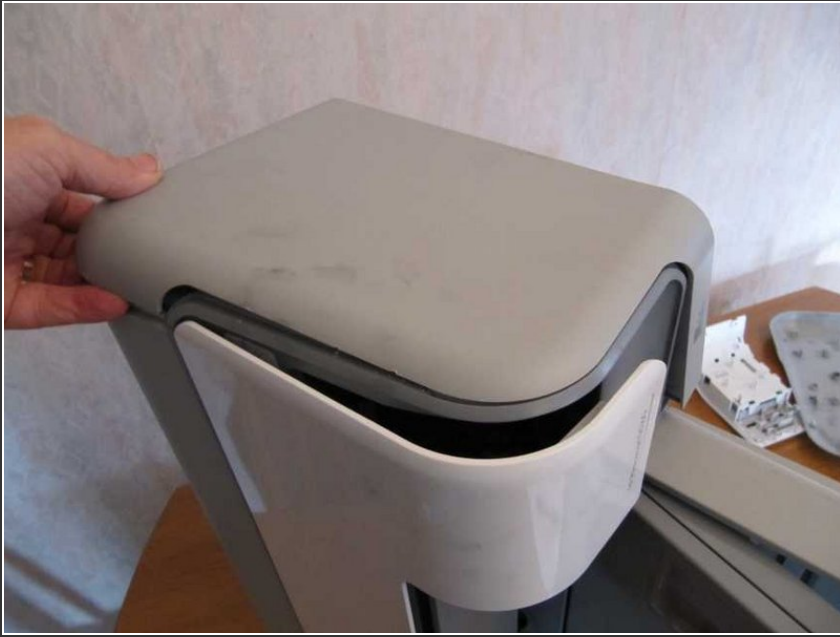
## Step 6

- Prise off the right hand end cover. This has clips in the same places as the left hand end cover, and the same procedure can be followed.

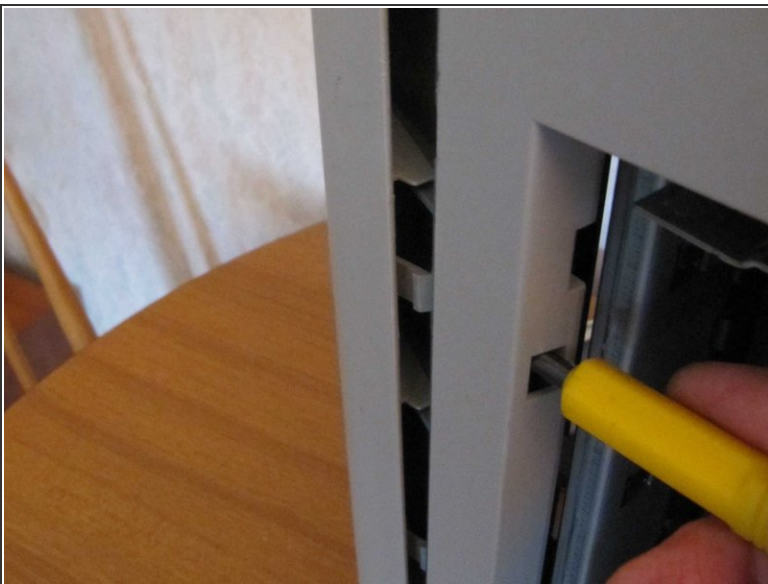
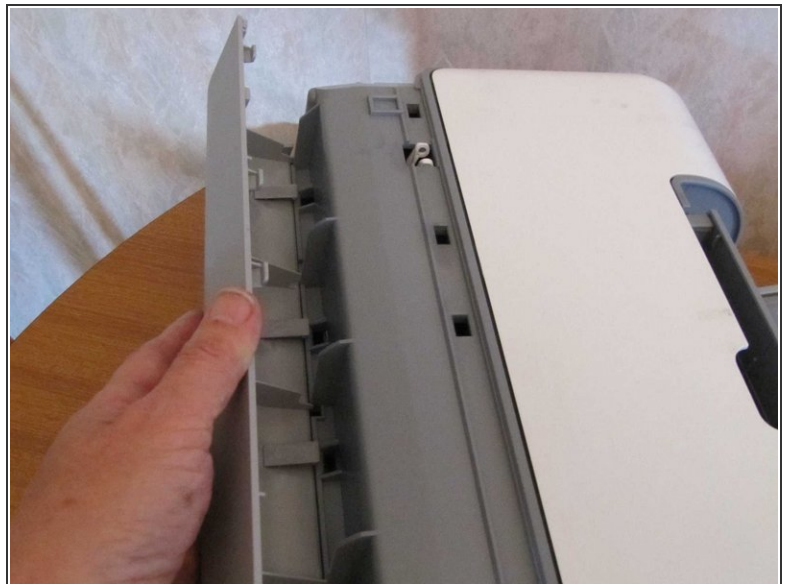
## Step 7

- Release the rear top cover. This is secured by 5 clips, the middle 3 of which can be released by inserting a flat screwdriver in the holes underneath them. The other 2 can be popped out quite easily.
- (On reassembly, locate the clips on the top of the printer, then insert the 5 on the back.)

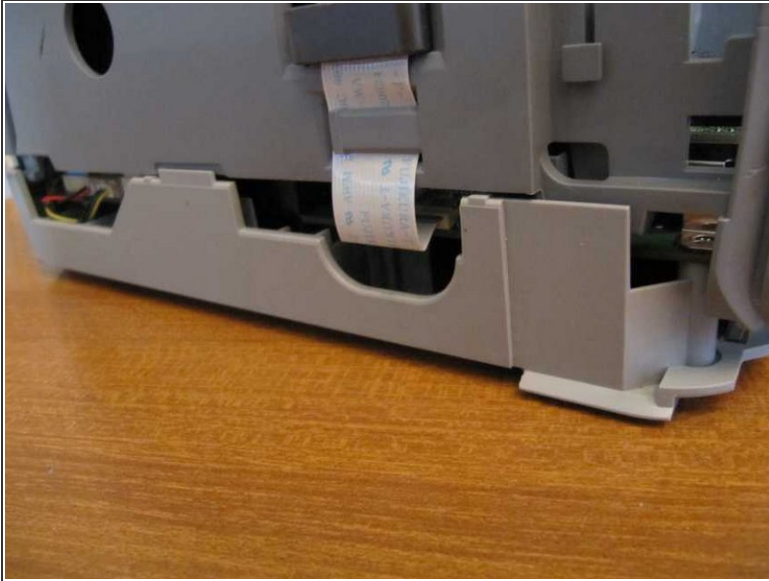
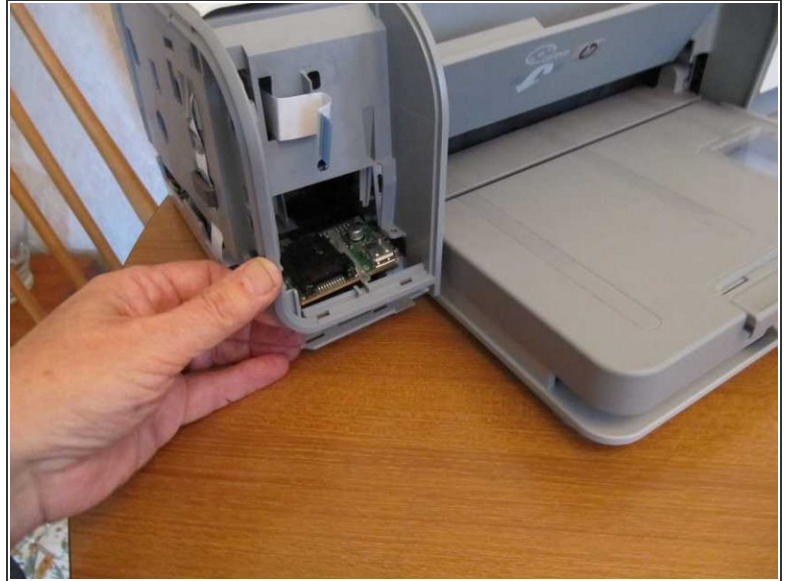
## Step 9

- Release the bottom end of the ribbon leading to the control panel.
- Now lift off the entire top cover. At the bottom left front you will need to ease it over the card reader assembly.
- The cover open linkage remains attached to the top cover. You can now gain full access to it if it's still causing trouble.
- The root cause of the problem seems to be that the vertical section of the linkage has too much freedom to rotate about an axis parallel to its length. You could try reducing its freedom by gluing a piece of plastic to the side member underneath the vertical piece in order to reduce the clearance.

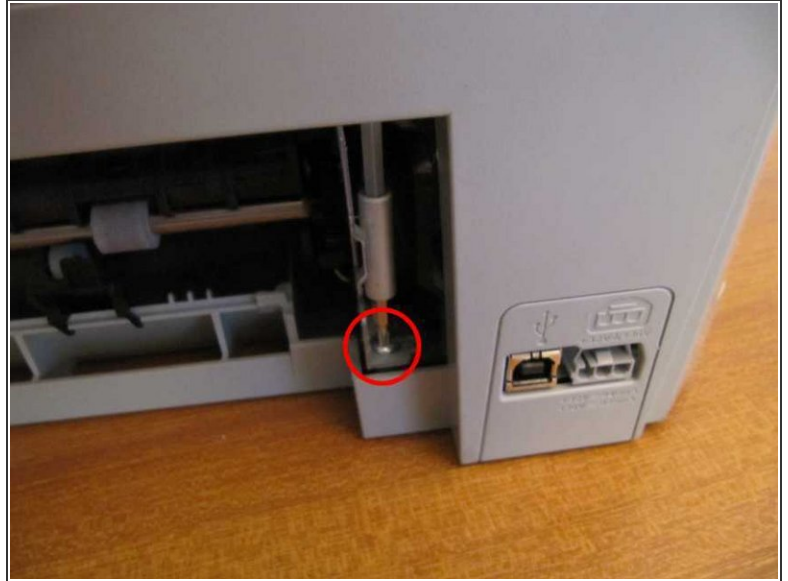
## Step 10

- Remove 2 screws on the left hand side, securing the print mechanism to the base through the main circuit board.
- Remove a further screw, visible from the rear of the printer, also passing through the circuit board at a rear corner.

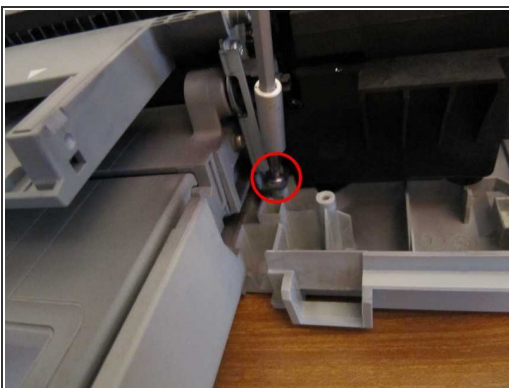
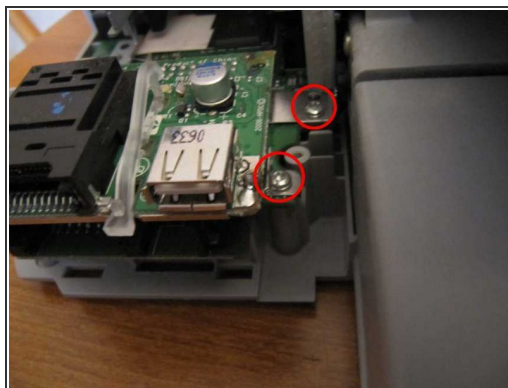
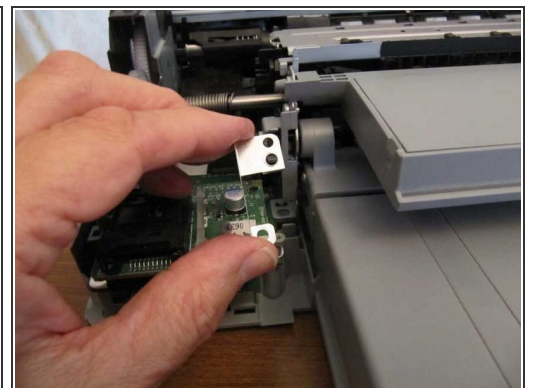
## Step 11

- Remove a screw, just to the right of the paper tray.
- Remove 2 more screws to the left of the paper tray. One of these releases a small piece of metal, which should be safely put aside, not to be forgotten on reassembly.

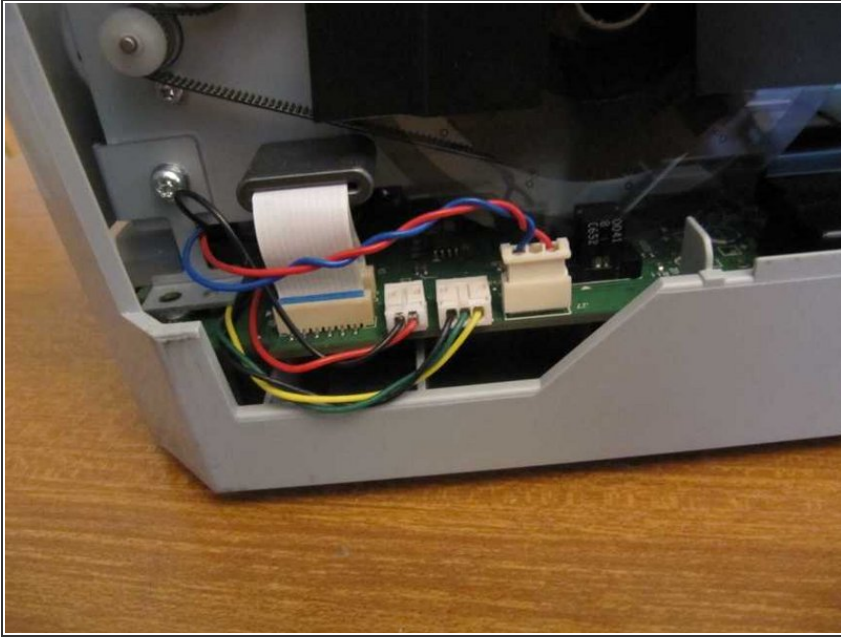
## Step 12

- From the left hand side near the rear of the printer, disconnect 2 ribbons, one behind the other, and 3 wire connectors.

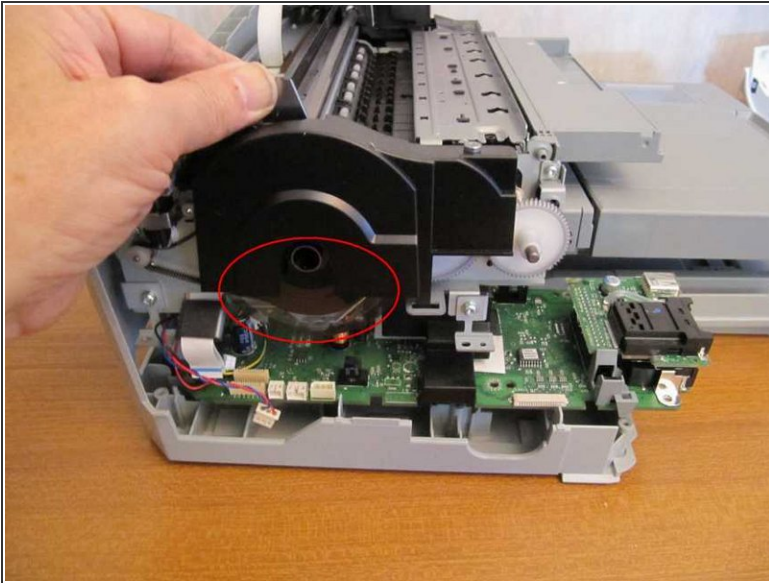
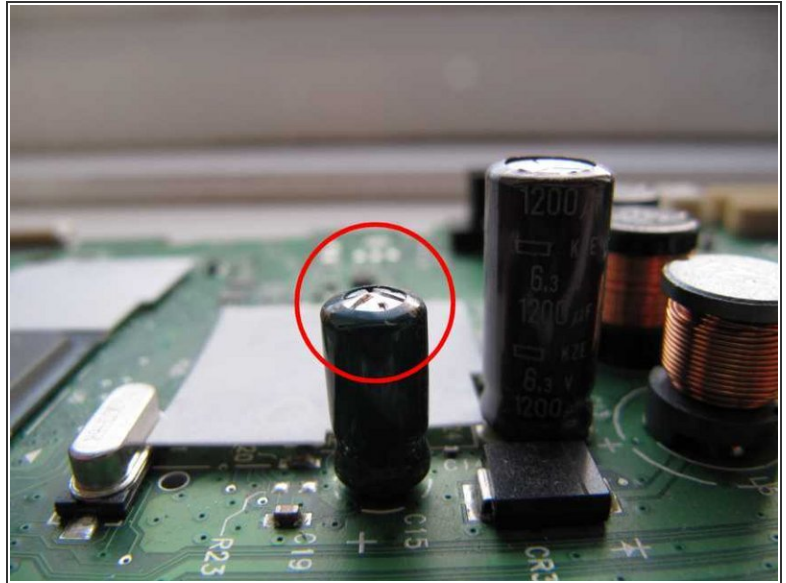
## Step 13

- Note the thin plastic encoding wheel which slots into an optical sensor on the logic board. Take great care not to damage this as you lift the print mechanism in the following steps.

- Lift the left hand end of the print mechanism. This will provide sufficient room to slide out the main logic board towards the front of the printer.
- Examine the main logic board for signs of overheating. Also look for any electrolytic capacitors with domed tops or signs of leakage, indicating that they are failing.

- There have been reports that some of these printers use electrolytic capacitors of poor quality, bearing the name TEAPO and having a green and gold sleeve. Pay special attention to any of these.

- Replacement capacitors should have the same or up to double the capacity (quoted in  $\mu\text{F}$ ), and the same or preferably higher Voltage and Temperature ratings.

- Care is required in removing and replacing any suspect or failed components as the tracks on the circuit board are very fine.

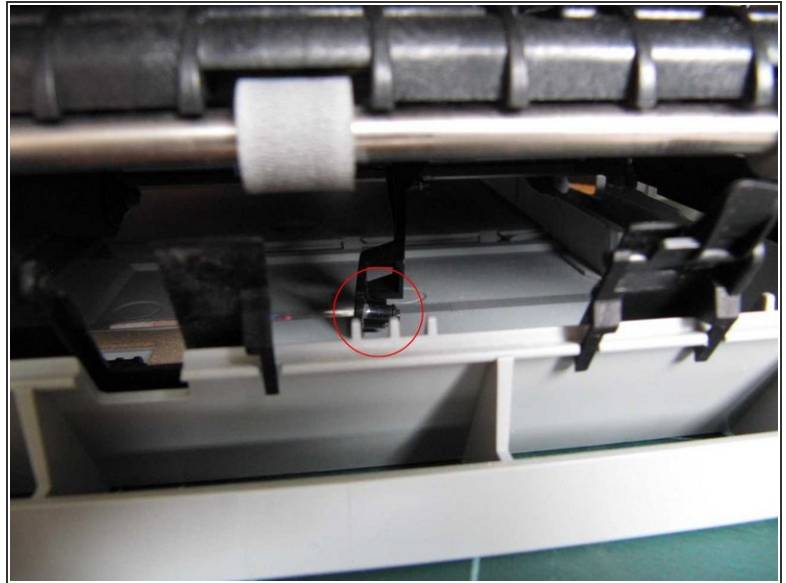
## Step 14

- The entire print mechanism can be removed from the base. First, release a lever at the left hand side of the back of the printer from its clip on a spindle. You may have to gently press on a tab near the other end of the spindle in order to bring the clip forwards so as to be able to release the lever.

- The print mechanism can now be lifted out. It may take some jiggling to release the metal mechanism frame from the plastic base at a point close to the clip which retains the aforementioned lever.

- On reassembly (or if you set the mechanism down on the bench) be sure to check that the lever and roller which press down on the paper in the tray is angled backward. If not, the weight of the mechanism will bend the lever and possibly break it or push off the roller (as has happened in the 2nd photo).

- On order to be able to position the print mechanism correctly you will need to lift the lever which fits into the clip on the spindle, so that it is positioned to do so.
