# HTC One Teardown

HTC One teardown on March 27, 2013.

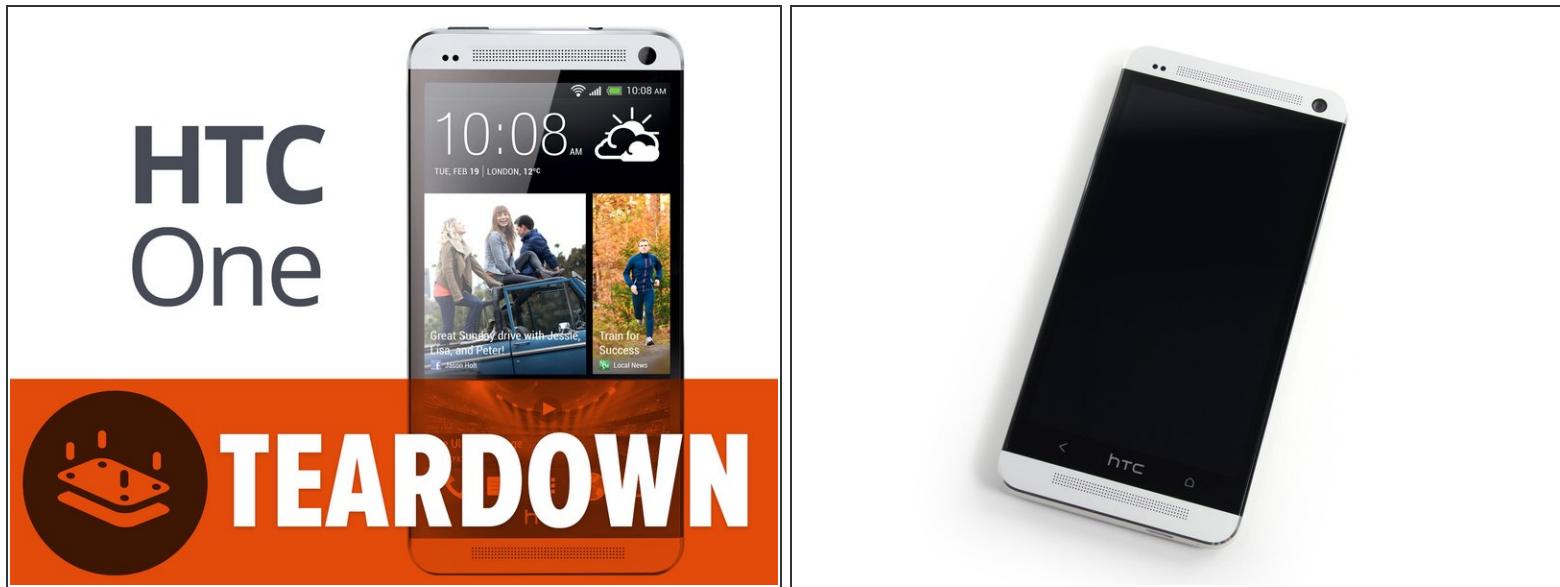
## Step 1 — HTC One Teardown

- Some people spend their whole lives looking for "the one." We found a suitable candidate and decided to court it the only way we know how: piece by piece.
- Tech Specs:
  - All-aluminum unibody construction
  - 4.7" display with a resolution of 1920x1080 (468 ppi)
  - Qualcomm Snapdragon 600 Quad-Core 1.7 GHz CPU
  - 2 GB DDR2 RAM
  - 4-megapixel UltraPixel Camera
  - HTC BoomSound

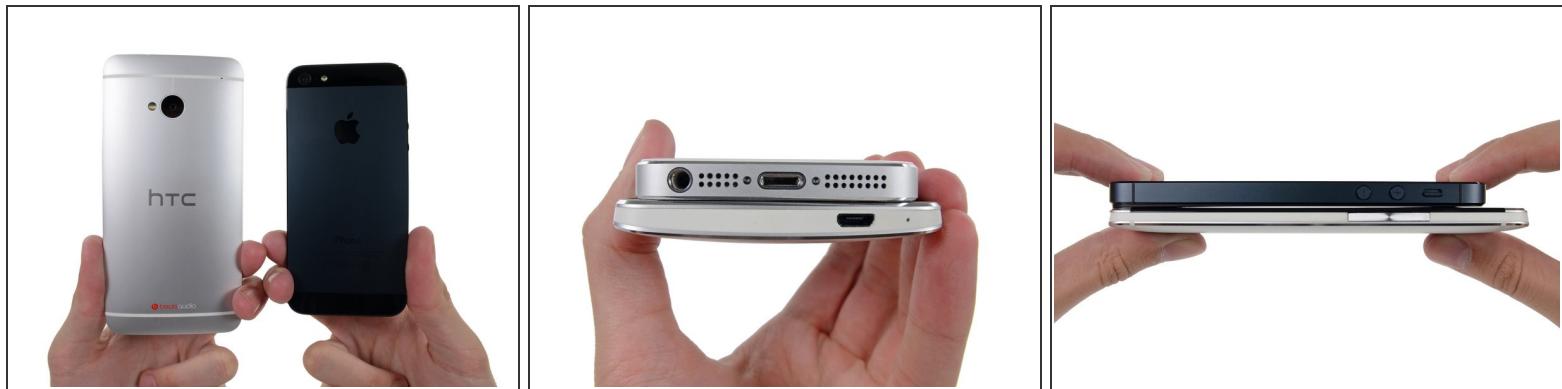
## Step 2

- It's no surprise that HTC appears to be taking a cue from the [iPhone 5's](#) design pattern in creating a sleek aluminum-bodied phone.
- Whereas Apple went with a flat backside to keep the iPhone's overall thickness down, HTC wanted a more ergonomic curved back.
- HTC has said over and over that they wanted to create a seamless product, and the absence of any exterior screws is a testament to that.
- Unlike the iPhone's volume buttons, which protrude from the case, the One's buttons lie flush with the sides so as not to interrupt the body lines.

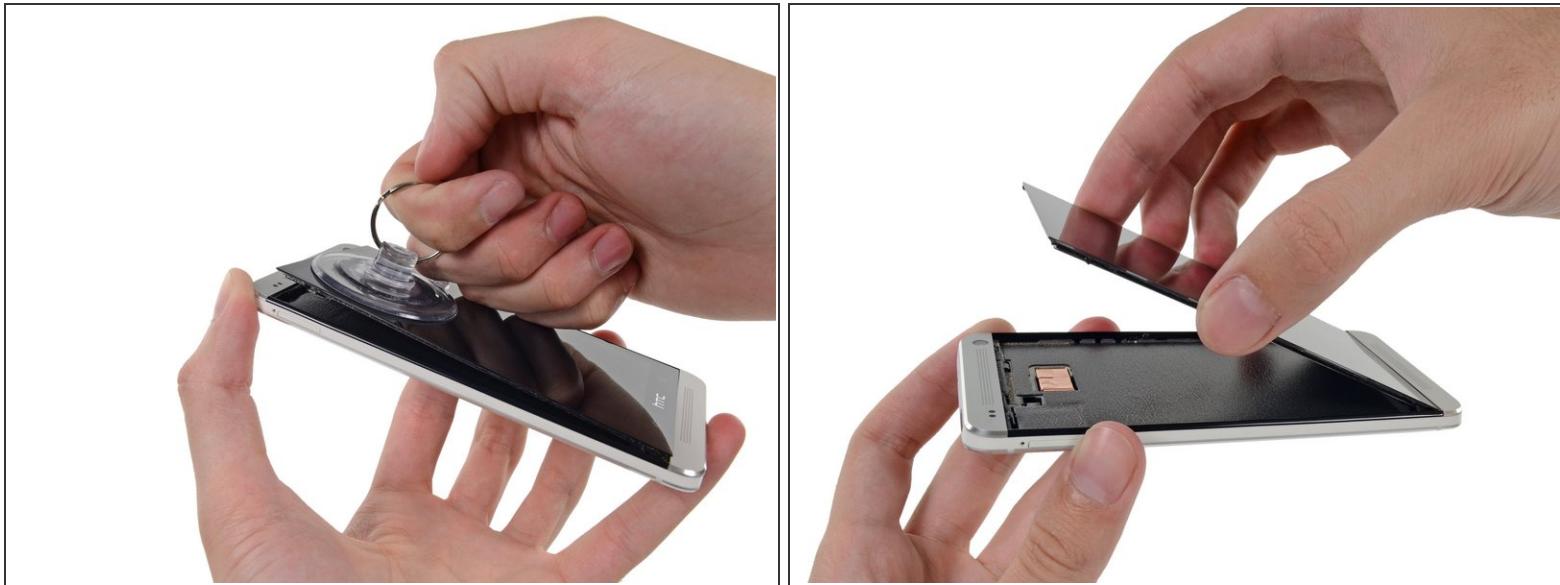
## Step 3

- To get things started, we dive into the one part of the HTC One that isn't aluminum: the 4.7" 1080p HD display.
- A small amount of heat and a suction cup were all that was required to create a gap in the One's [zero gap construction](#).

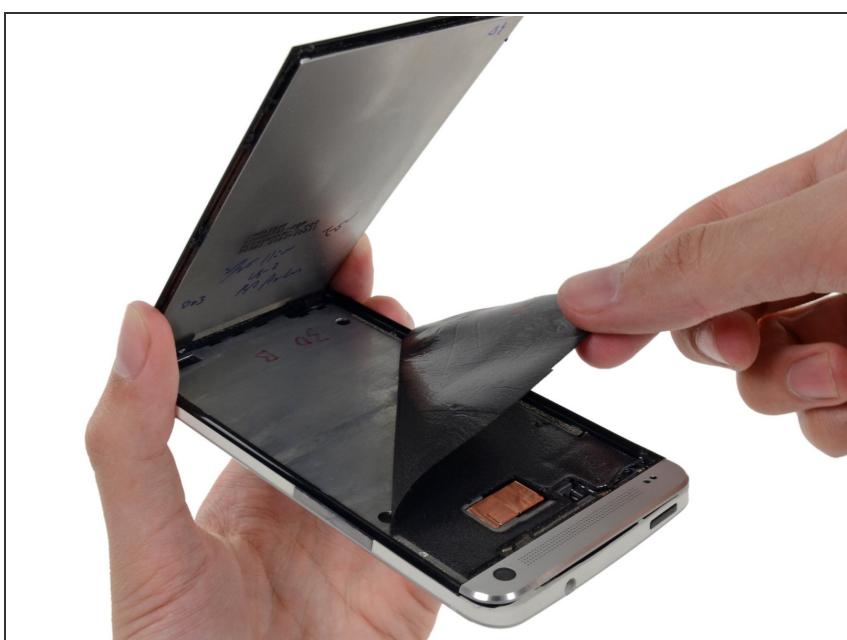
## Step 4

- While the display can be lifted, it can't be removed as it is still connected via the display ribbon cables, which are routed underneath the case assembly.
- In hopes of discovering any hidden screws, we remove the large foam padding adhered to the top of the case assembly.
- No dice.

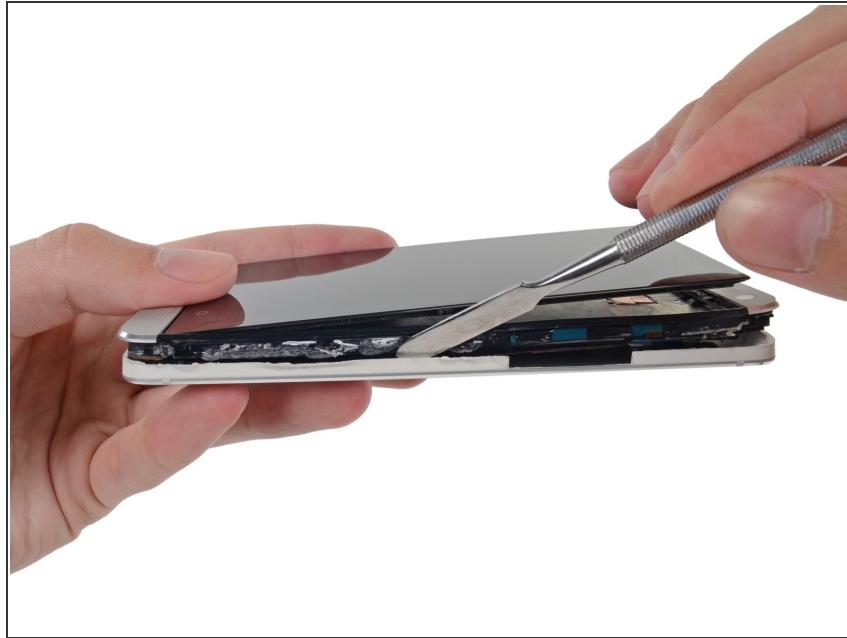
## Step 5

- With no clear path to entry, we decide to get a little more creative with our approach...for a good half hour.
- Utilizing the steady hands of a seasoned device surgeon, we free the One's innards from the dungeon-esque aluminum case with a [metal spudger](#).

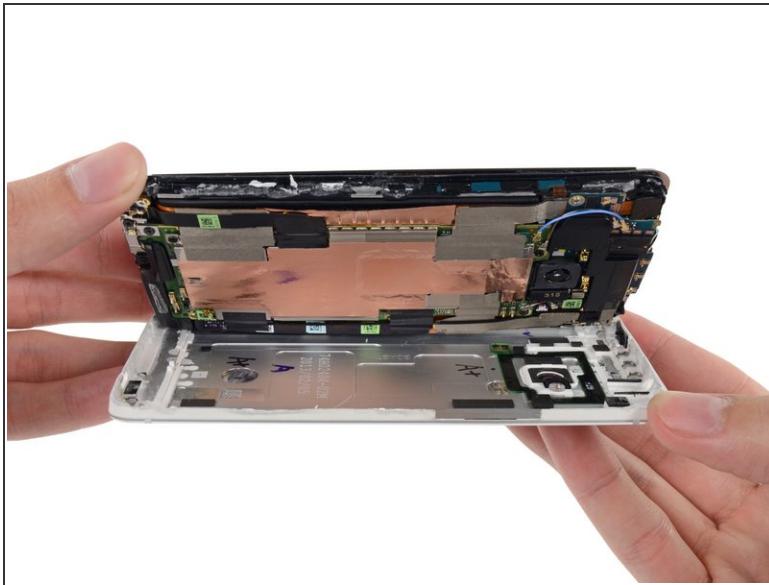
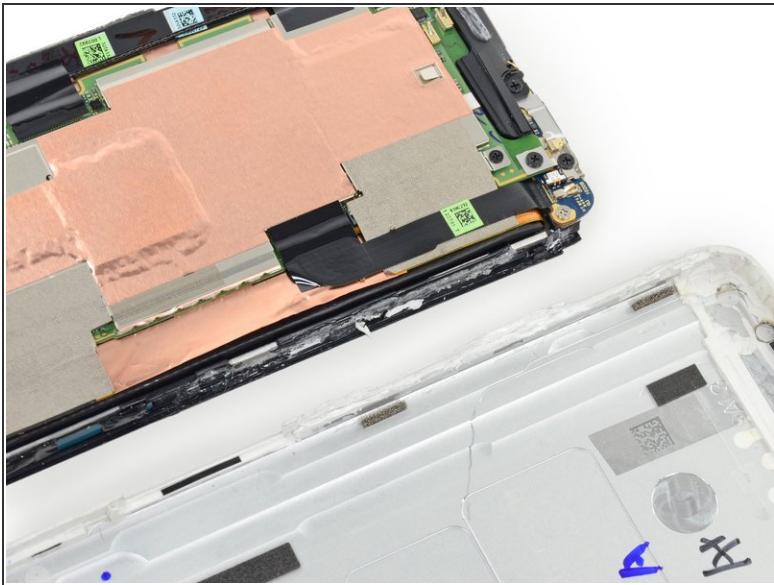
## Step 6

- We won't lie, getting to this point was an arduous and daunting task. The amount of work required to separate the rear aluminum case and the front case was immense.
- Nevertheless, we present to you the contents of the One.
- Our diligent spudgering appears to have permanently mangled the plastic bezel surrounding the aluminum case. It's possible that prying at a snail's pace while applying heat could minimize this damage, but we're not too hopeful. This phone was not made with open-ability in mind.

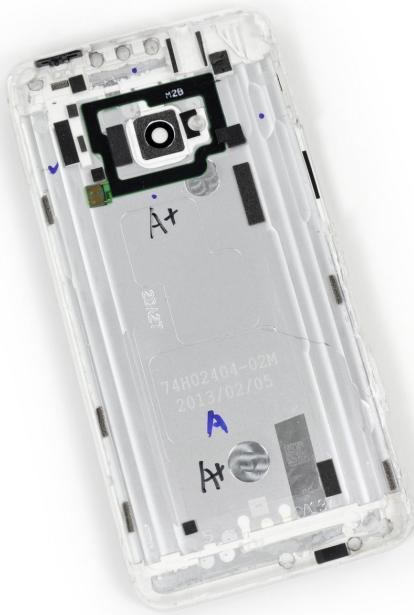
## Step 7

- The number one standout feature of the One is certainly the aluminum unibody, which required much [custom tooling](#) on HTC's part to achieve the perfect fit and finish.
- Around the camera bezel we find the near-field communications (NFC) antenna and its pressure contacts. NFC has recently become pretty standard in the smartphone industry, something that might have helped the [Nexus Q](#) gain more traction last year.  
**(i)** With the rear case off, we find the One's report card. It looks like straight As, although at this point we are not sure the repairability score will fare so well.

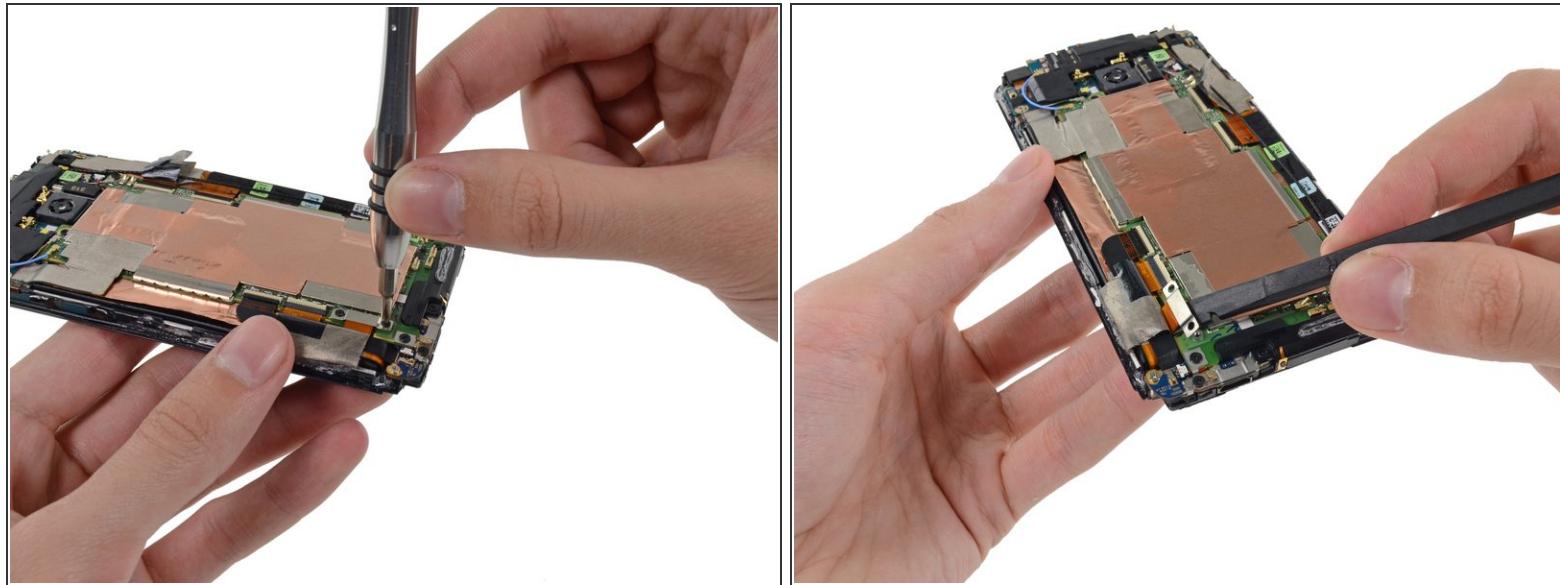
## Step 8

- The back of the One is covered in a sea of copper tape and ribbon cables, and only after a diligent search are we able to locate the battery connector—although no clear path to the battery itself.
- The battery connector is secured to the motherboard with screws. After a couple of turns with our [64 bit kit](#)'s precision driver, it's released and ready for removal from the device... but not yet.

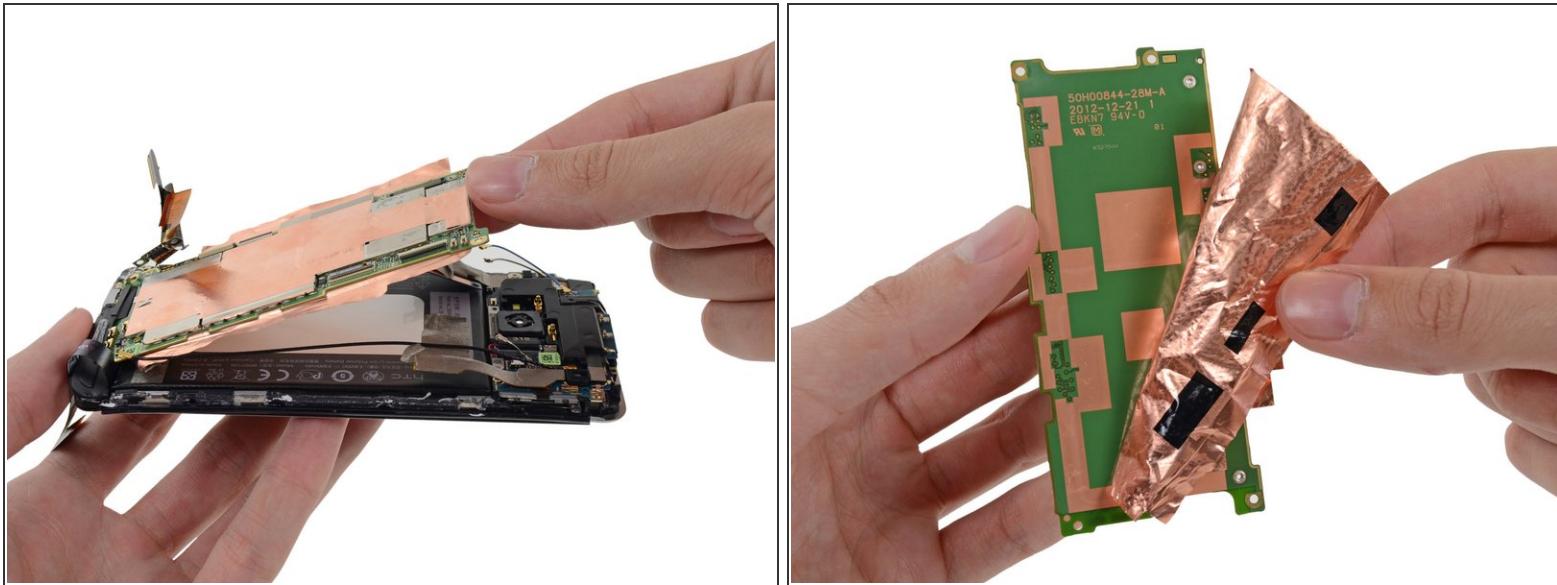
## Step 9

- The motherboard of the HTC One is pretty much encapsulated within copper shielding. Two flat pieces of copper adorn each side of the motherboard.
- Here's the thing about copper shielding. It dissipates heat and provides electrical grounding. However, copper shielding is a pain to deal with during reassembly—kind of like trying to straighten out aluminum foil once it's been crinkled.

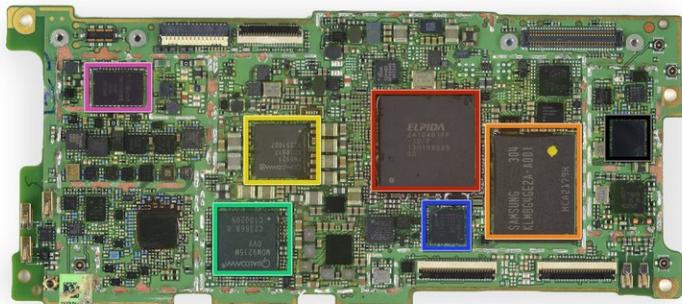
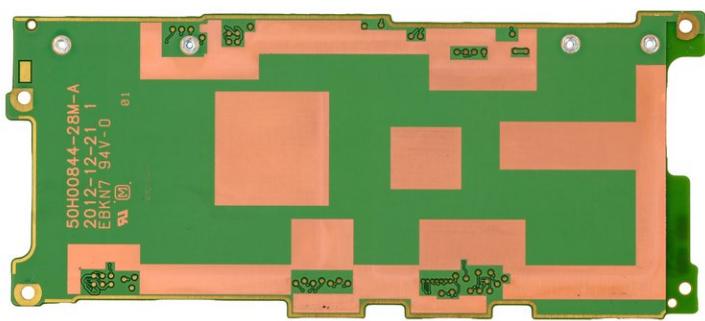
## Step 10

- All ICs are located on the front side of the motherboard:
  - Elpida BA164B1PF 2 GB DDR2 RAM + Qualcomm Snapdragon 600 quad-core 1.7 GHz CPU
  - Samsung [KLMBG4GE2A](#) 32 GB NAND flash memory
  - Qualcomm [PM8921](#) power management IC
  - Qualcomm [MDM9215M](#) 4G GSM/UMTS/LTE modem
  - Synaptics S32028
  - TriQuint [TQM7M9023](#) multi-band power amplifier
- Broadcom [BCM4335](#) single-chip 5G WiFi™ 802.11ac MAC/baseband/radio with Bluetooth 4.0+HS & FM receiver

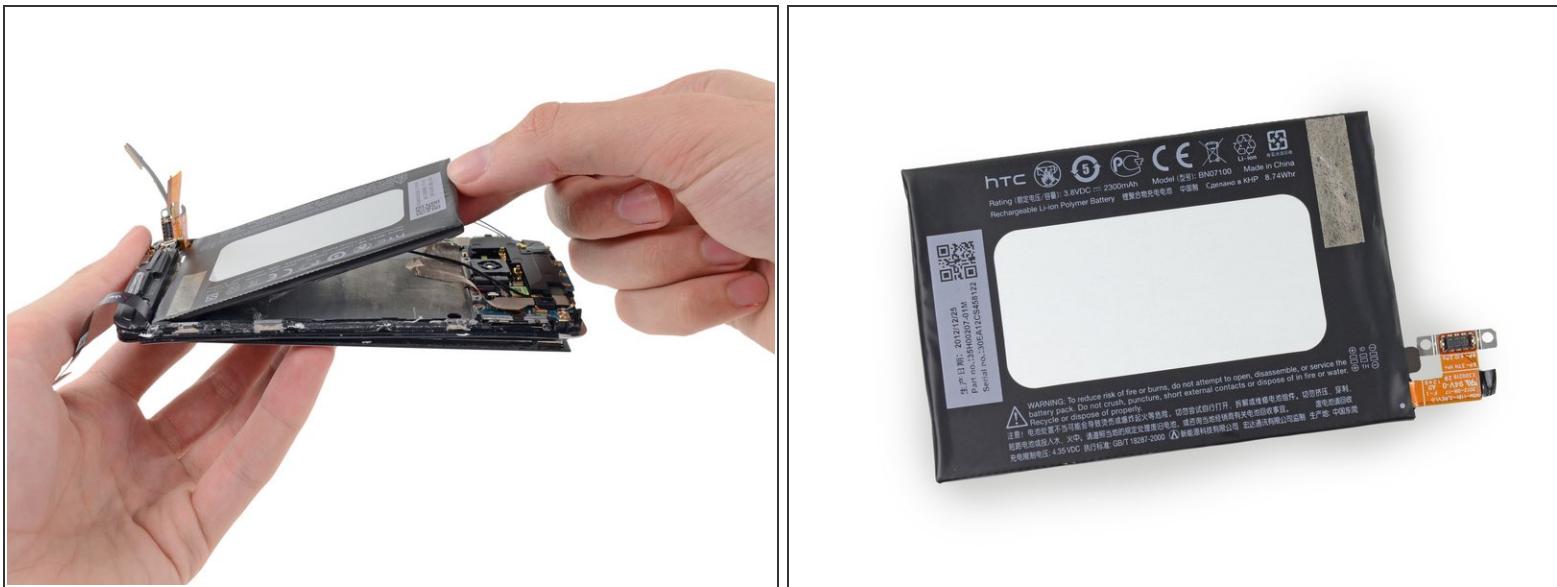
## Step 11

- Now that the motherboard has been removed, we're finally able to access the sandwiched-in battery. After some prying and peeling, we slowly extract the well-adhered battery from the midframe.
- The 3.8 V battery is rated at 2300 mAh and weighs 38.3 g. For comparison, the [iPhone 5](#) has a 3.8 V, 1440 mAh battery, and the [Galaxy S III](#) has a 3.8 V, 2100 mAh unit.
- Less than a week after the [BlackBerry Z10](#) wowed us with its user-installed battery, the HTC One shatters our dreams of widespread repairability.

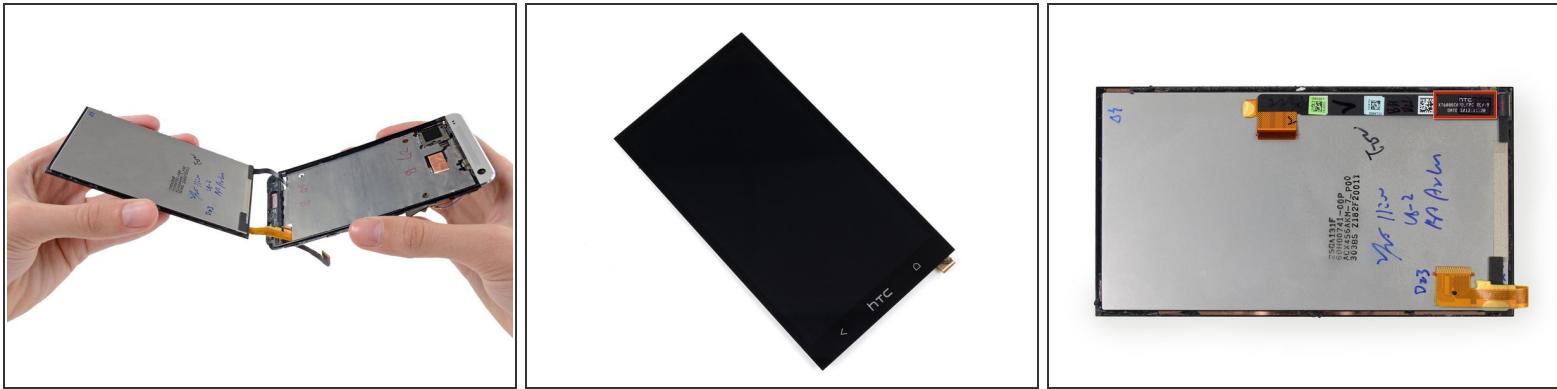
## Step 12

- The HTC One's 1080P, 468 ppi resolution rivals today's HDTVs and the 10.6" [Surface Pro](#), but in a 4.7" size.
- Nine steps after prying the display assembly up from the case, we finally get a look at it on its own. Just like we saw earlier with the battery, this component can't be replaced without removing everything from the rear case...and then first taking out the motherboard.
- There are a number of strange markings on the back of the display panel that we can only identify as the signatures of family physicians.
- Aside from the inspection notes, the cable is labeled XT6088C07B\_FPC REV: 8 DATE: 2012.11.30, indicating that at least certain parts of this phone have been in the works for quite some time.

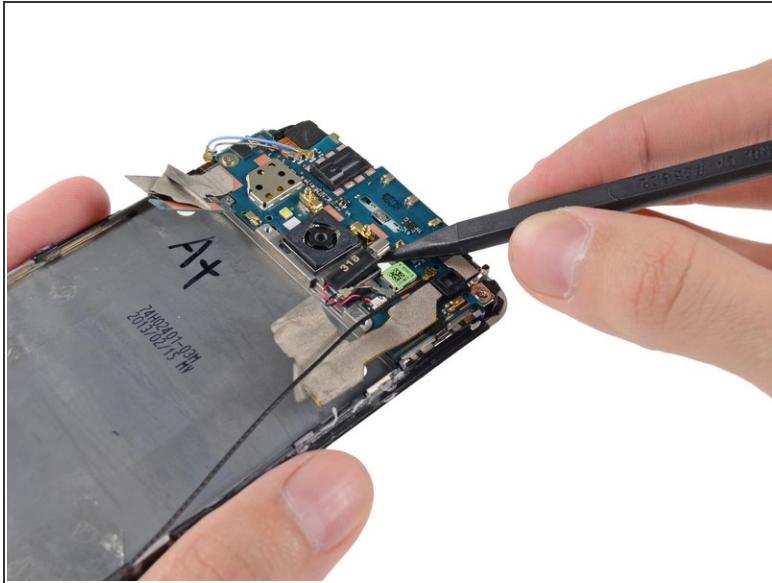
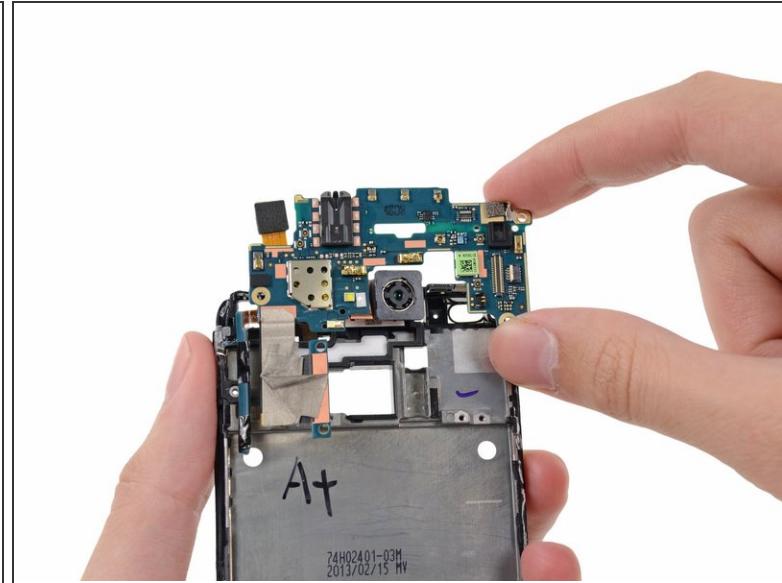
## Step 13

- Prying out the vibrator motor frees the daughterboard for its escape from the midframe.
- There's a lot going on with this board—it's a host to the front- and rear-facing cameras, headphone jack, ambient light sensor, volume switches, and several spring contacts.

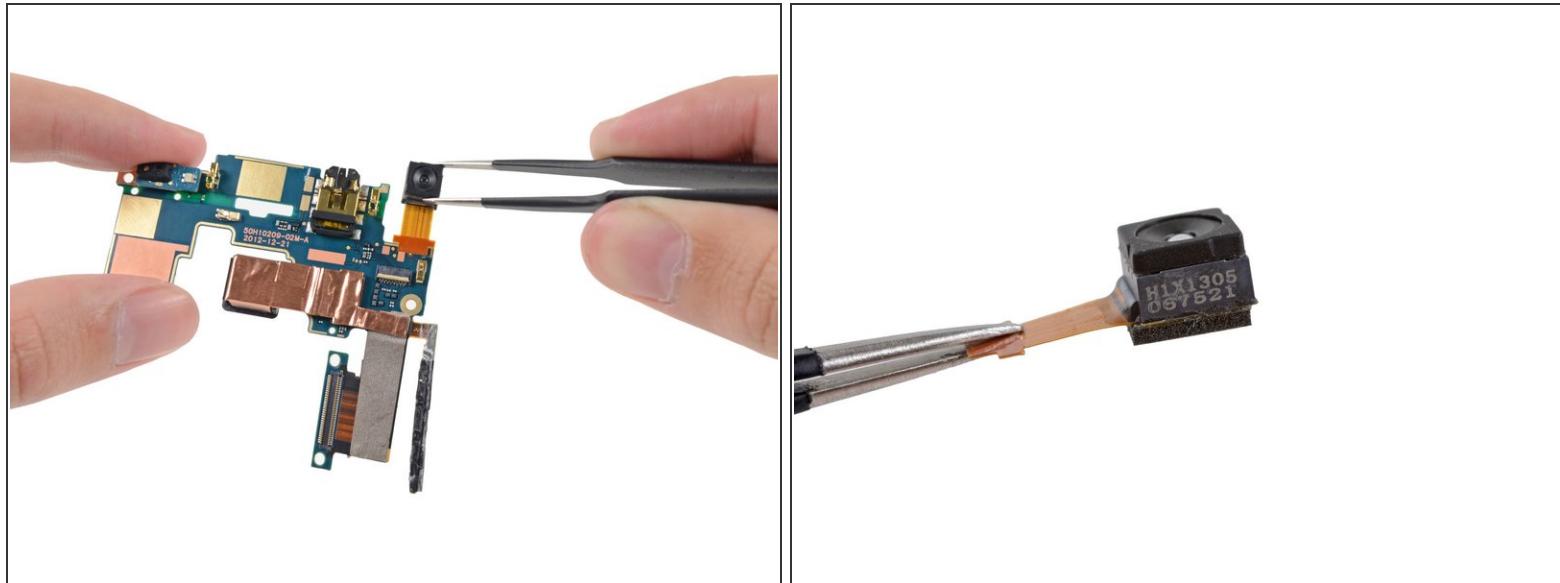
## Step 14

- Off comes the 2.1 MP front-facing camera.
- This teeny-tiny unit is labeled H1X1305 067521.
- Chipworks [took apart](#) their HTC One and found OmniVision die marks inside.

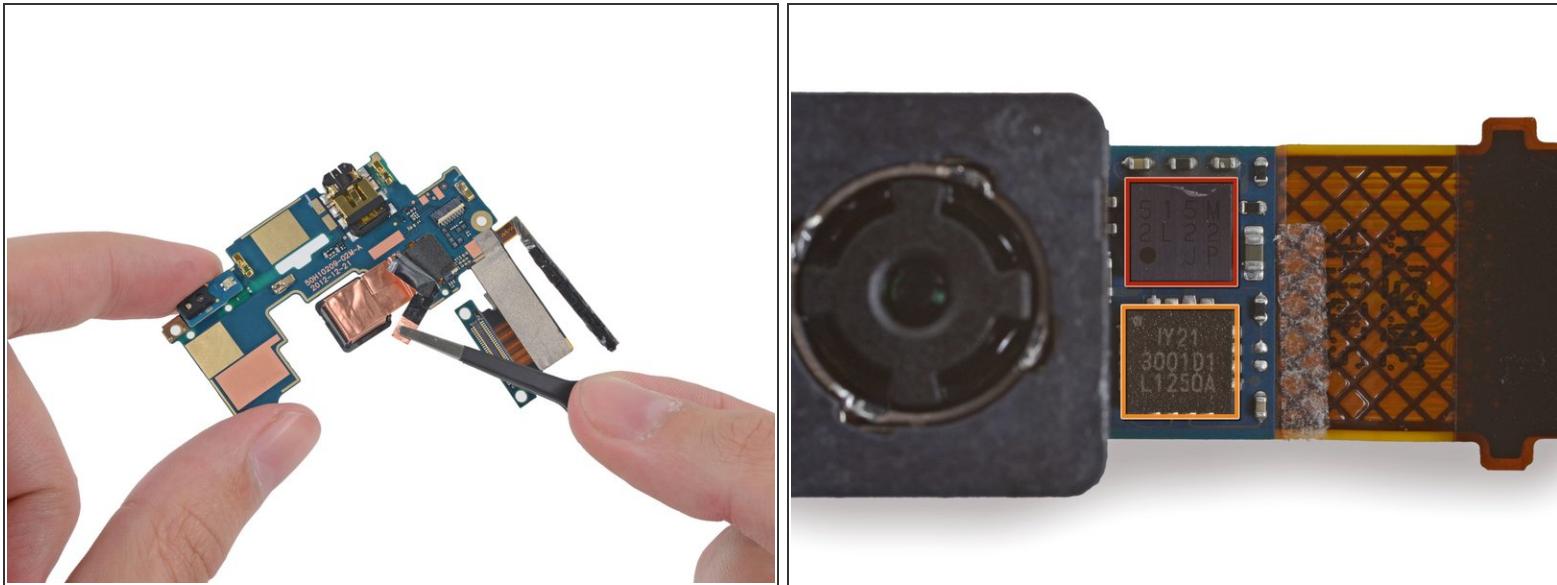
## Step 15

- There is no respite for the weary—even the rear camera is coated in copper shielding.
- This is the HTC [UltraPixel](#) camera, a f/2.0 aperture, 28 mm lens unit with a dedicated HTC [ImageChip™ 2](#).
-

Chipworks found it to be a 4 MP backside-illuminated sensor made by ST Microelectronics.
- With the rear camera out, we find two small ICs hiding on the camera's ribbon cable:
  - 515M 2L22 JP
  - IY21 3001D1 L1250A
- Manufacturing such a small camera that can do so much is a hefty task, and a shortage of these units is a big reason why HTC has had to [delay the official launch](#).

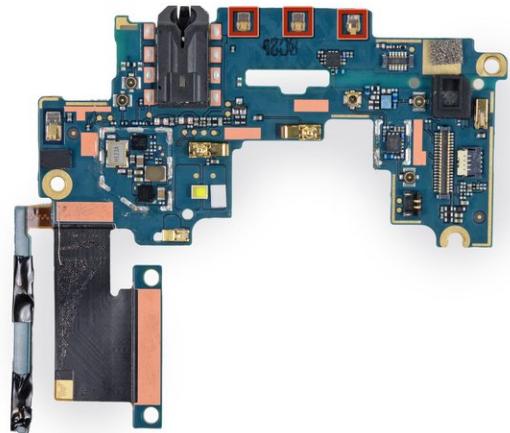
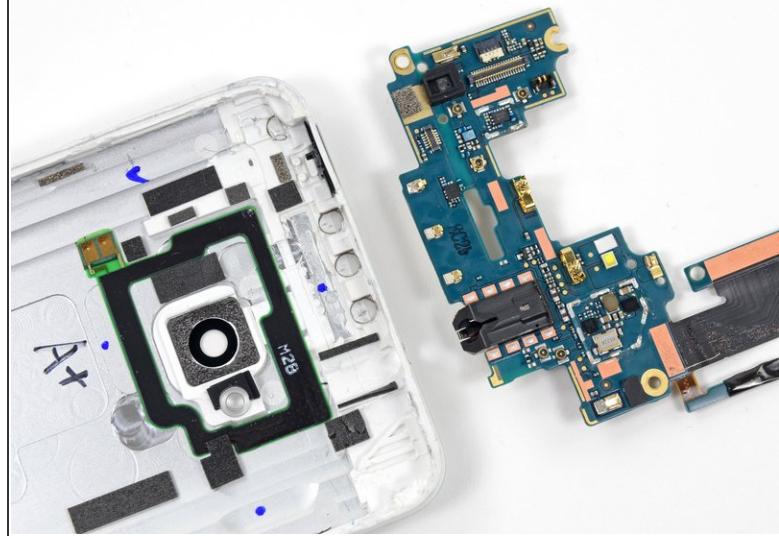
## Step 16

- The daughterboard remains, but there is still a mystery left unsolved.
- No phone operates without antennas, and antennas don't transmit signals well through metal walls. Considering that this daughterboard is on the receiving end of the motherboard's antenna cables and sits directly under the plastic bezel at the top of the phone, we're thinking it has something to do with wireless signals.
- See those three spring contacts along the top of the board? They meet the rear case in an area obscured by the plastic bezel. If we had to guess, that's where HTC put the antennas.

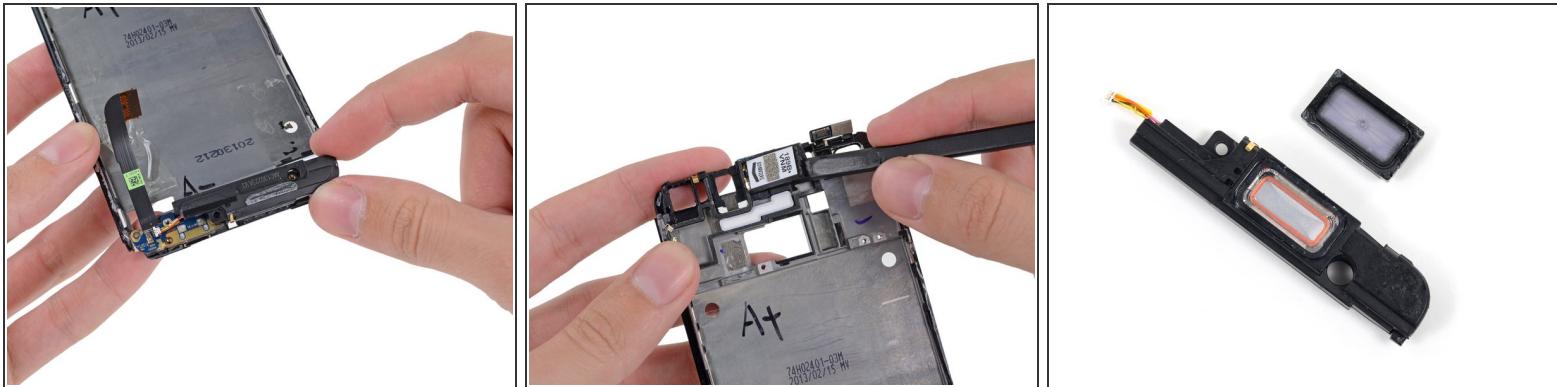
## Step 17

- Again with the lack of surprises, our dual-speaker HTC One comes with—wait for it—two speakers.
- HTC has been using [Beats Audio](#) in its mobile devices for a while now. Whether the choice is based on actual performance or fueled by brand recognition, Dr. Dre's company again got the call—this time to tune, tailor, and approve the One's stereo speaker design and throw in a software equalizer.

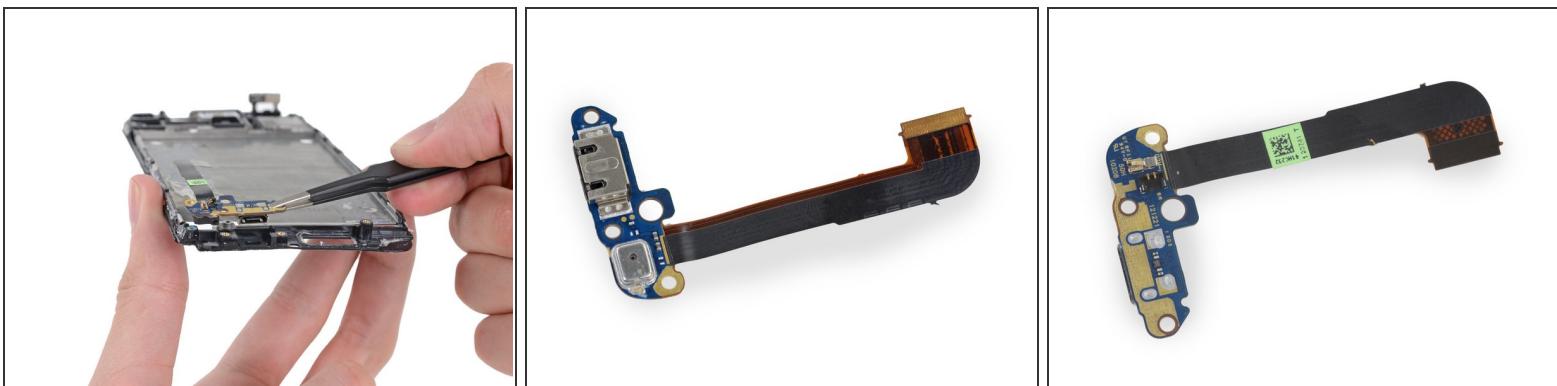
## Step 18

- We've come to the *stern* conclusion of the midframe. We find the USB *port* and microphone. This little I/O is not the *star-board* but it is helpful if you need to ask for directions.
- On the flipside we see the connector for the speaker. It looks like most of the audio runs through this little board.

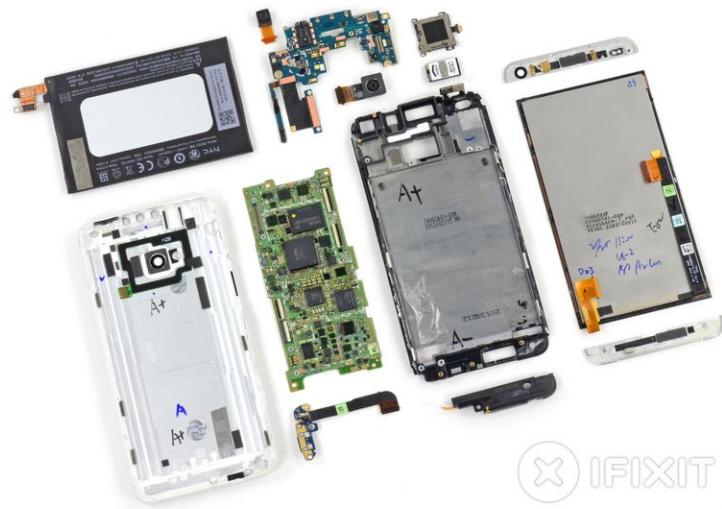
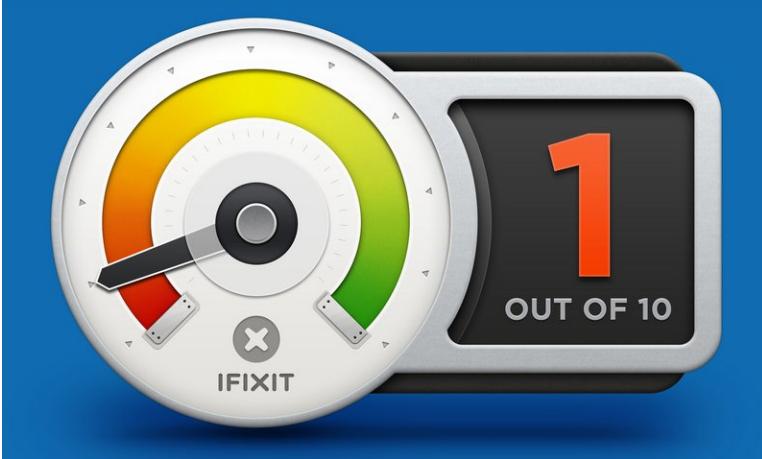
## Step 19

- HTC One Repairability Score: **One out of 10** (10 is easiest to repair)
  - Very, very difficult (possibly impossible?) to open the device without damaging the rear case. This makes every component extremely difficult to replace.
  - The battery is buried beneath the motherboard and adhered to the midframe, hindering its replacement.
  - The display assembly cannot be replaced without removing the rear case—this will make the most common repair, a damaged screen, nearly impossible.
  - Copper shielding on many components is difficult to remove and replace.
  - Solid external construction improves durability.
