Hamilton Beach 25460Z Top Heating Element Solders Replacement

Use this guide to replace damaged solder joint(s) that can be preventing your Panini Press from heating up.

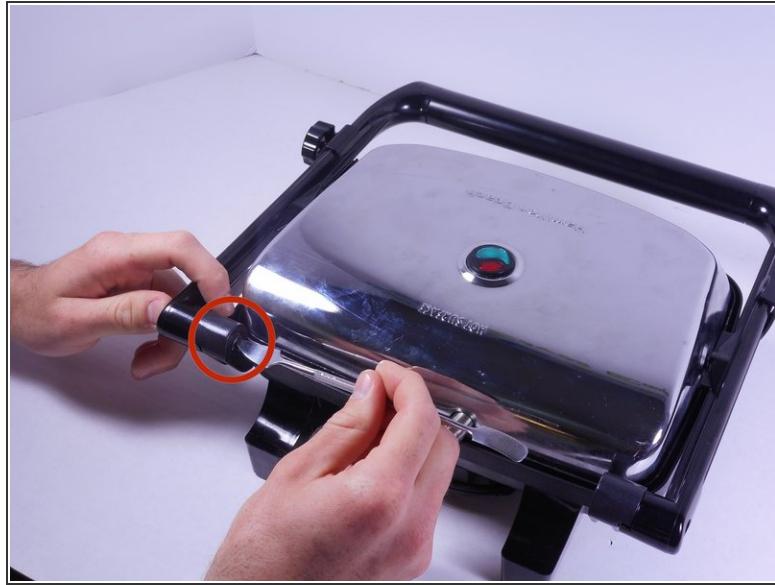
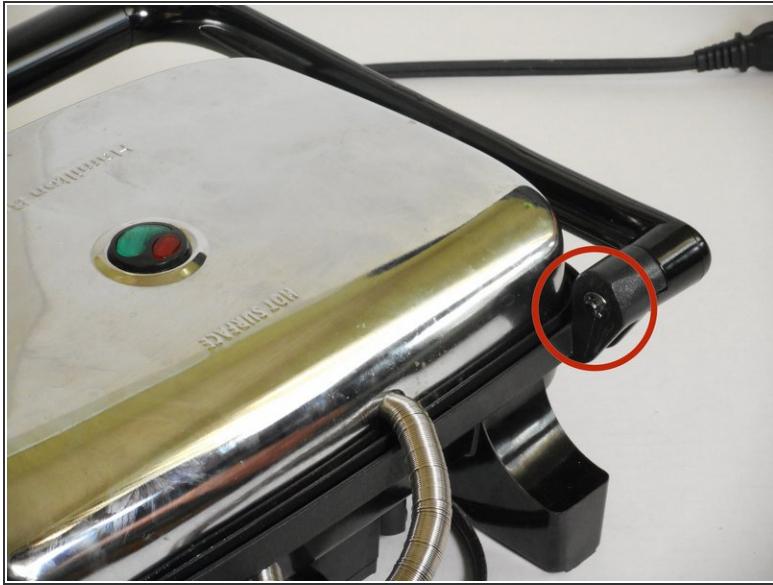
Step 1 — Handle

- On the back of the press, remove the locking washer by prying upwards with the nylon or metal spudger tool.
- Repeat for the other washer across from the first one.

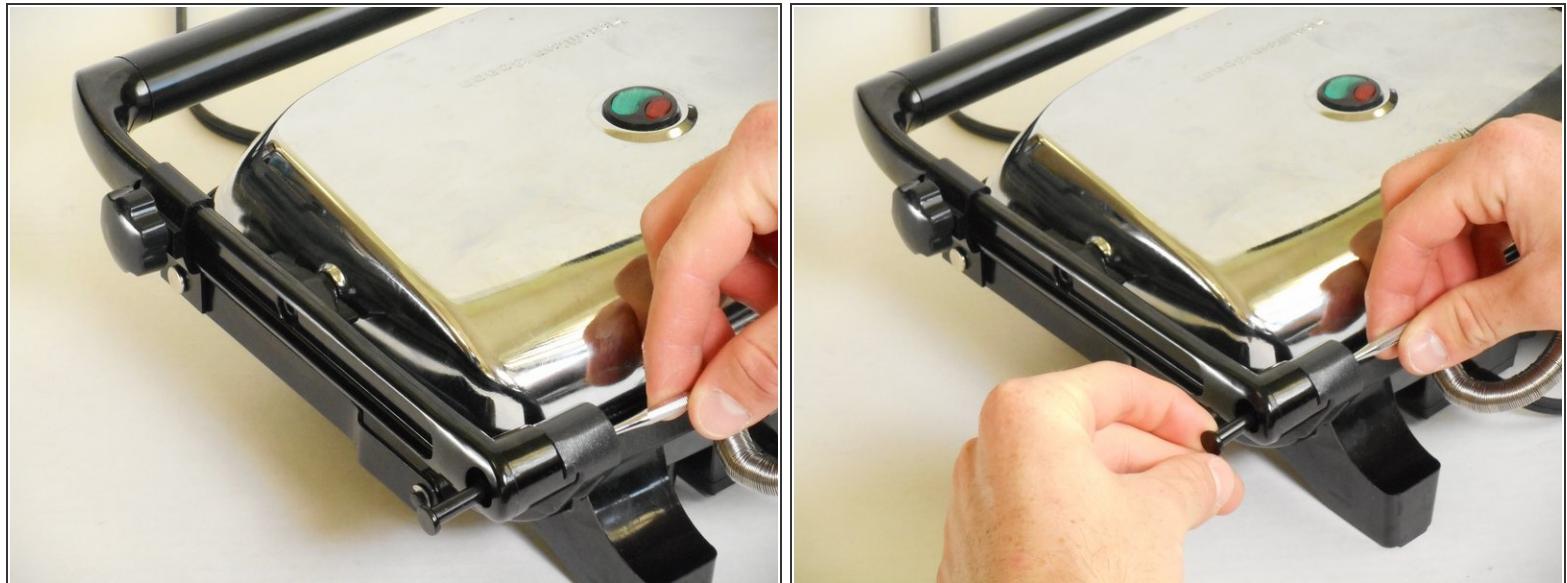
Step 2

- Using any long, thin object, push the 43mm bolt from the inside towards the outside to expose the end of the bolt.
- Pull the end of the bolt out to completely remove it.
- Repeat for the second bolt.

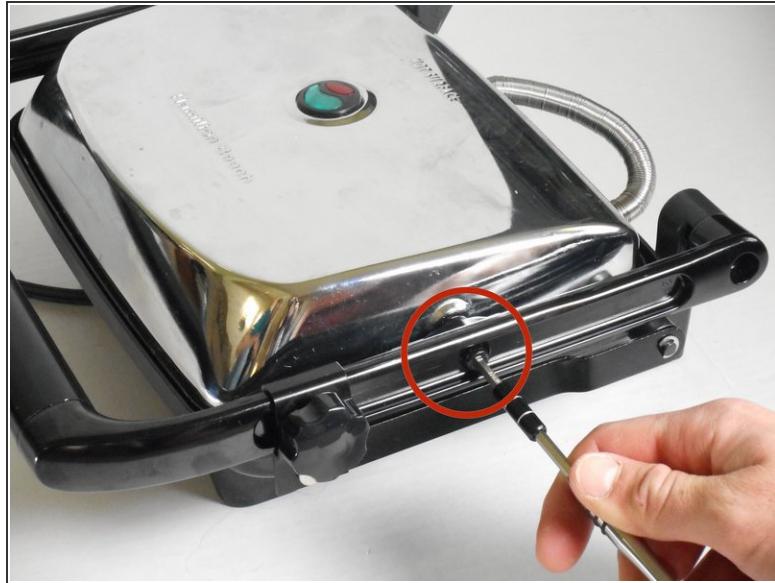
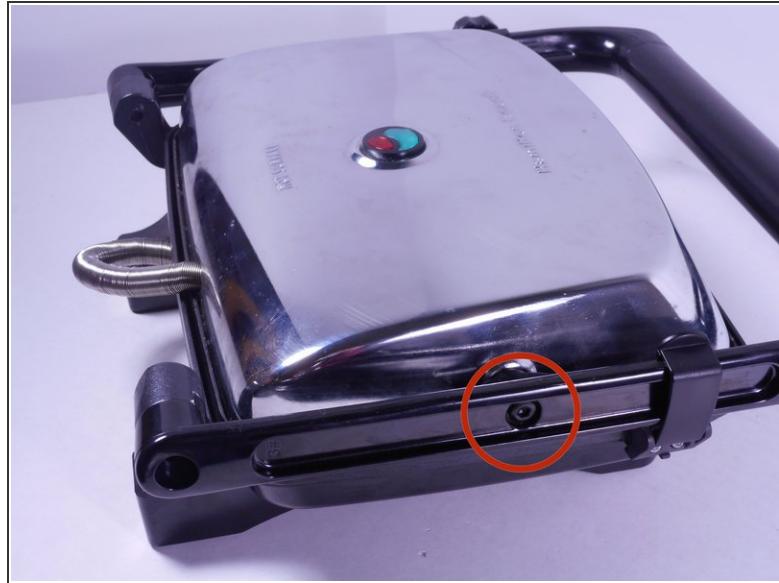
Step 3

- Using the 4.0mm Allen Wrench, unscrew the two 26mm bolts connecting the handle to the upper heating element housing on both sides.

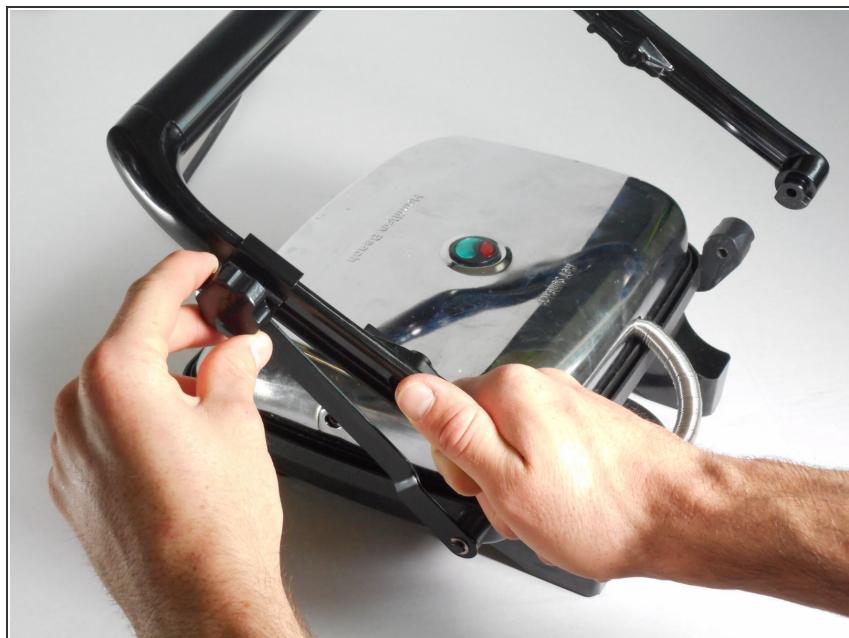
Step 4

- Unscrew the locking knob all the way to remove it.

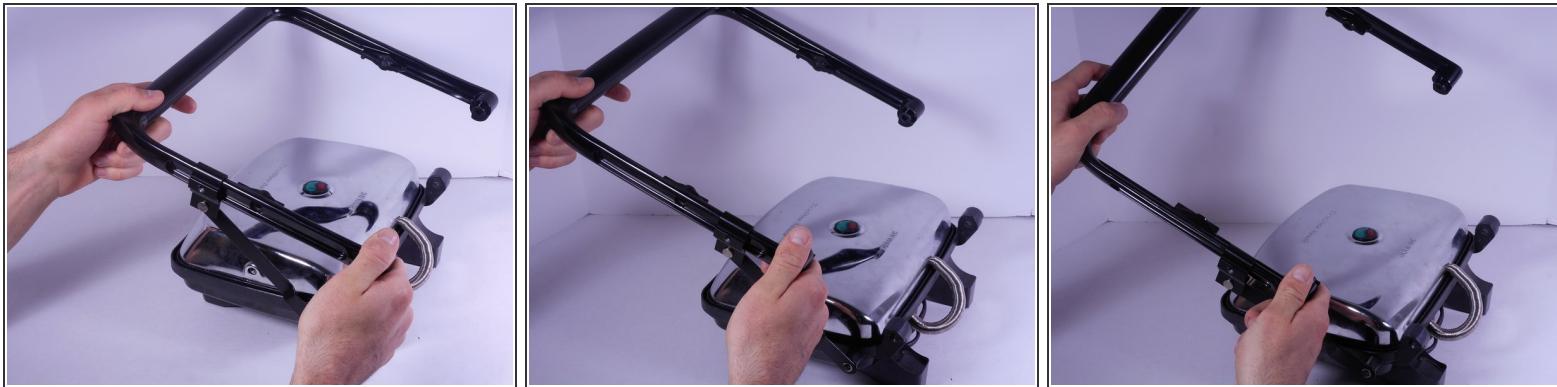
Step 5

- Slide the locking knob couple down to the base of the handle, then pull up on the free end of the handle. It will easily pop off.

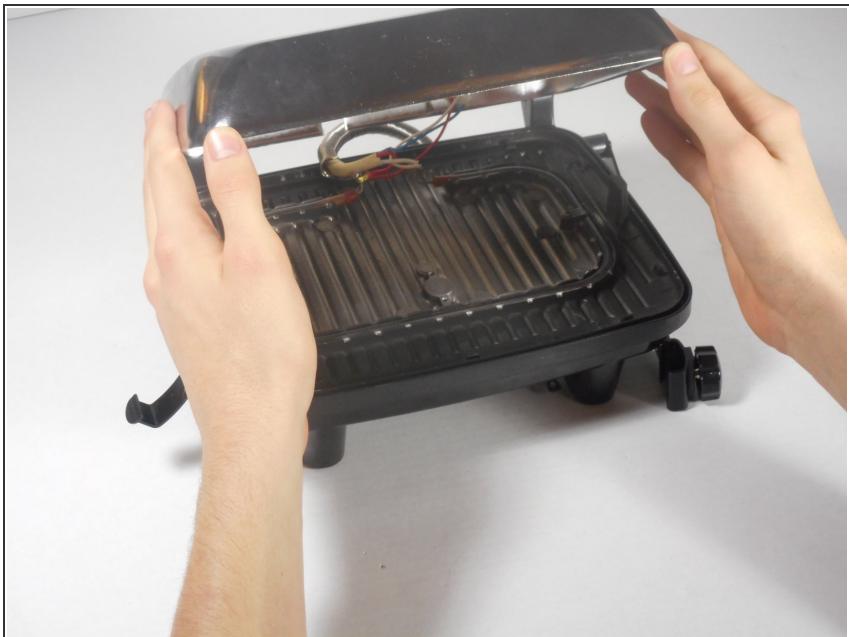
Step 6 — Top Heating Element Solders

- Gently separate the heating element housing from the cooking surface by pulling up on the housing and pushing down on the surface.

Pulling too far or too hard can break the delicate internal wiring.

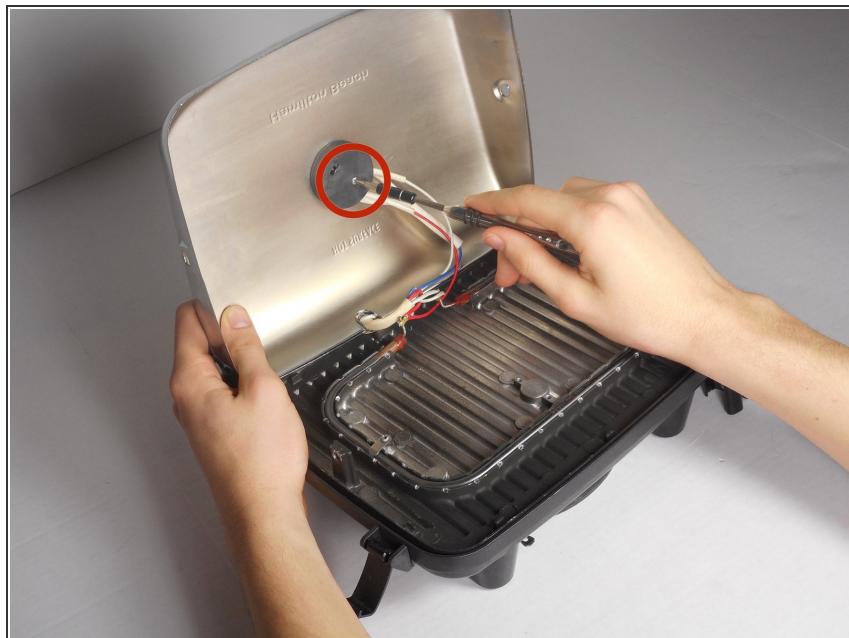
Step 7

- On the underside of the housing, use the PH2 Screwdriver to remove the single 12mm screw to disconnect the LED tray.
- The housing can now be completely removed.

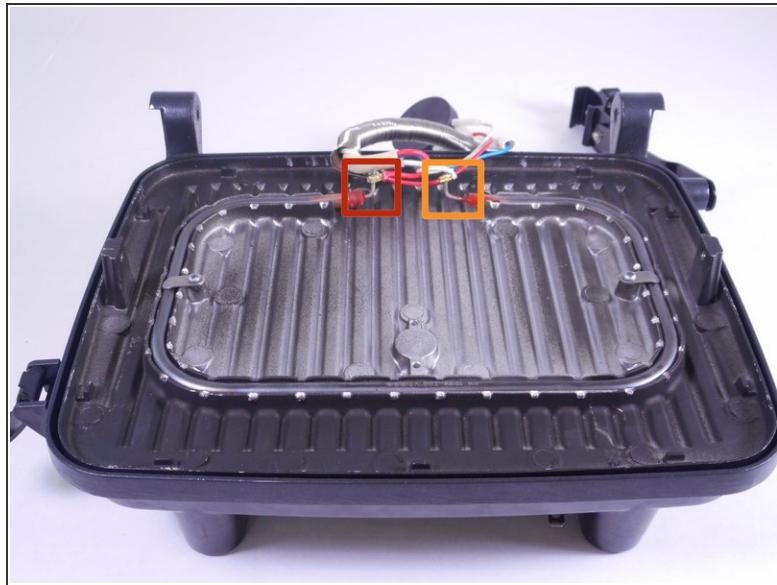
Step 8

- The left lead needs to be connected to the two red wires.
- The right lead needs to be connected to the two white wires.
- One or both of the leads can have damaged solder, resulting in poor connections between the lead and the wire ends.
- De-solder the existing solder joints on the lead(s).
- Solder the wire ends back to their corresponding leads.
