How to Get Rid of Fan Clicking Noises on a Toshiba TDP-XP2

This guide shows how to remedy excessively loud clicking noises on a Toshiba XP2 projector.

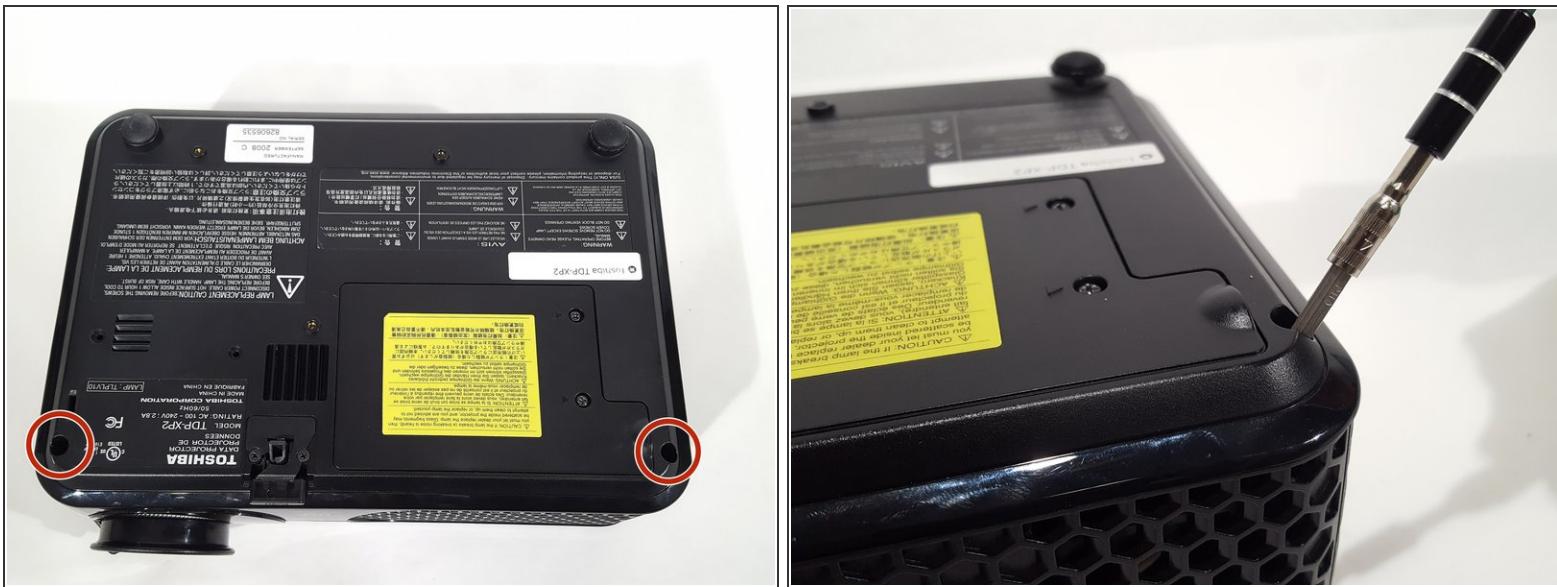
Step 1 — How to Get Rid of Fan Clicking Noises on a Toshiba TDP-XP2

- Start by removing the two screws on the bottom of the device as shown.

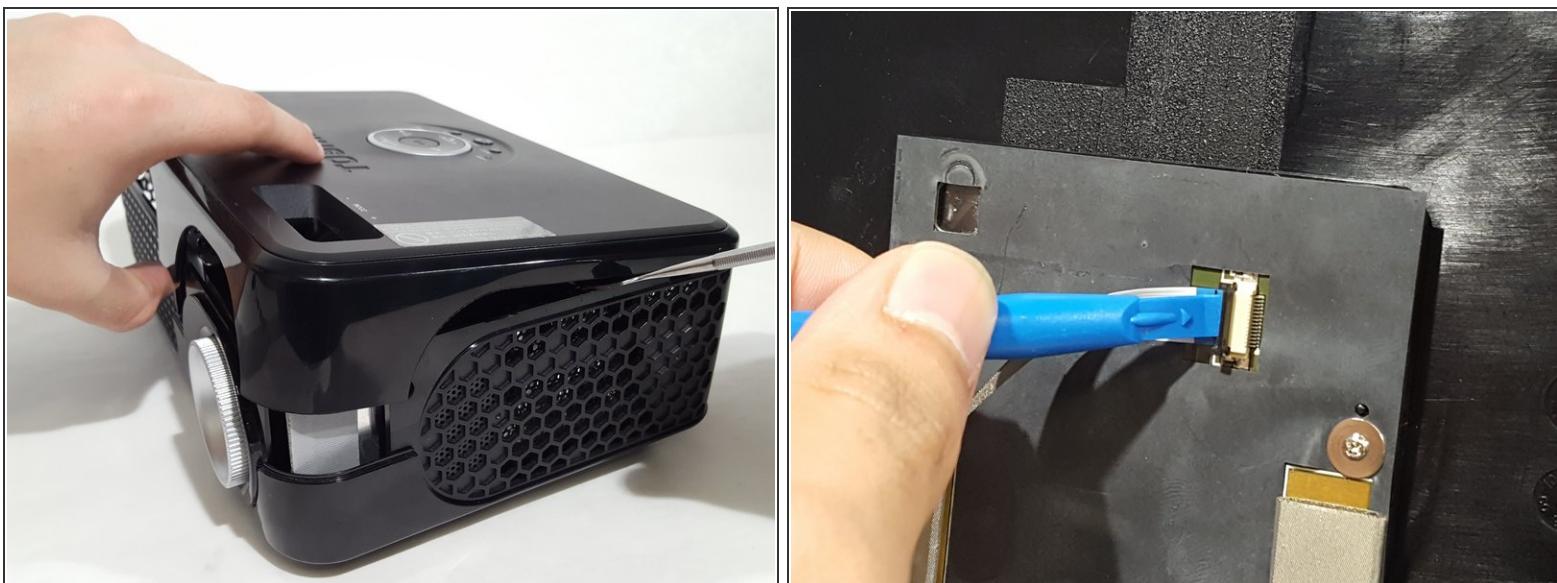
Step 2

- Remove the top plastic cover from the device. The back is snapped on so it would help to have leverage from a prying tool.
- Remove the ribbon cable attached to the plastic piece just removed. Remember its orientation for re-assembling later.

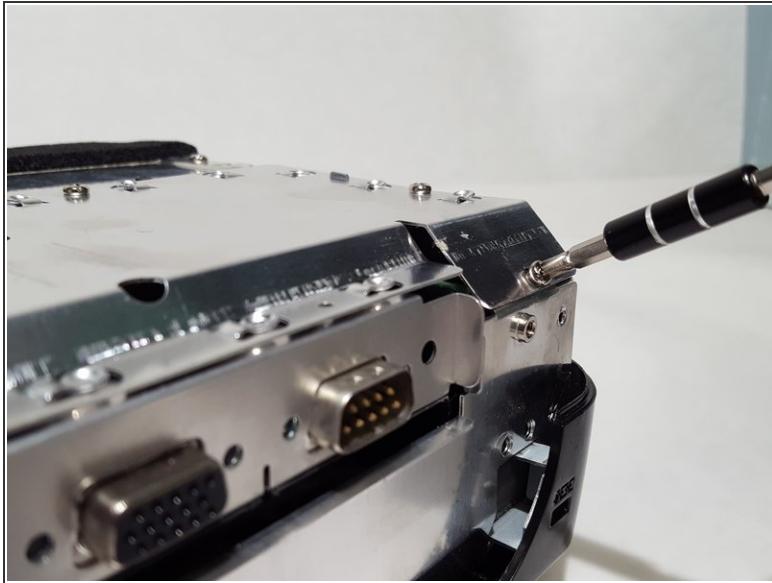
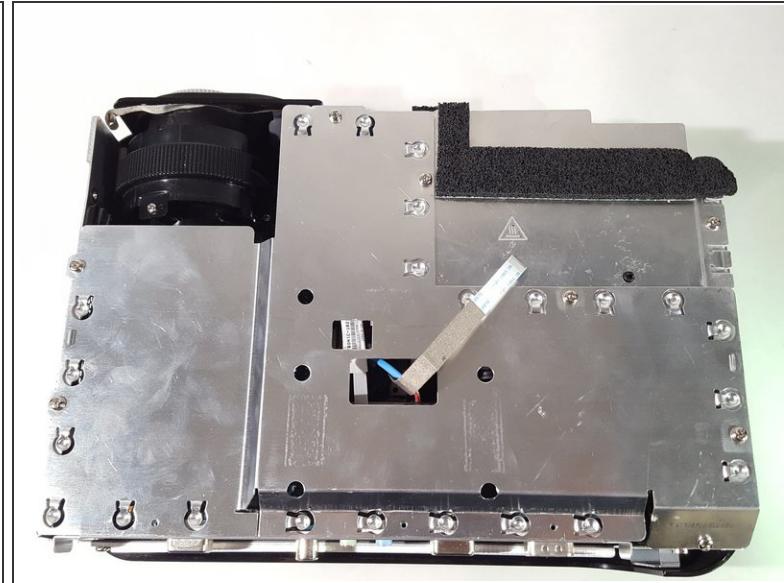
Step 3

- Unscrew the screws from the metal shielding to remove it.

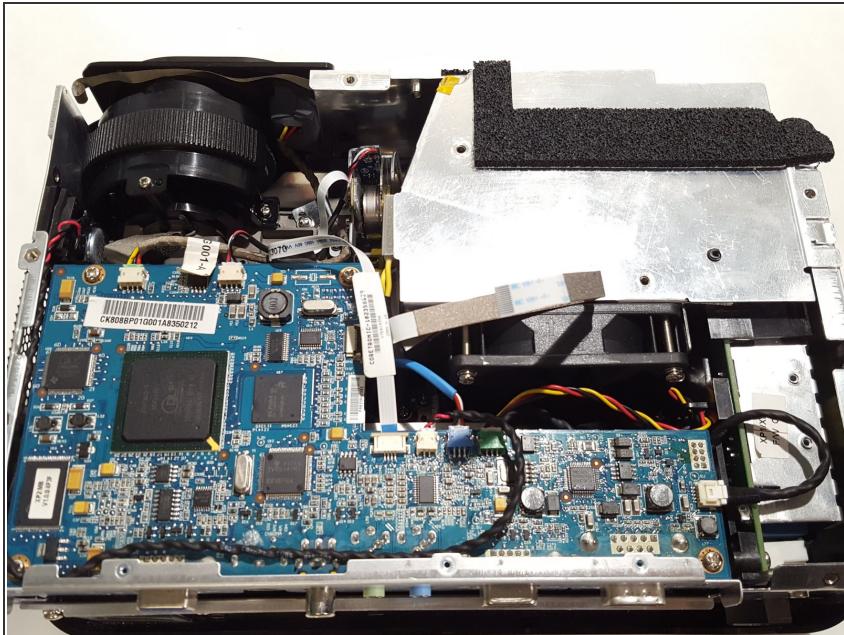
Step 4

Sometimes cables can get in the way of the internal fan and will grind against it creating a moderate clicking sound. This guide will show how to get rid of that noise.

- Move any wires out of the way of the fan so they won't grind up on it during operation.
- If the cables do not stay out of the way, tape them down away from the fan.
