How to fix a cracked frame Google Pixel 2 and 2 XL

A known issue of the google pixel 2 series is the cracking mid frame and as a result the water resistance is no longer intact.

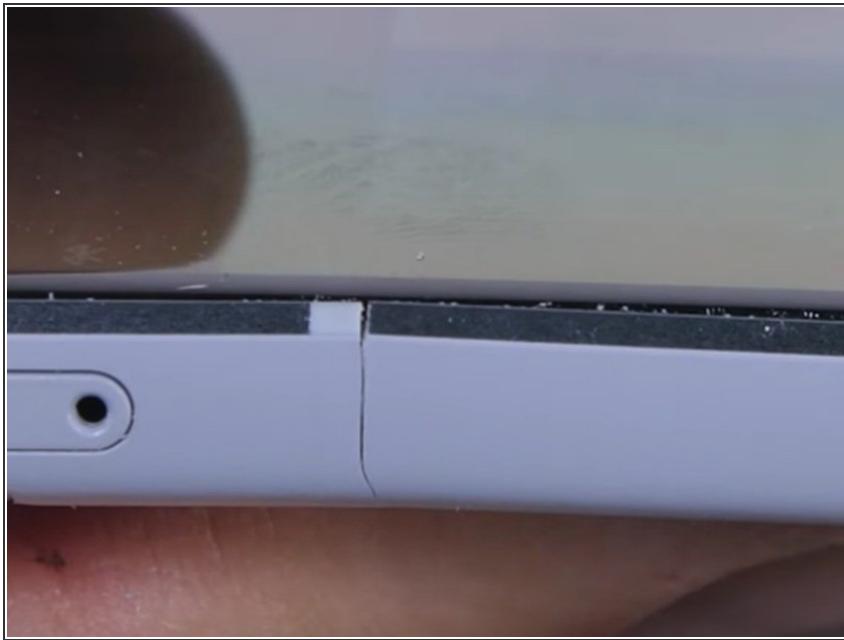
Step 1 — Check the defect

- First you need to inspect the exterior of the device and locate the cracks. Usually the biggest cracks are located near the sim card slot and down the volume buttons.
