# How to fix the display issue on Maschine MKII

Maschine is a great product, but its construction has not been thought through entirely. Here's how to fix a common issue with the Mk2 units.

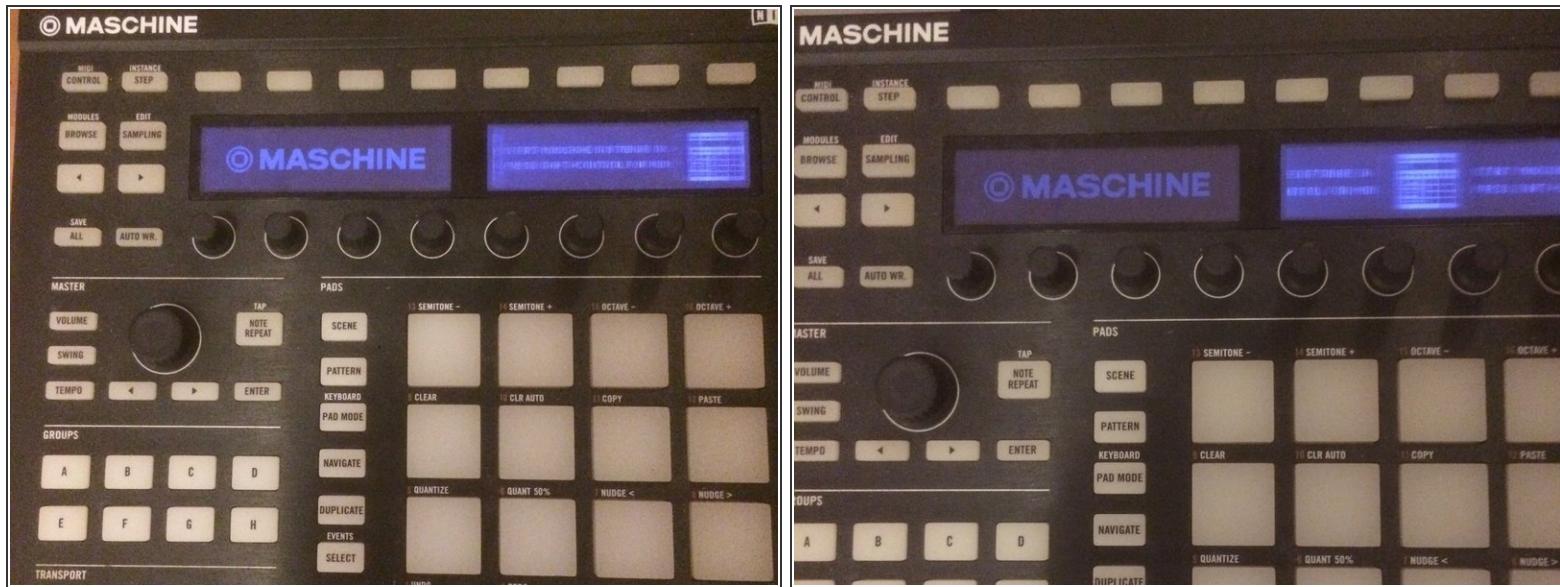
## Step 1 — Diagnose

- As you can see the right display is brighter, and fuzzy.

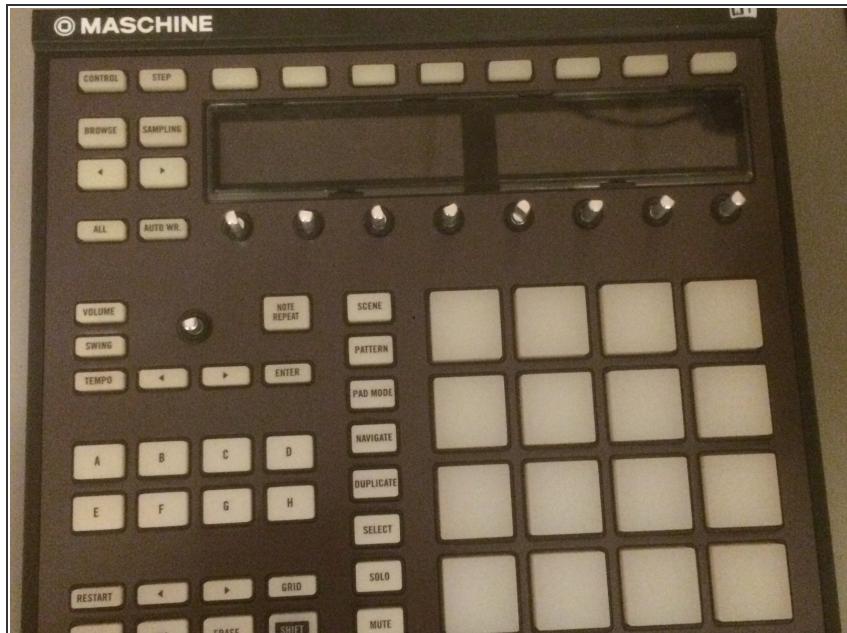
## Step 2 — Remove all knobs

- since we don't know if we're going to remove the PCB, or if it's fixed to the knobs, it's best to remove all plastic caps

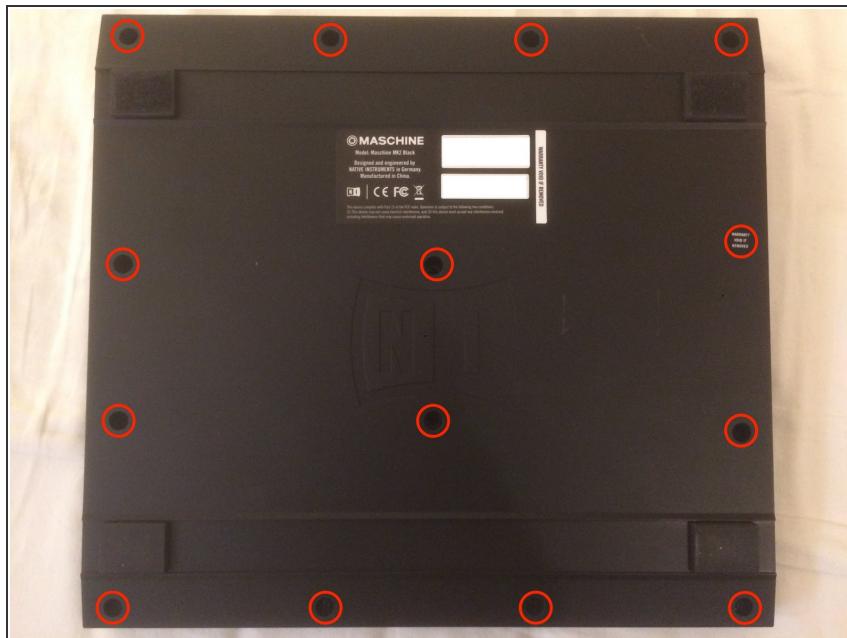
## Step 3

- remove all screws marked in red, make sure you put them in a bag or a box, so you don't lose any.

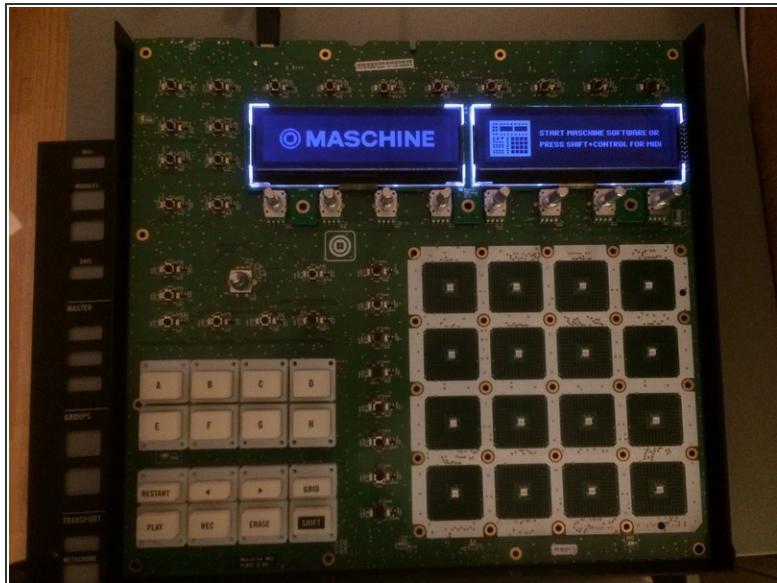
## Step 6

- I put it in the bottom panel, so I could test if the issue persisted on the PCB. I also inspected the PCB for oxidation to make sure it wasn't water damage, since I got it second hand.
- After plugging in the device, and fiddling with the display connection to the right it turned out to be functioning properly, but looked broken due to a design flaw.
