Hytera TC-580 Microphone Replacement

Replace the microphone on the Hytera TC-580 with some soldering.

Remove and replace the microphone built into the TC-580 circuit board. This will require soldering that could permanently damage the circuit board of your radio so please consider other options for repair. This repair is for users that can't have other parties hear them on the radio.

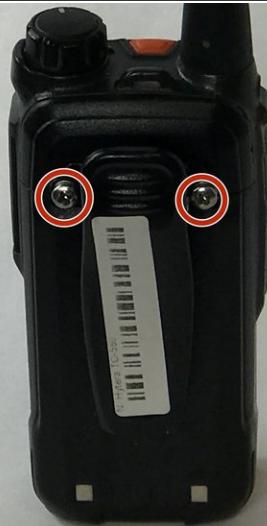
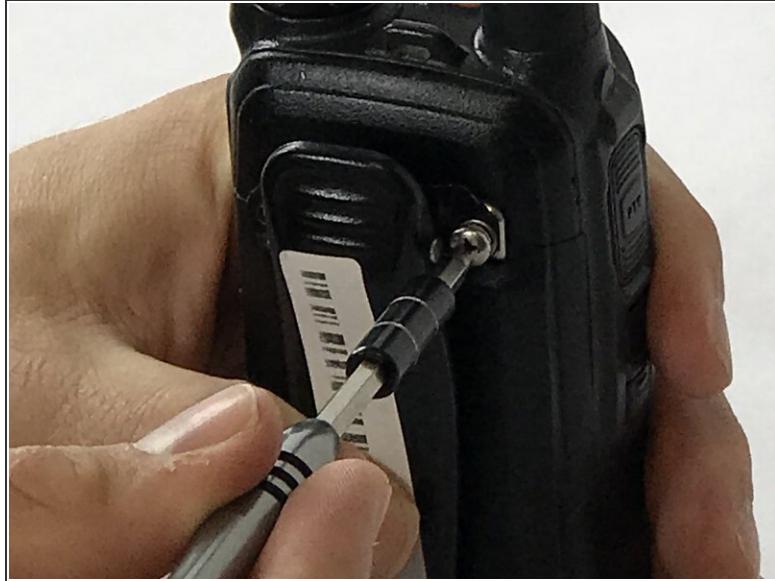
Step 1 — Battery

- Remove the two 10mm Phillips #0 from the belt clip.

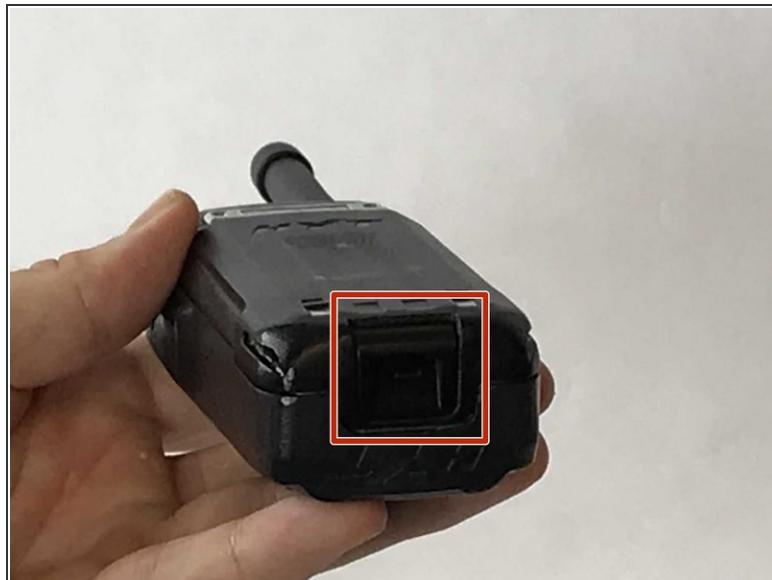
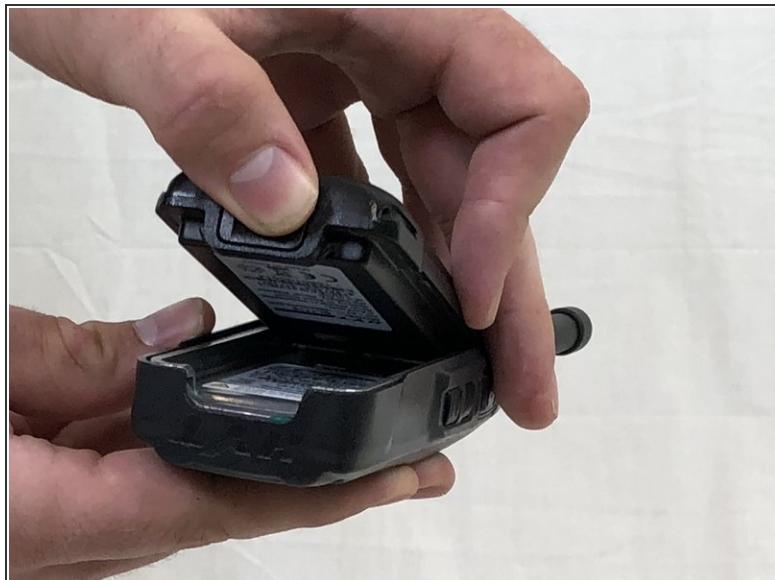
Step 2

- Push in the release button and pull up on the battery to remove.

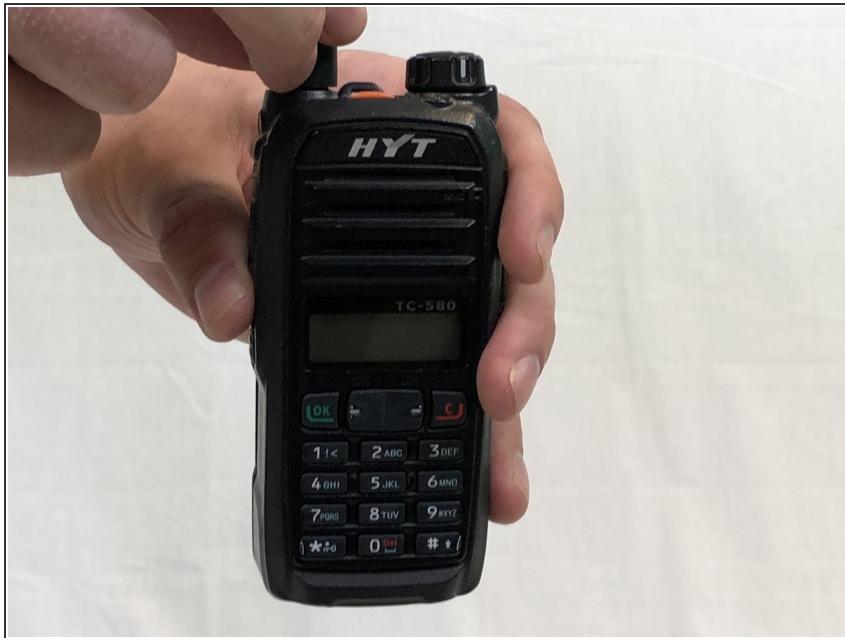
Step 3 — Antenna

- Twist antenna counter-clockwise and set damaged antenna aside.

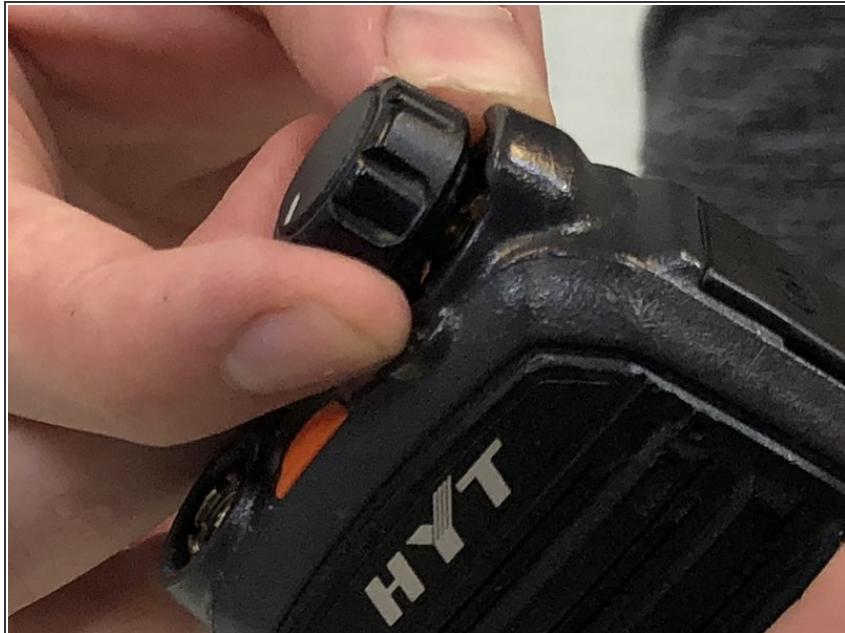
Step 4 — Keypad

- Remove the volume knob by firmly lifting up on both sides of it.

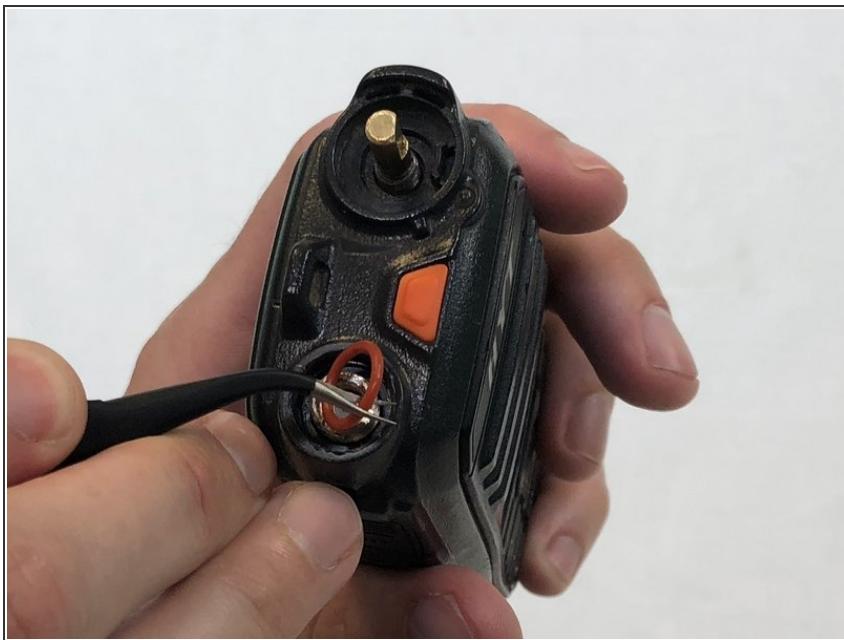
Step 5

- Remove the orange o-ring around volume knob using tweezers.

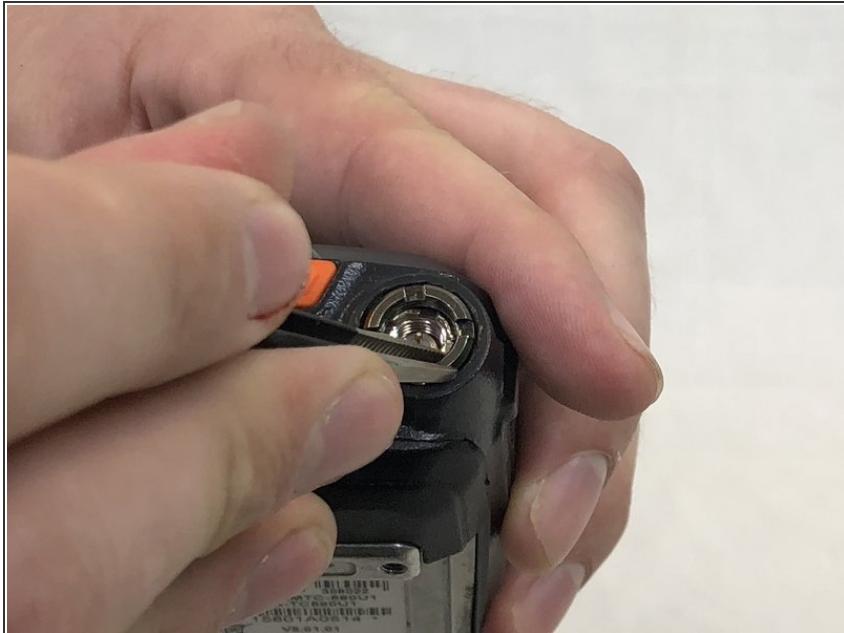
Step 6

- Remove grey nut from base of volume knob by turning it counterclockwise with a set of tweezers.

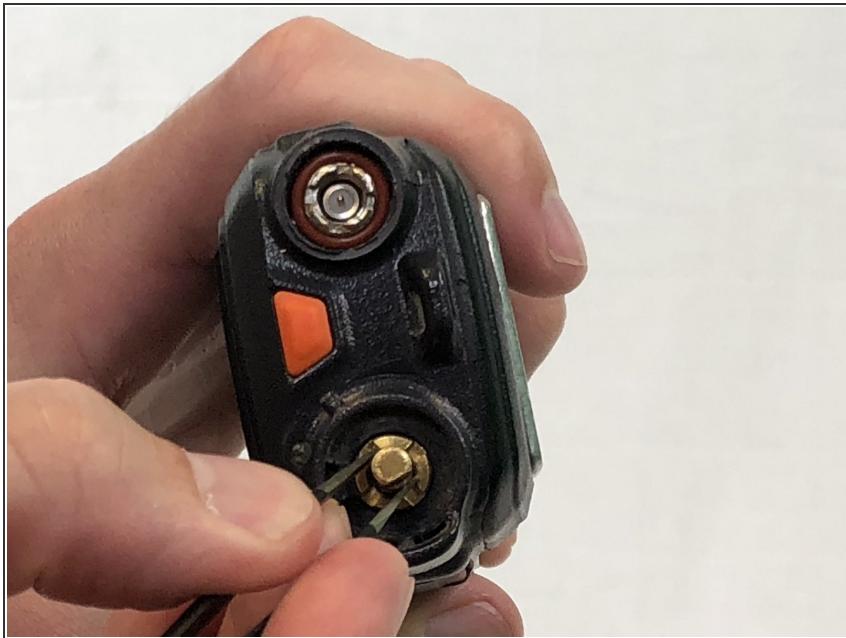
Step 7

- Remove the brass washer from the base of the antenna slot by turning it counterclockwise with a set of tweezers.

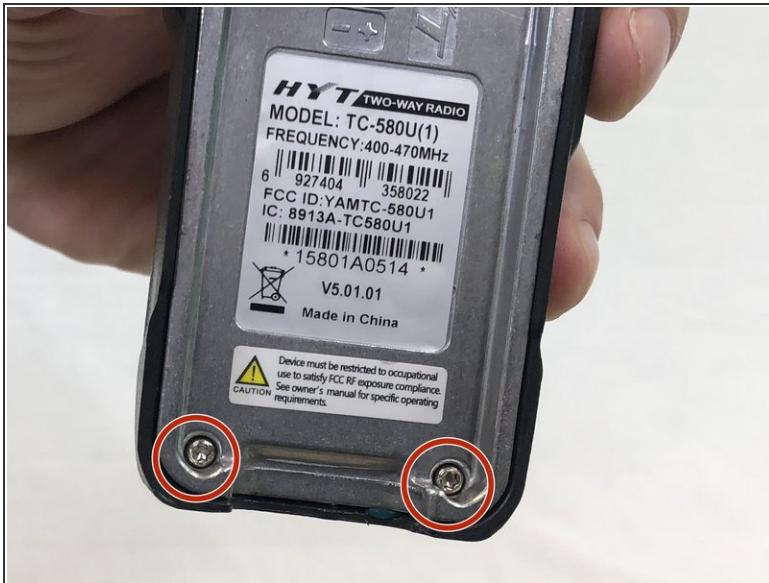
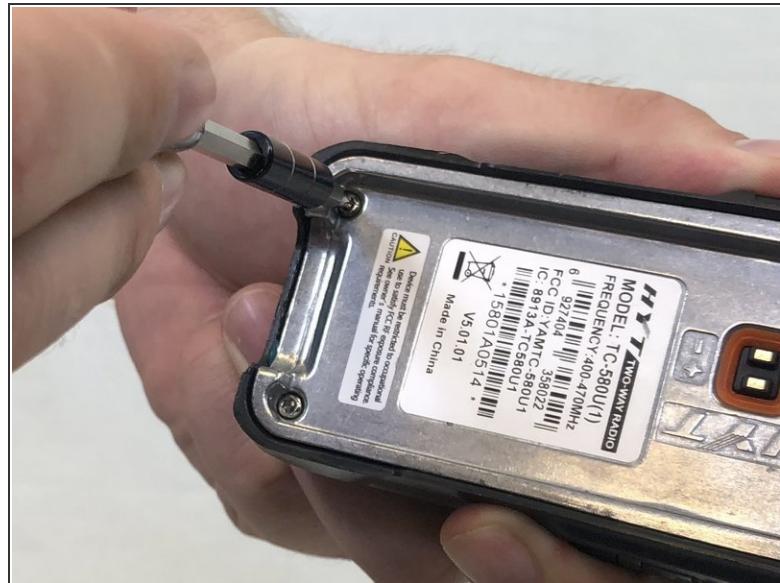
Step 8

- Remove the two 15mm T8 Torx screws from the base of the battery cavity.

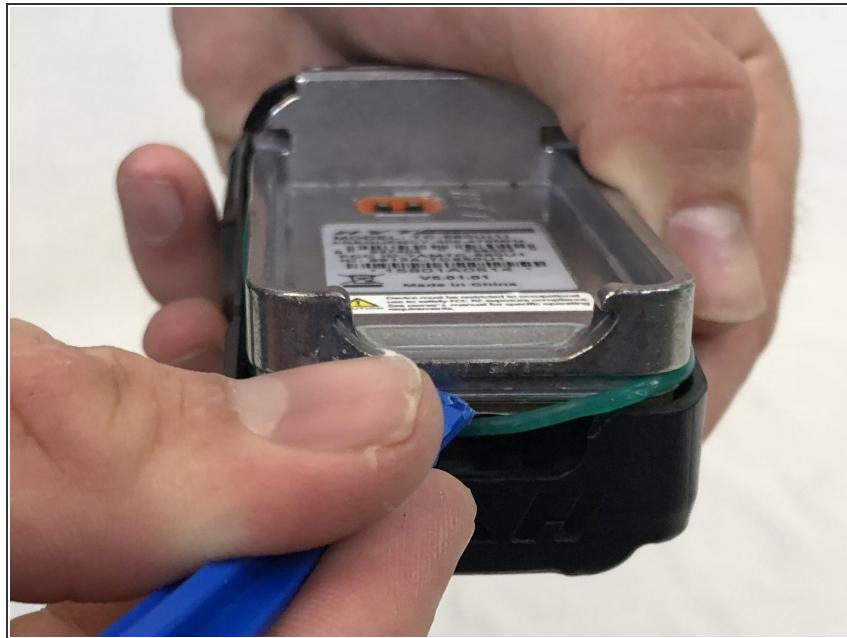
Step 9

- Using a plastic opening tool, pry in between the plastic case and metal circuit board to remove the board.

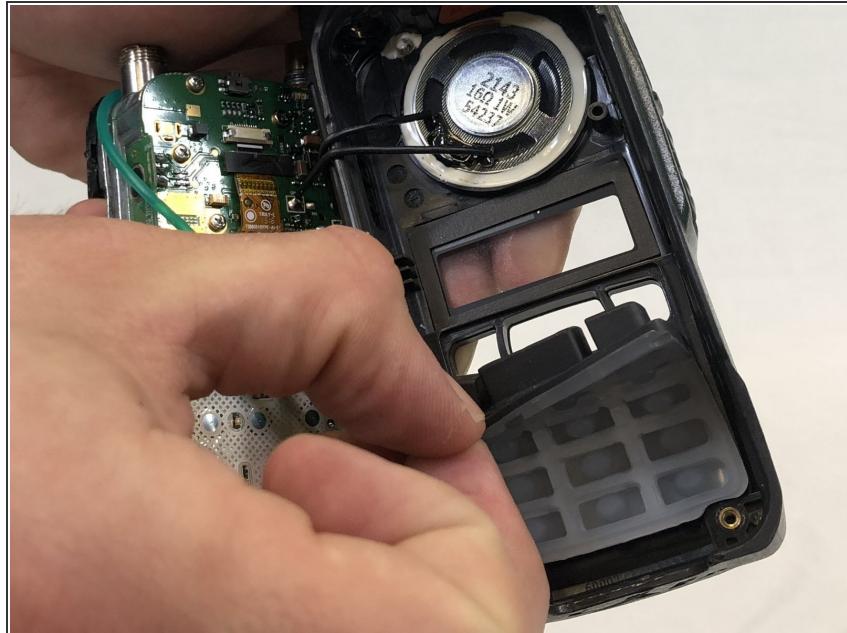
Step 10

- Peel off the keypad by hand.

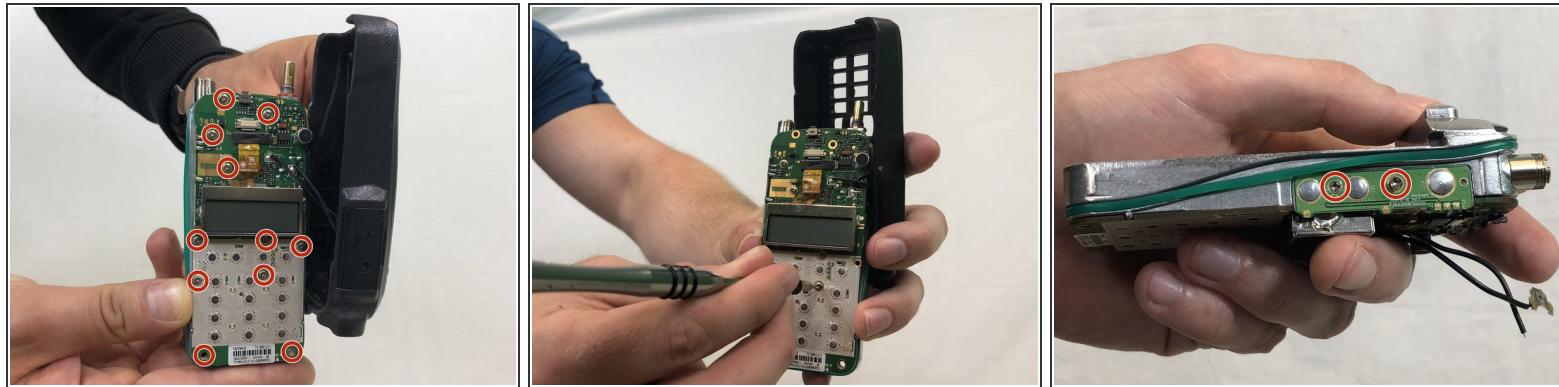
Step 11 — Speaker

- Remove eleven 4mm Phillips #00 screws.

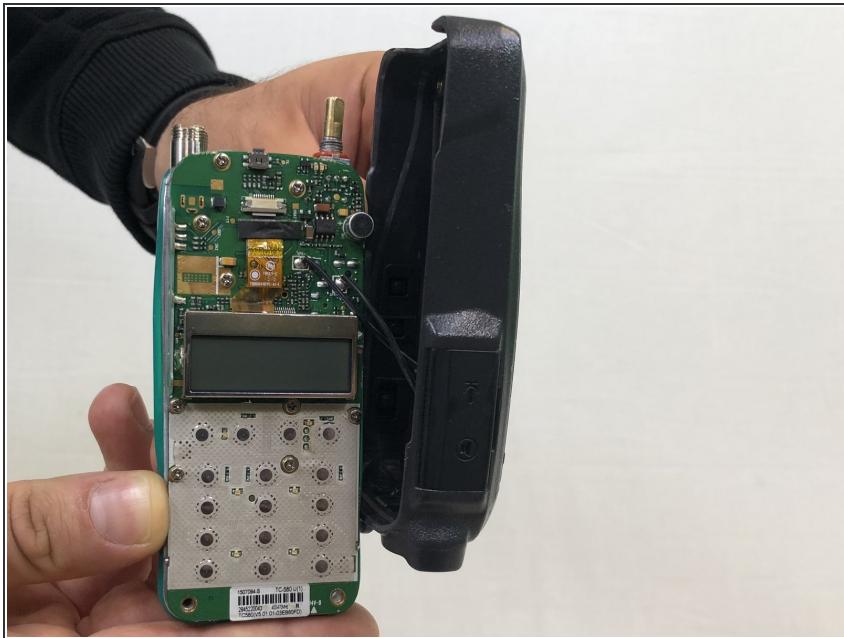
Step 13 — Microphone

- If not already done, remove the circuit board completely from the case.
