IKEA KOPPLA Connector (fix)

Correct issue with intermittent USB charge functionality

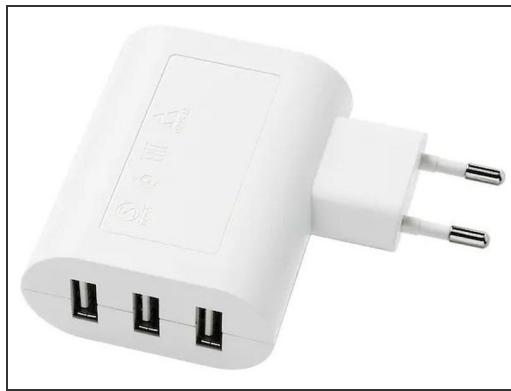
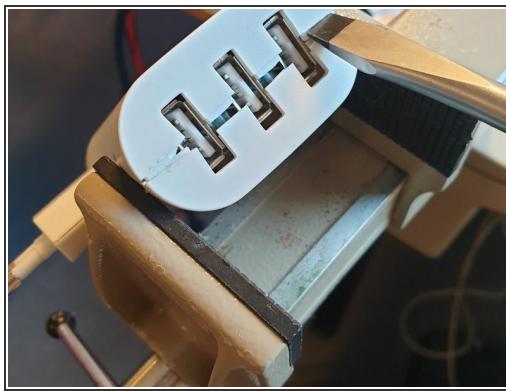
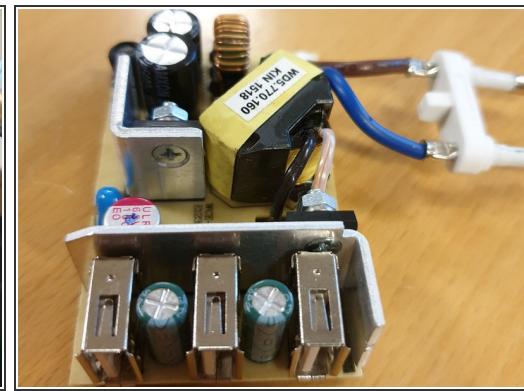
Step 1 — break open the adapter

- open device , using brute force is the only option because it's ultrasonic welded together.
- use screw driver or squeeze in a vice to crack it open."

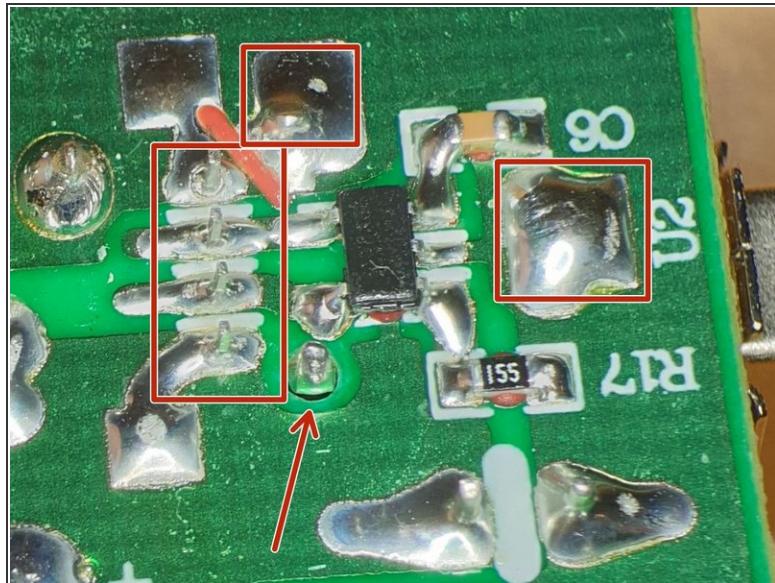
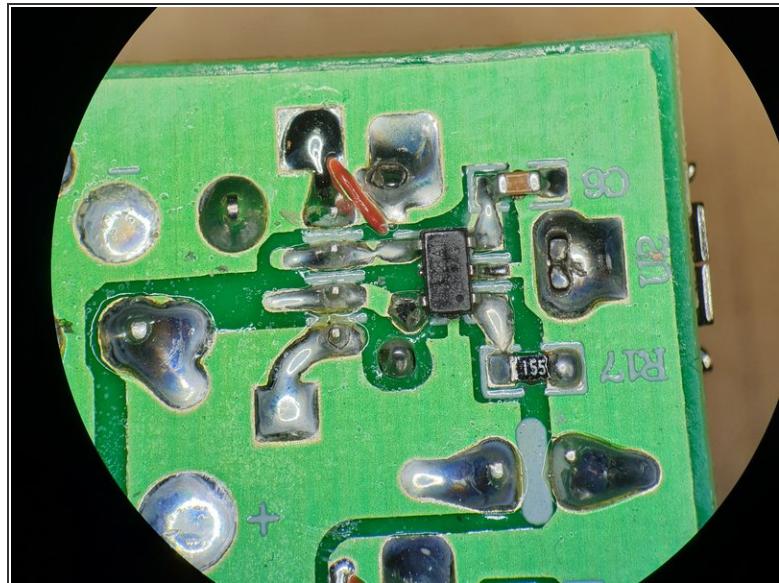
Step 2 — Fixing the issue (broken solderpoints)

- Resolder all the USB connector pins (red box'es), on all 3 USB connectors to be sure they are functional. (on this image the top one is defective)
- The reason solder points break is the connector support is soldered onto the board on one side only. Not by the arrow. Thereby adding stress directly to the soldered pins.
- In addition the connector pin (square) near the U2 marking is too short and therefore may not be soldered properly.
- see 2nd image for example of front support pin is pulled out of solder area.

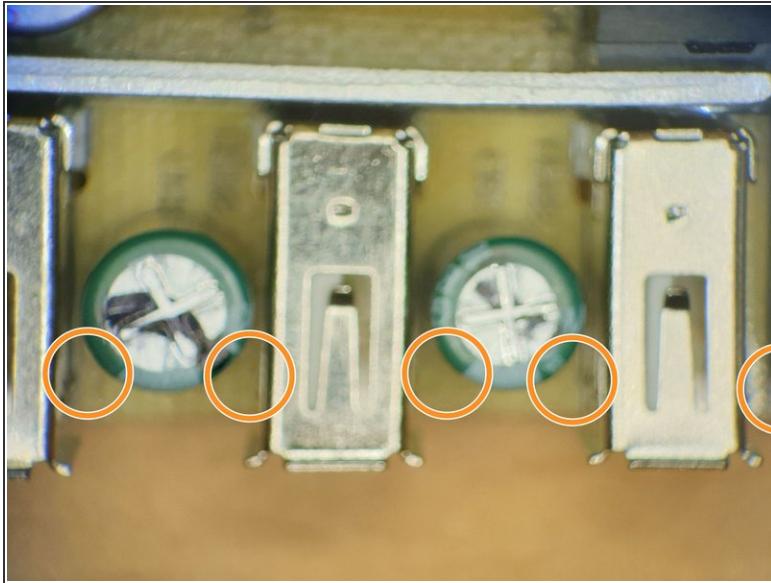
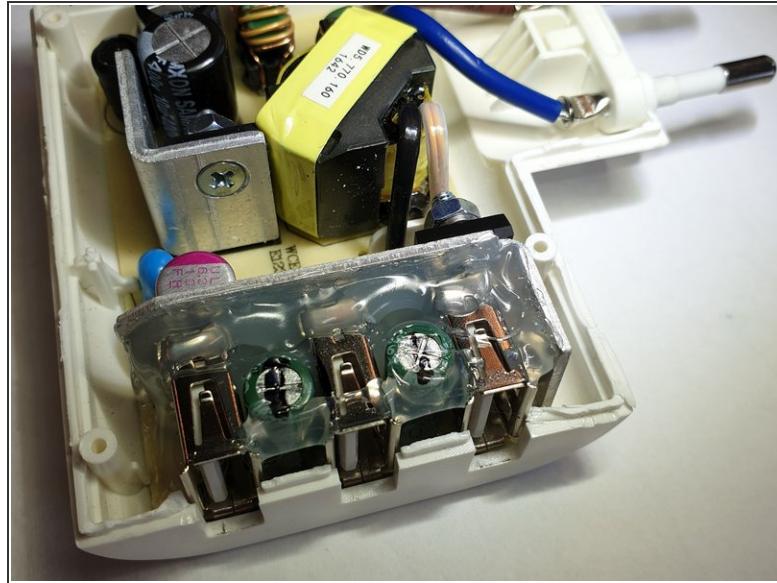
Step 3 — add glue to connectors

- add hot melt glue in these areas on the board and on the side of the connector.
- Add the cover first to understand where there is room for it in the cover.
- If connector is not glued, it is likely the charger will stop working again in the near future.
- Ikea have been notified of this issue.
