Insignia Flex 10.1 NS-P10W8100 Camera Replacement

How to replace an Insignia Flex 10.1 NS-P10W8100 camera.

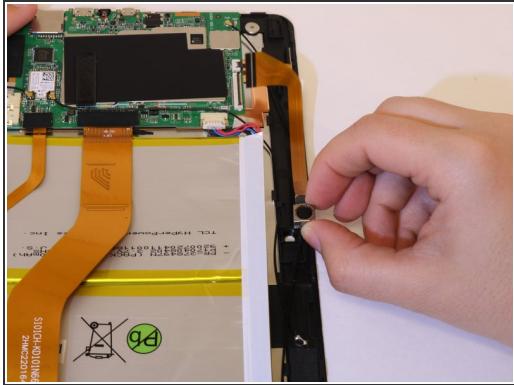
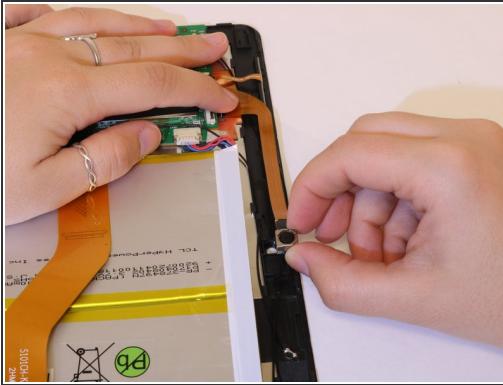
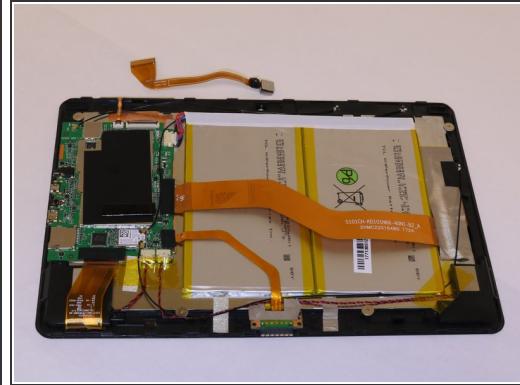
Step 6

- Remove the camera by pulling it upward.
