# Insignia NS-CLIP02 Power Auxiliary Port Replacement Replacement

Written By: Erik

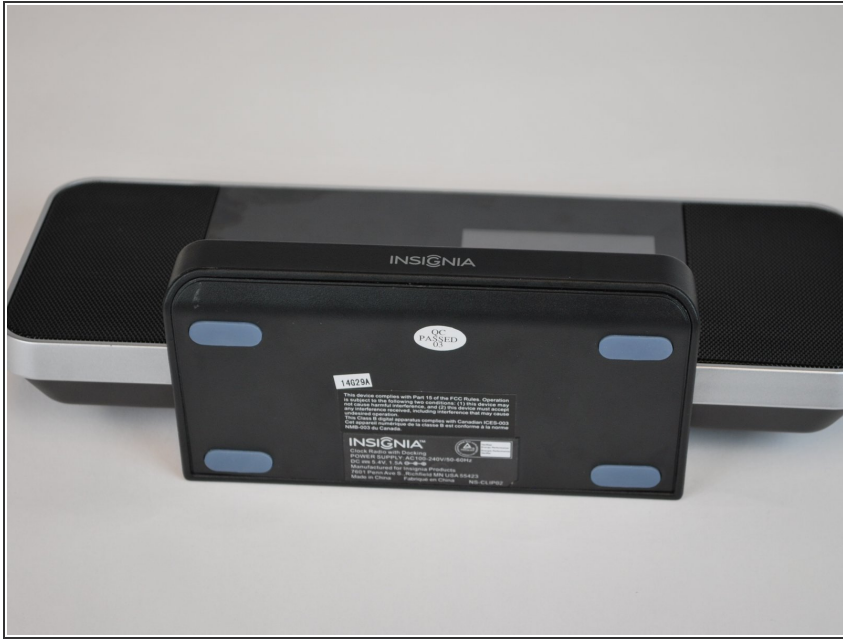
## Step 1 — Power Auxiliary Port Replacement

- Locate the bottom of the device.

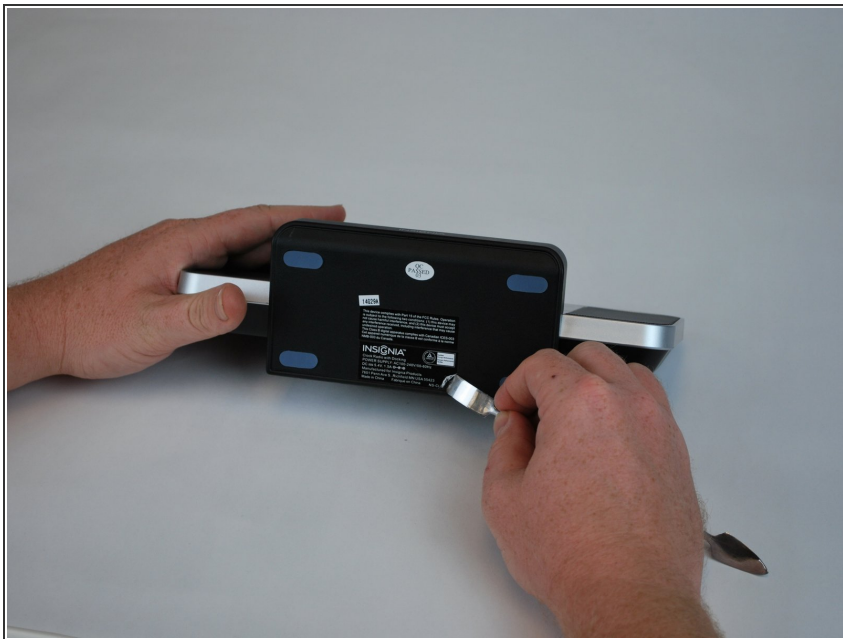
## Step 2

- Begin by using a metal spudger to peel back the adhesive sticker and locate the 11mm screw beneath the sticker.

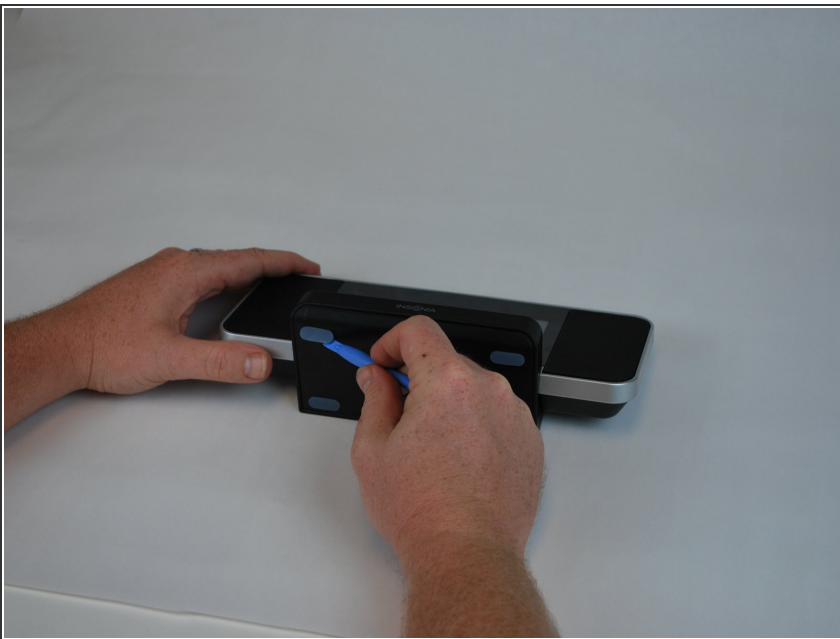
### Step 4

- Using a plastic spudger, peel off the adhesive gel stoppers.

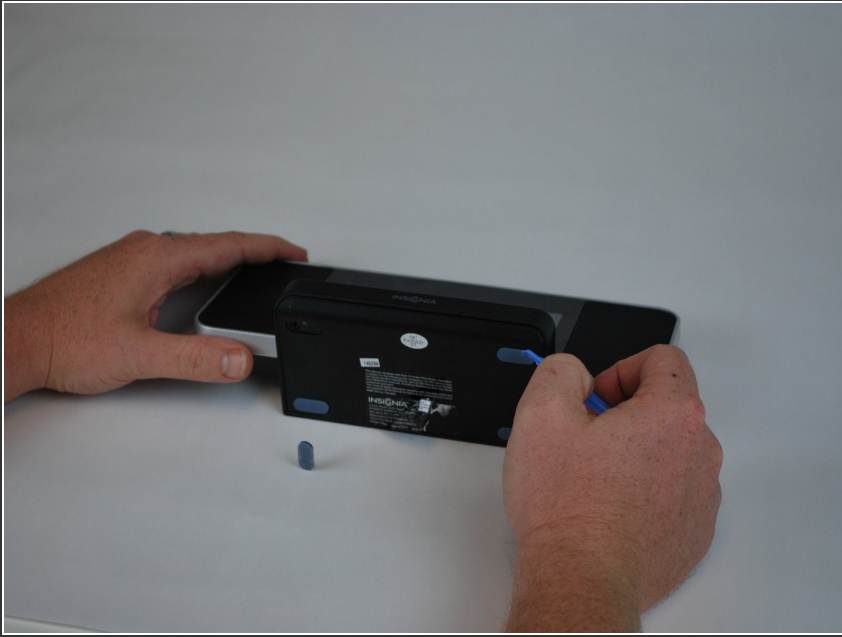
## Step 5

- Continue peeling the rest of the gel stoppers from the bottom of the device.

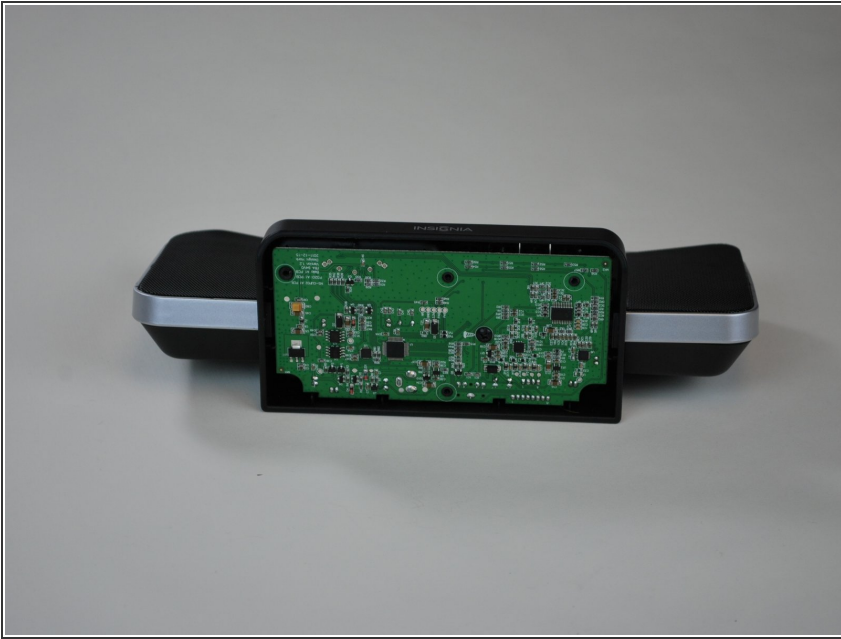
## Step 7

- Once you peel off the bottom from the device, you will see the motherboard.

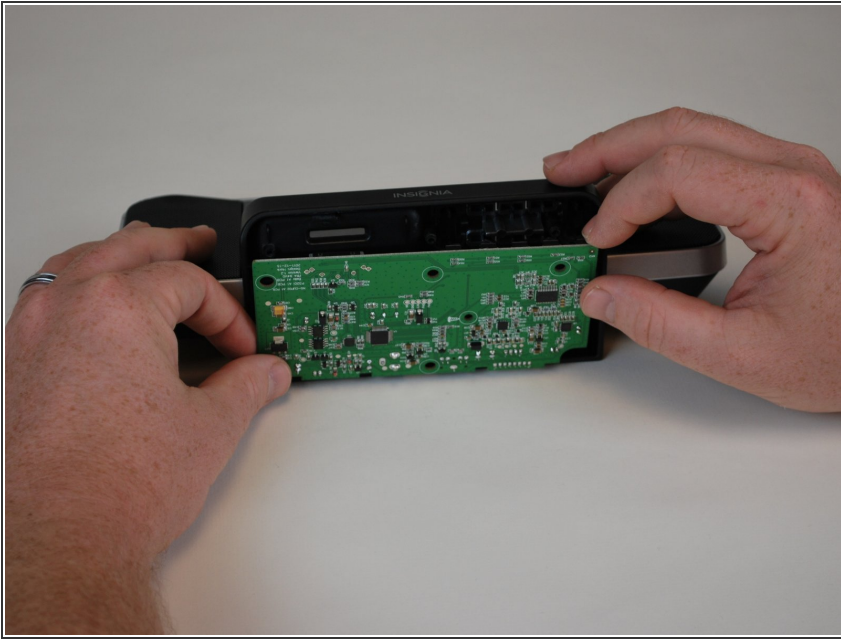
## Step 9

- Lift the motherboard from the device.

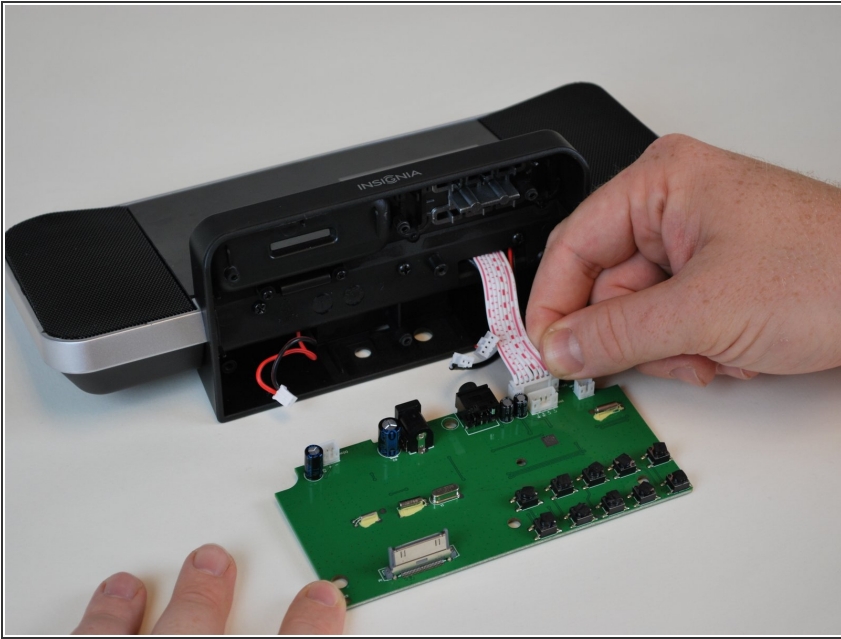
## Step 14

- Remove the LCD screen plug last. Then, follow the following instructions in reverse, replacing the old motherboard with the new one to fix the power auxiliary port.

To reassemble your device, follow these instructions in reverse order.
