Kenwood KDC-BT565U CD Drive Replacement

This guide shows you how to replace the internal CD drive found in the Kenwood KDC-BT565U.

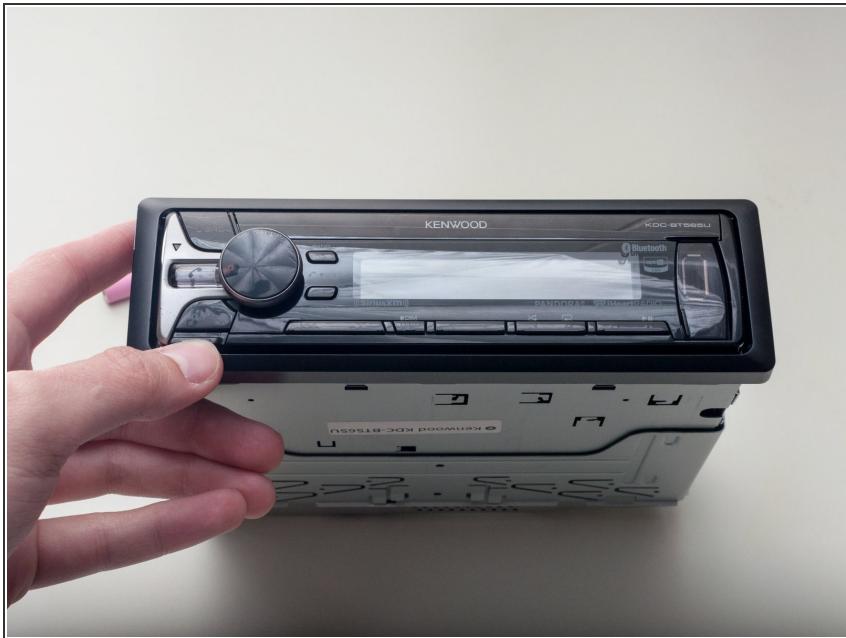
Step 1 — Face Plate

- Press the eject button on the bottom left corner of the face plate.

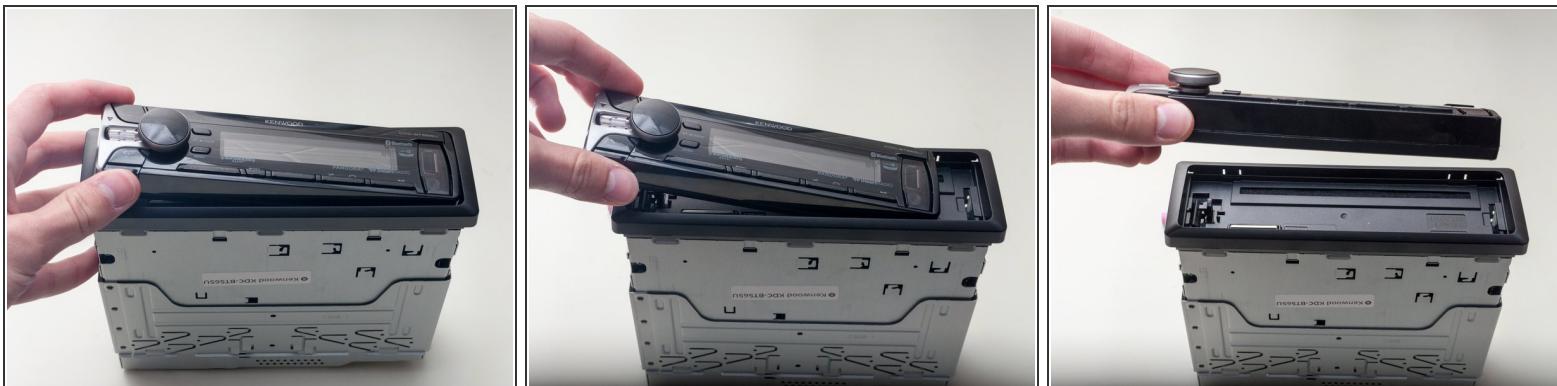
Step 2

- Begin by slightly lifting the face plate out from the side located by the release button.
- Slide towards the side of the eject button, *then* completely lift out.

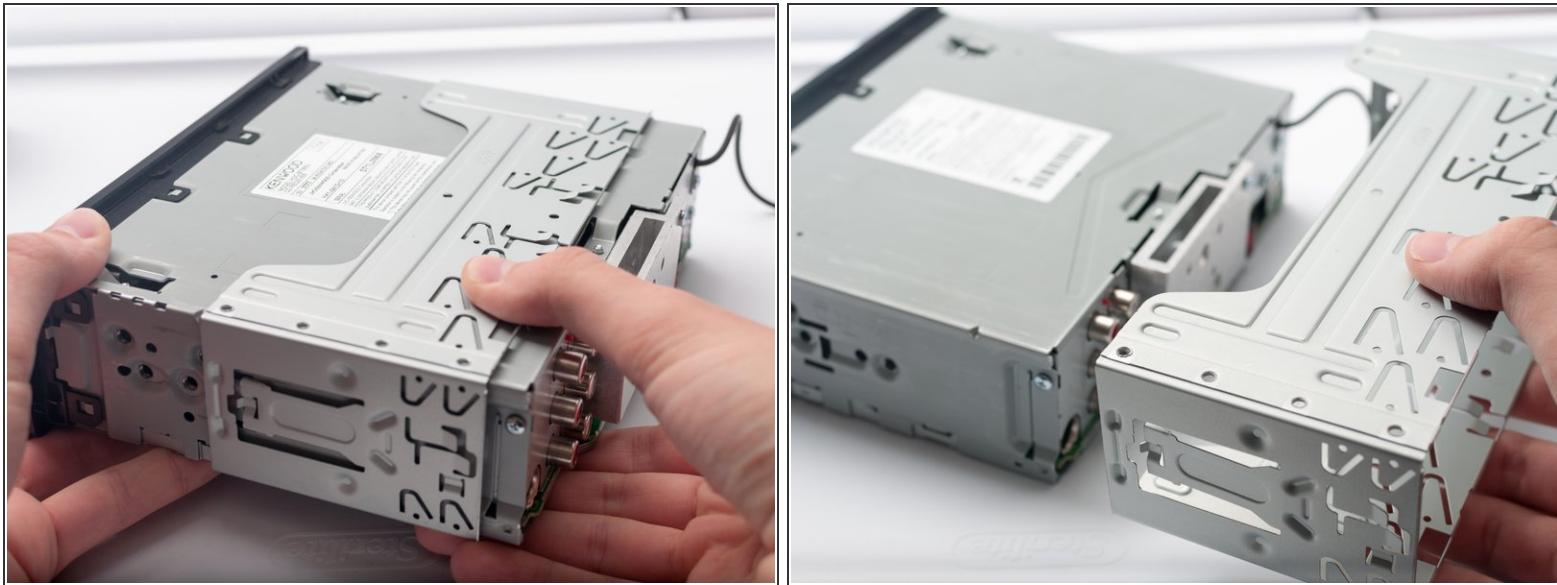
Step 3 — Metal Sleeve

- Grasp the outer metal sleeve with one hand and the front of the unit with the other.
- Slide the sleeve back until it comes off the unit.

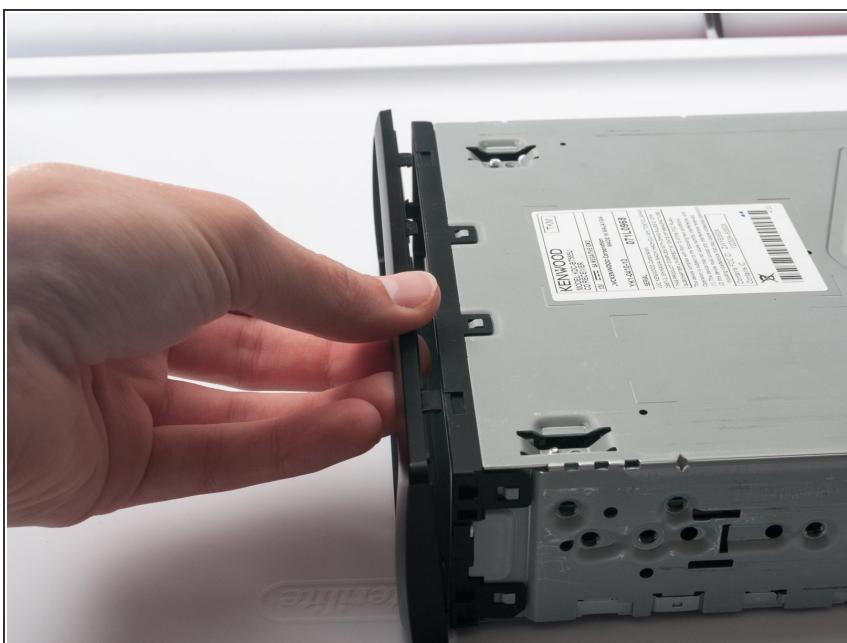
Step 4 — CD Drive

- Remove the thin frame from the front of the device. This can be done by first unsnapping the top pegs and then the bottom ones.

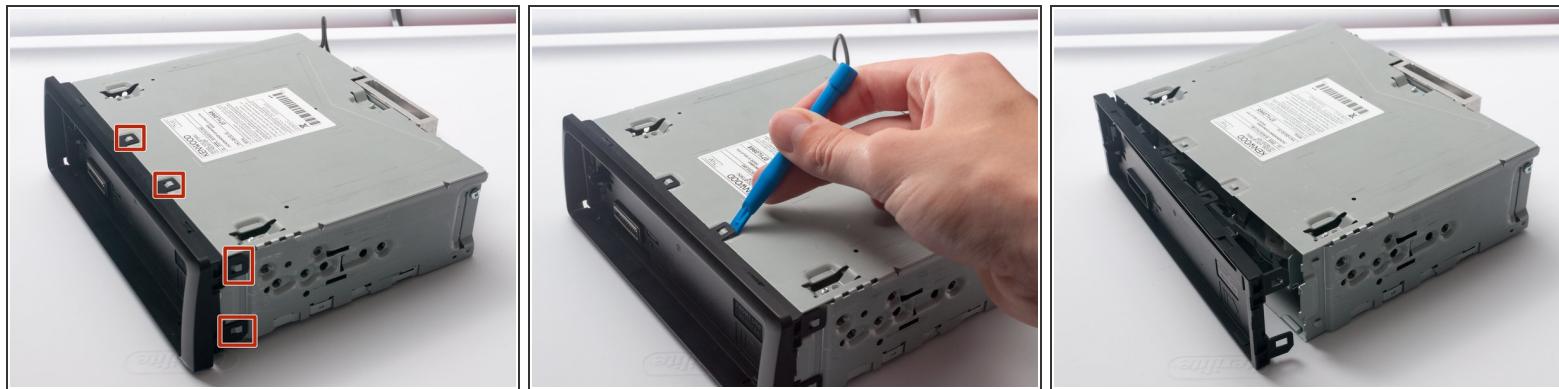
Step 5

- Lift the clasps of the tabs around the edges by using a plastic opening tool or spudger.

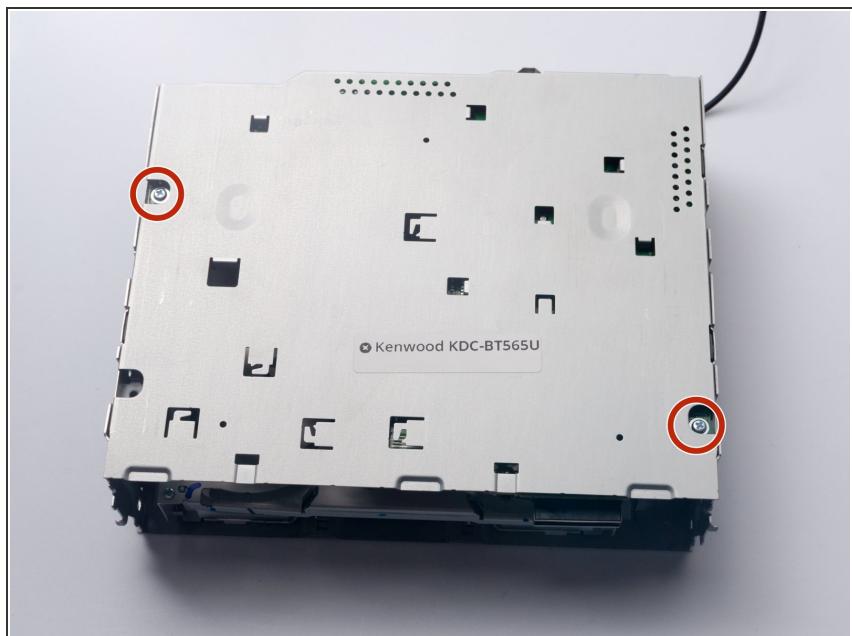
Step 6

- Remove the two 5.5mm Phillips #0 (PH0) screws on the bottom of the unit.

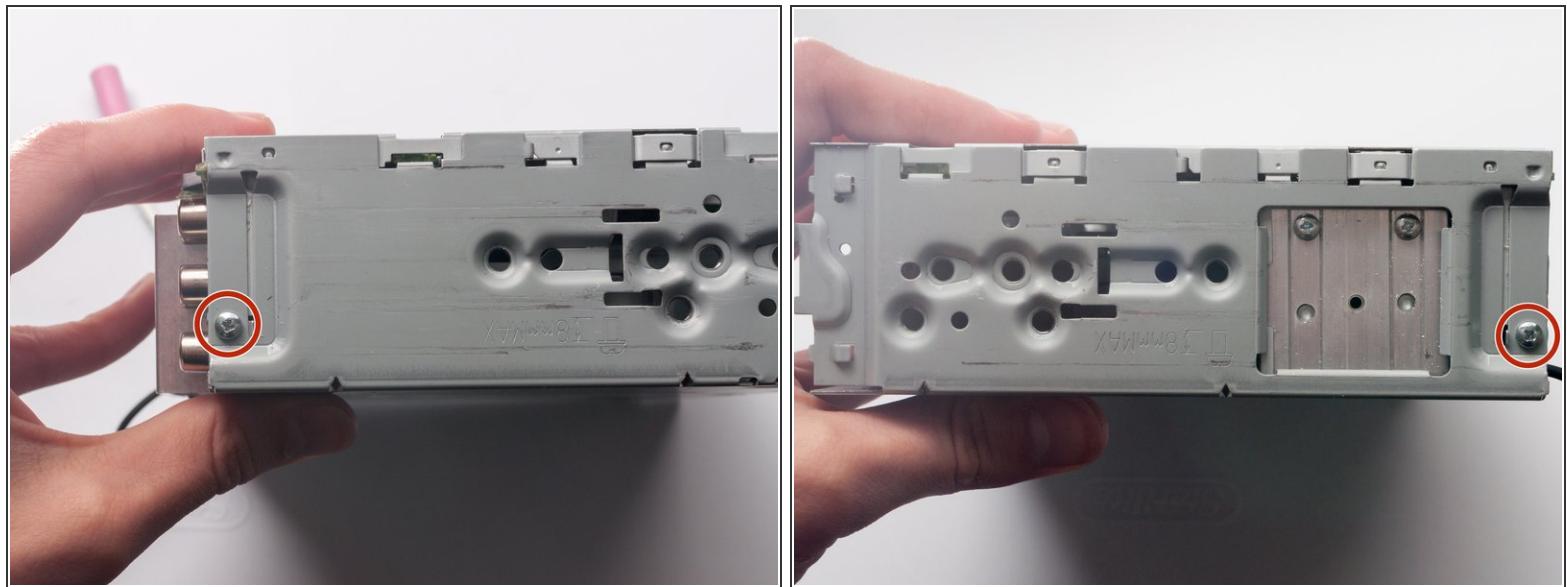
Step 7

- Remove the two 6mm Phillips #0 screws from the side of the unit.

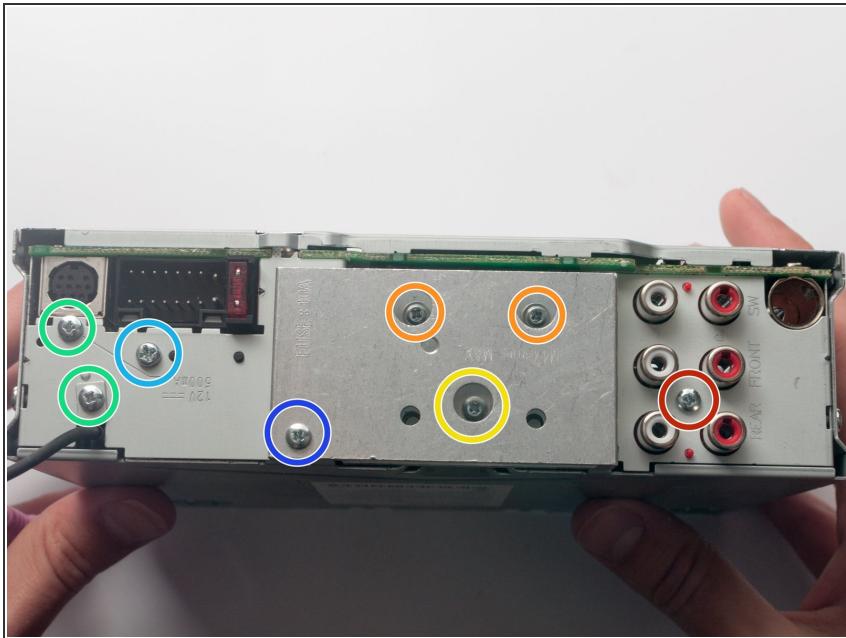
Step 8

- Remove the 7.5mm Phillips #0 screw in between the red and white RCA inputs.
- Remove the two 13.5mm Phillips #0 screws towards the top of the aluminum block.
- Remove the 10mm Phillips #0 screw towards the bottom of the aluminum block.
- Remove the two 6mm Phillips #0 screws found above the microphone mount and below the circular port.
- Remove the 7.5mm Phillips #0 screw next to the large rectangular power connector.
- Remove the 10mm Phillips #0 screw that resides above the aluminum block.

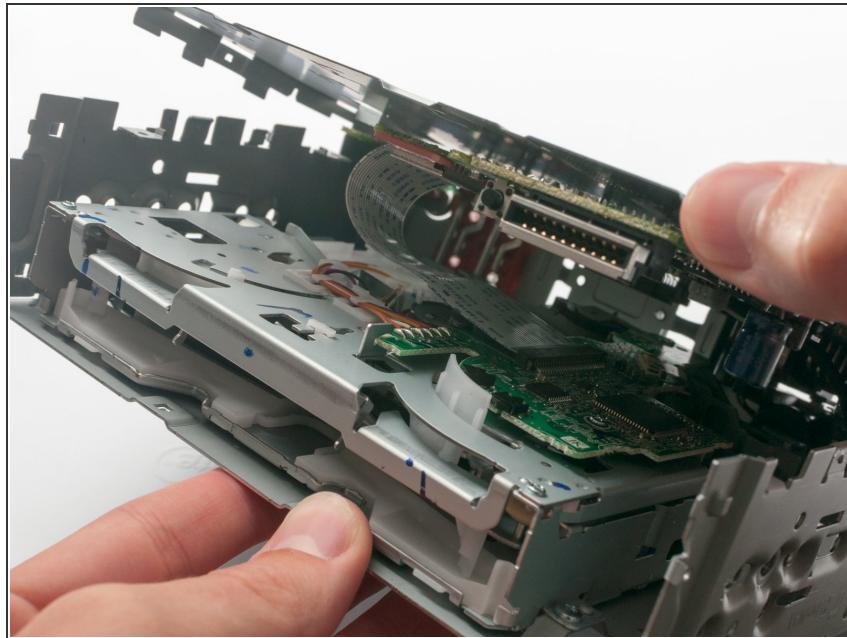
Step 9

- Separate the top and bottom metal housings of the unit carefully.

⚠ There is a connecting ribbon that links the two halves. Too much force could rip and irreversibly damage the ribbon.

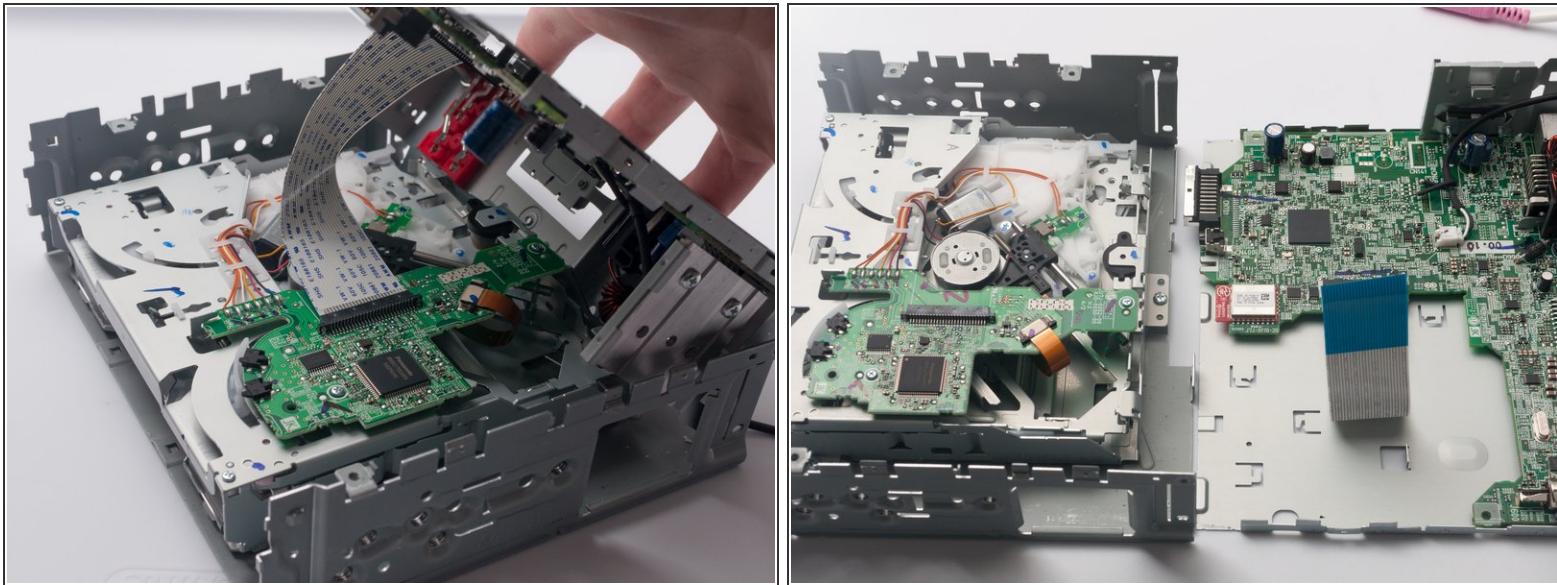
Step 10

- Carefully pull the ribbon out of the connector found on the bottom half of the unit (the bottom half has the CD drive).
- To remove the ribbon, grip the black base connector with one hand and the base of the ribbon with the other. The ribbon will have a blue, reinforced section close to the base (seen in second picture) which makes it easier to pull.

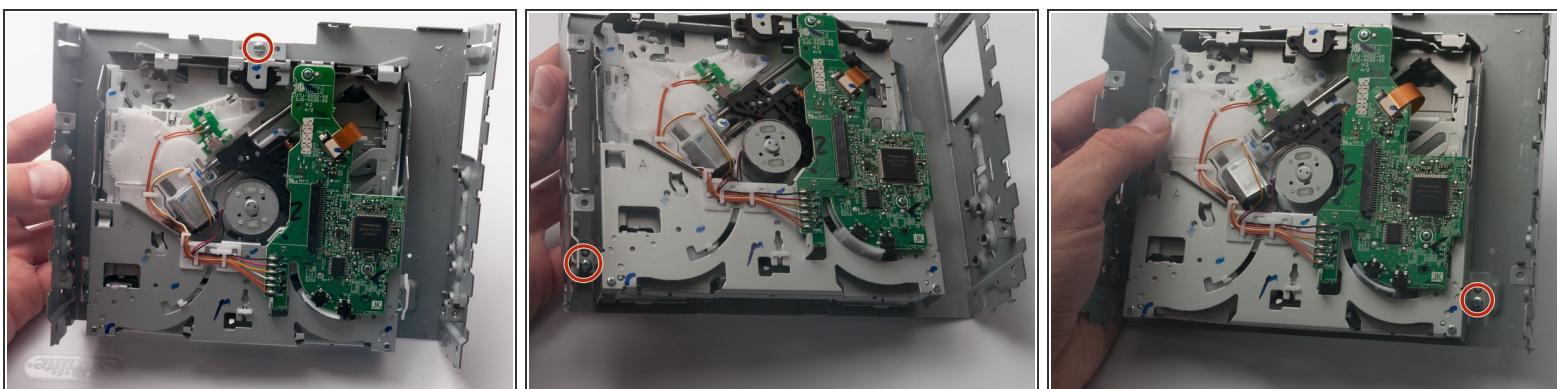
Step 11

- To fully unmount and replace the CD drive, remove the three 6mm Phillips #0 screws that hold the drive to the housing.

To reassemble your device, follow these instructions in reverse order. Be careful when reattaching the new CD drive's ribbon to the motherboard. The ribbon can be bent easily.
