KitchenAid Blender 5KSB52 Ultra Power hard rubber coupling Replacement

Kitchen Aid Hard Rubber Coupling for Mixer 5KSB52 Ultra Power. Replace the overcharged, low-performance coupling.

Written By: Froebel Christian

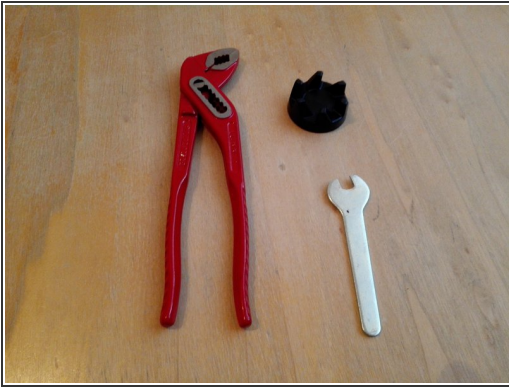
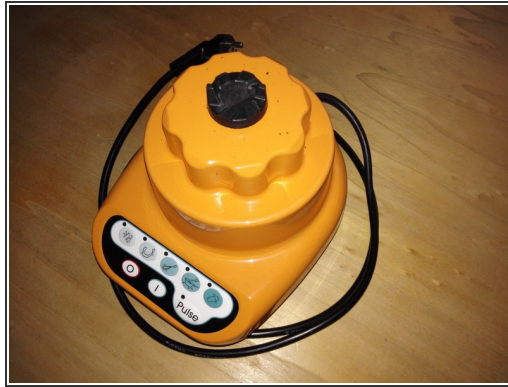
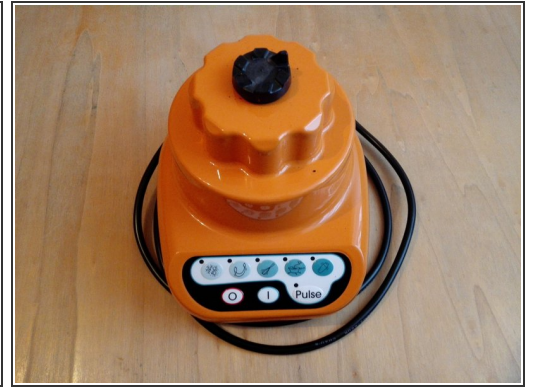
Step 1 — Hard rubber coupling

- Disconnect the blender from the power supply. Prepare tools and spare parts. Tools required: original spanner, small water pump tongs. Spare part: hard rubber coupling

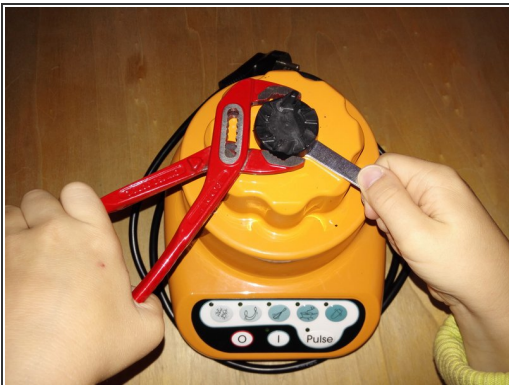
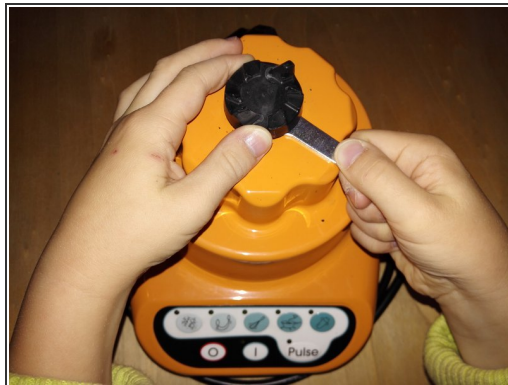
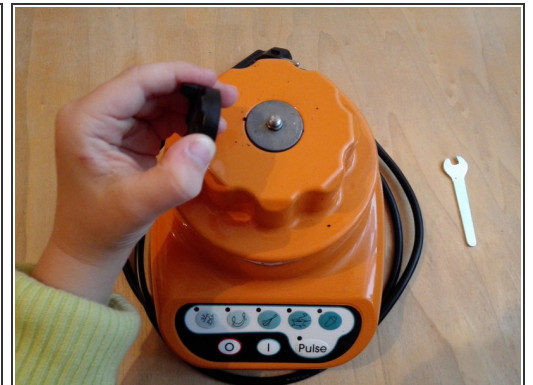
Step 2

- Loosen the defective coupling with water pump tongs and original open-ended spanner. Hold the axis with an open-ended spanner and unscrew the coupling. Remove coupling.

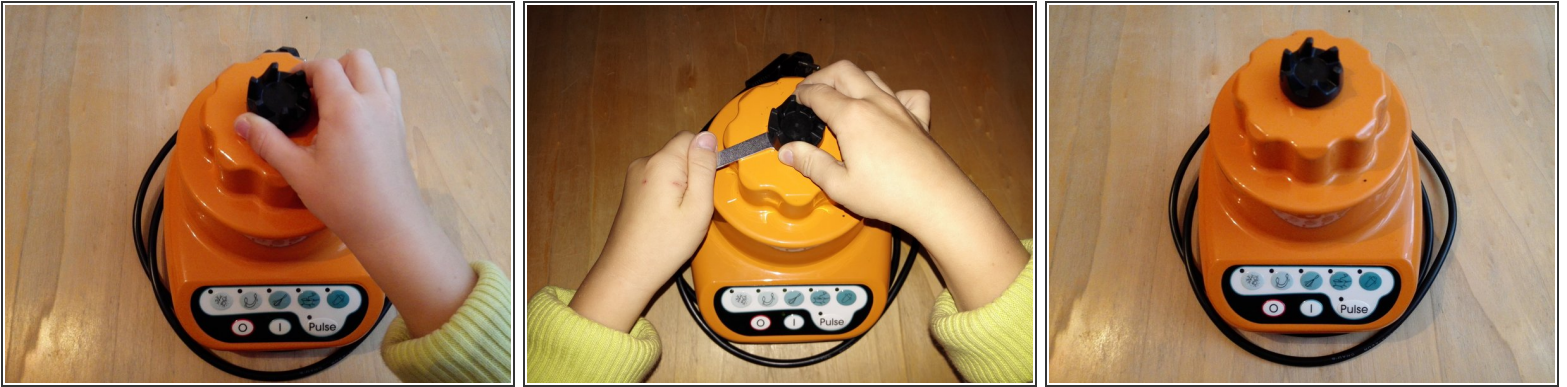
Step 3

- Insert the new coupling and screw it on slightly. Screw the new coupling by hand with a spanner.

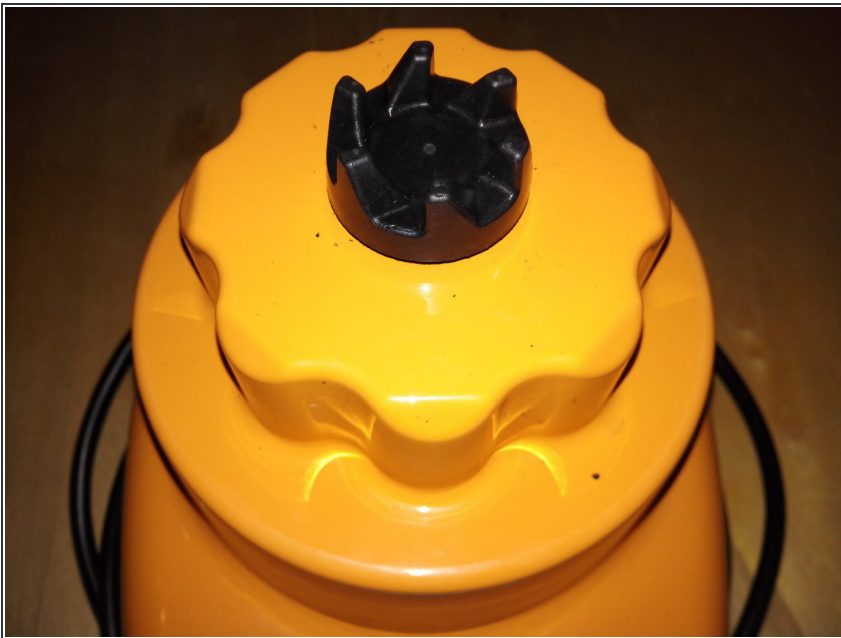
Step 4

- Finished.
