# LG Tribute HD Rear Camera Replacement

A guide for replacing the rear camera of a LG Tribute HD LS676 due to damaged rear camera causing blurry photos, error messages or not able to take photos

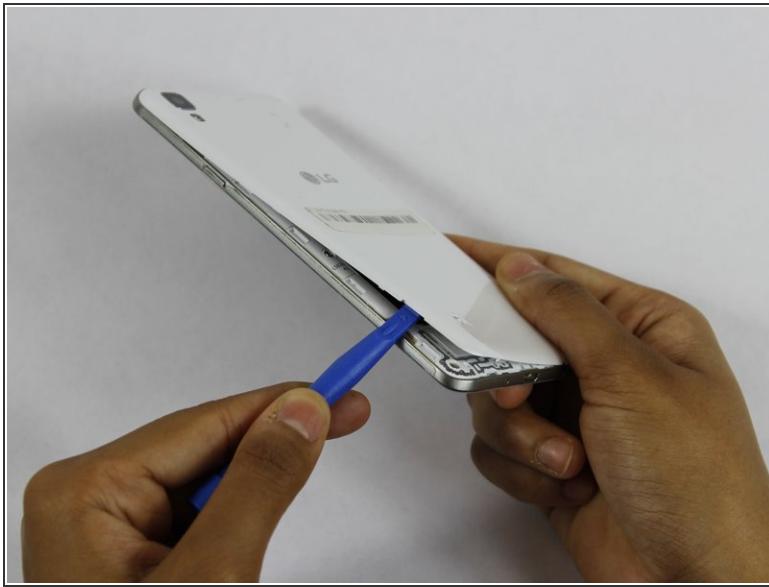
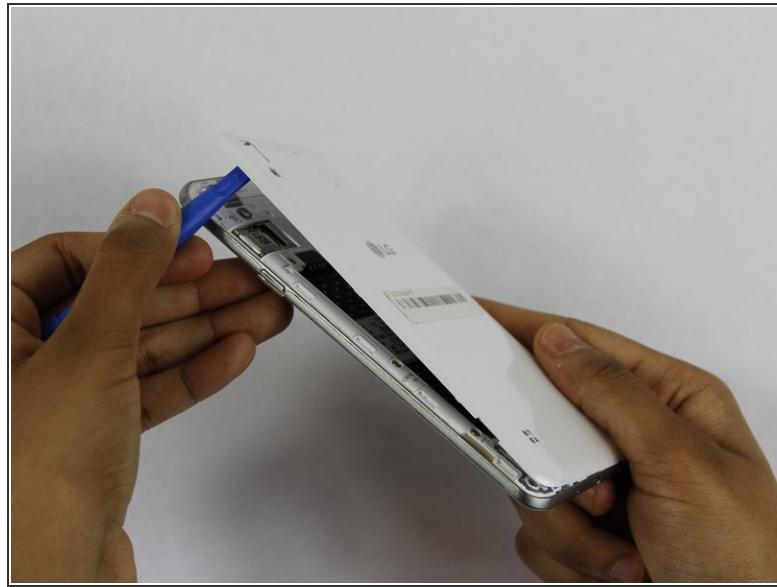
## Step 1 — Battery and SD Card

- Insert a fingernail, or plastic opening tool, into the cutout on the back cover and pry outward to remove.

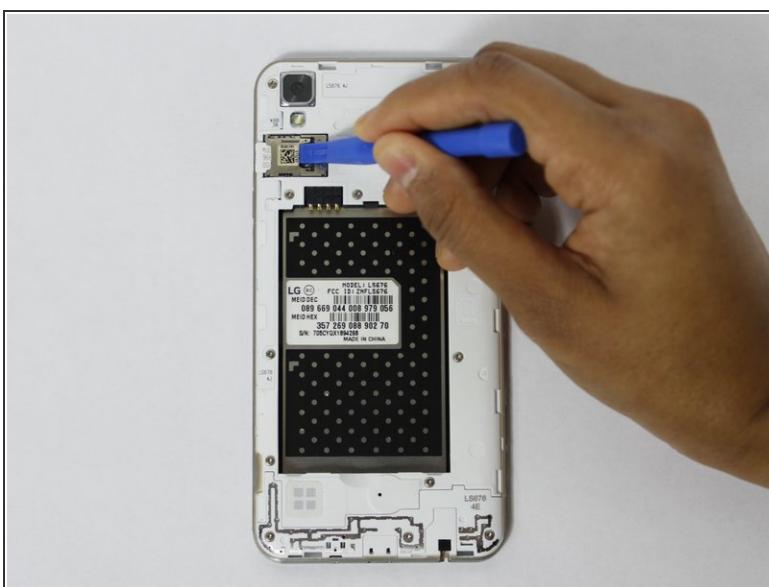
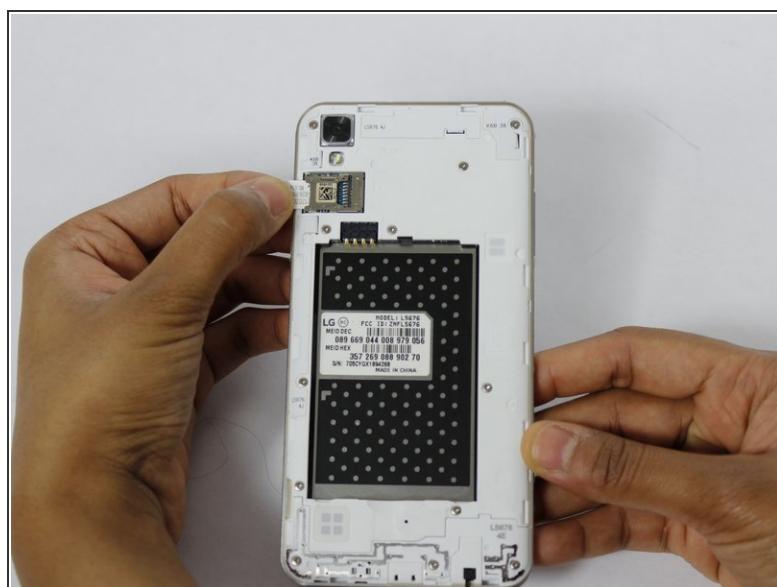
## Step 2

- Pull the battery out of the phone.
- Remove the SD Card by sliding the card out as shown.

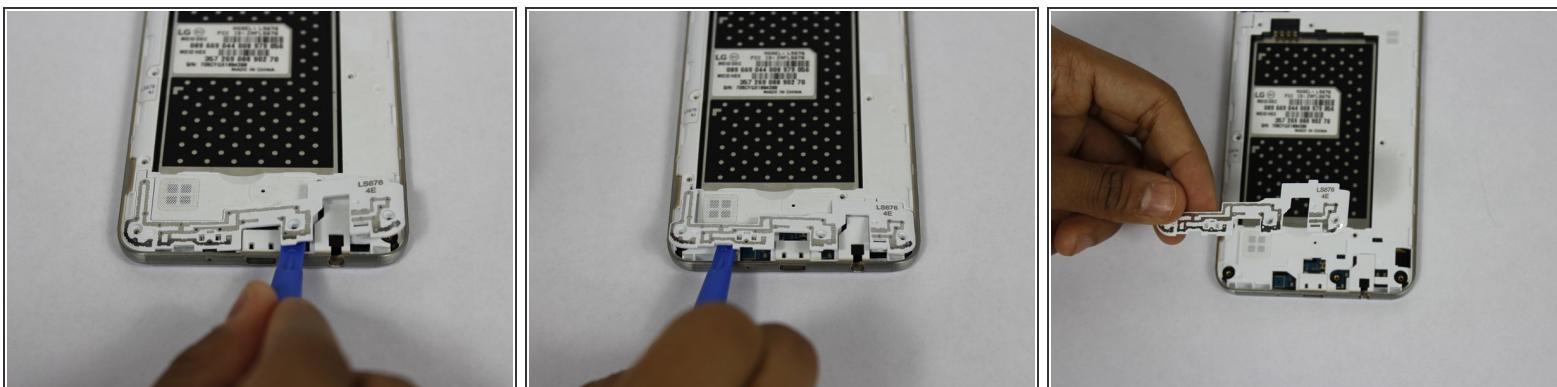
## Step 4

- Using a plastic opening tool, remove the antenna extender from the mid-frame.

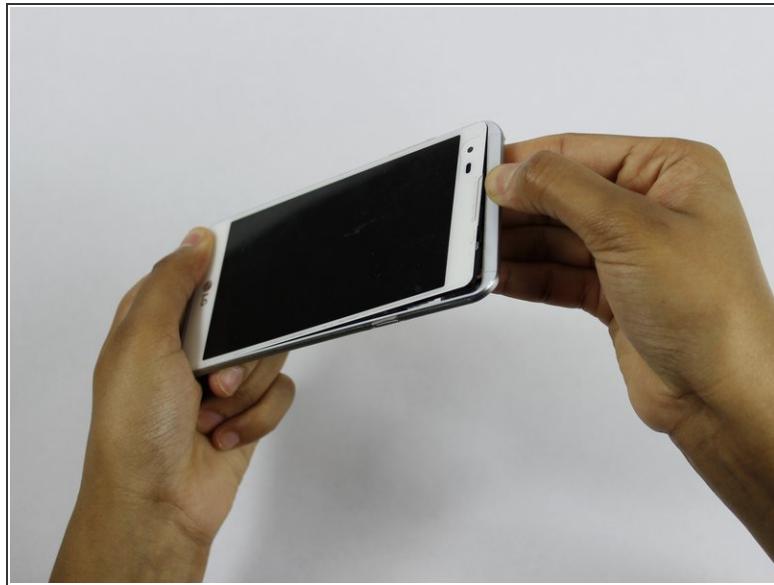
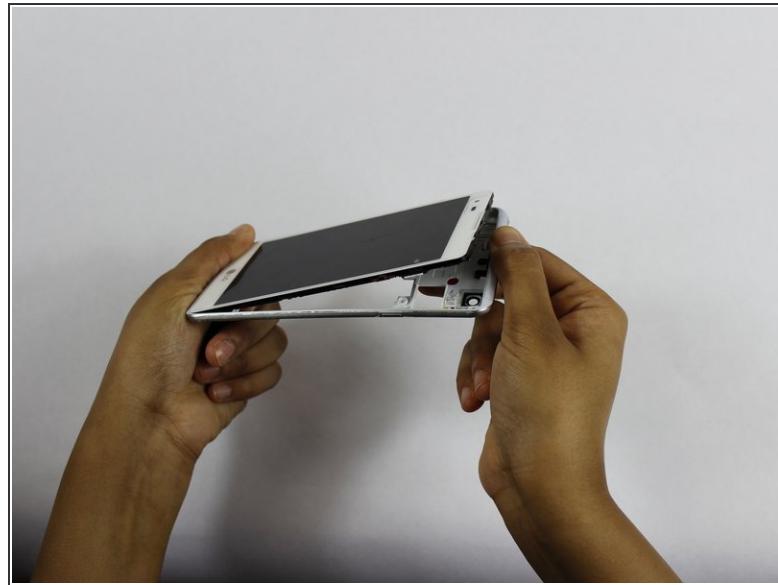
## Step 5

- Using your fingers, remove the mid-frame.
