Leader Impression i10A-LE Speakers Replacement

This repair guide is for the Leader Impression i10A-LE speaker replacement. This replacement will take 15 minutes to complete.

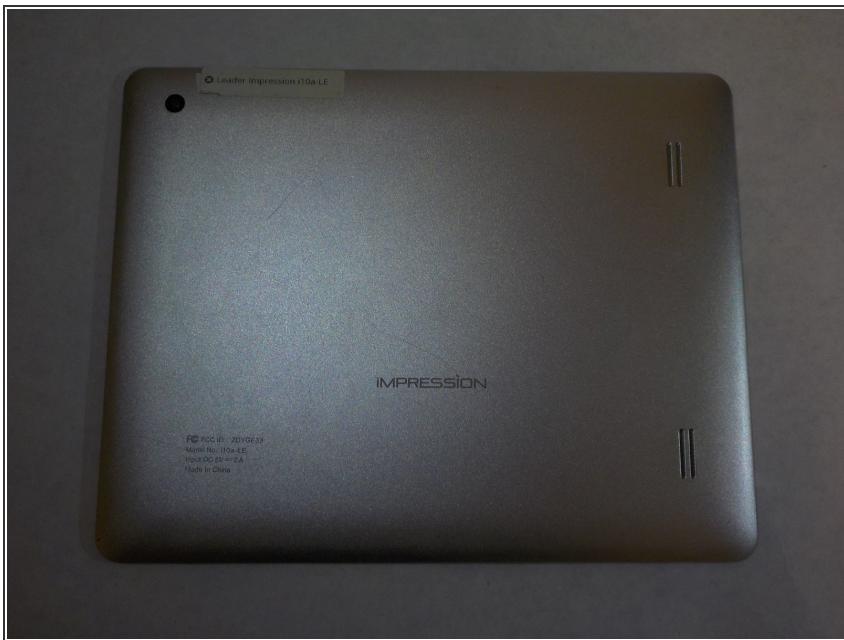
Step 1 — Speakers

- Start with your Leader Impression i10A-LE with the word "Impression" closest to you and the camera in the top left corner.

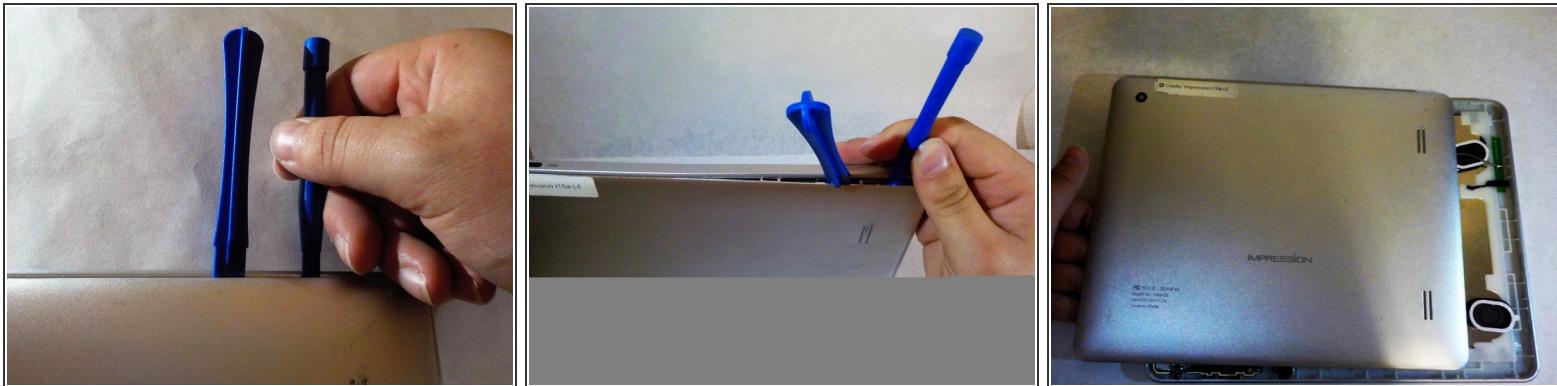
Step 2

- Start by prying the back off by using plastic opening tools
- Using the plastic tools slide the flat end into the device.
- Gently pry the back piece until you hear a popping noise.
- Once the back is loose, remove it from the device and set aside.

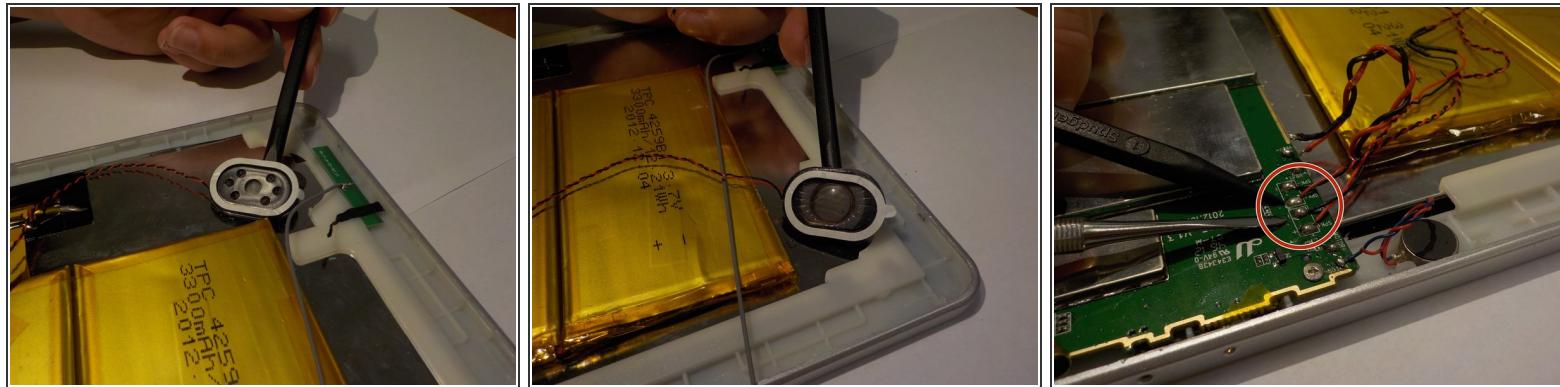
Step 3

- Use the spudger to pry both of the speakers from the tablet.
- Follow both sets of speaker wires to the motherboard where they are connected.
- Desolder the wire connections from the motherboard.
