Lenovo 100s Chromebook-11IBY Webcam Replacement

This guide will show how to remove and replace the webcam for the Lenovo 100s Chromebook-11IBY.

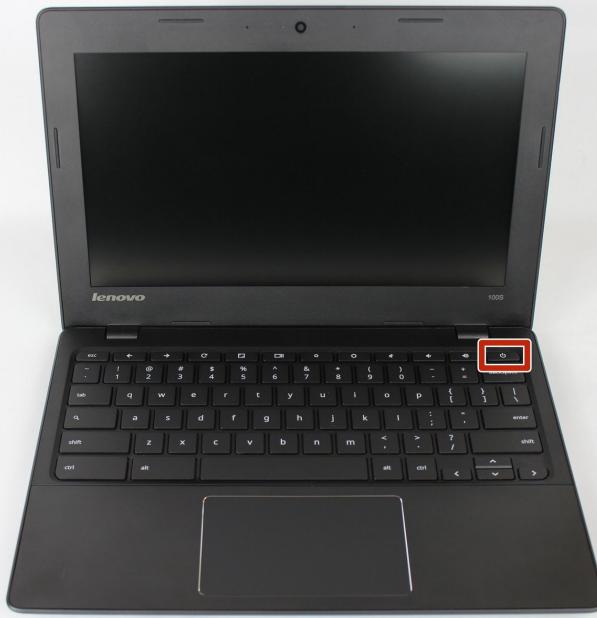
Step 1 — Webcam

- Ensure your device is turned off and unplugged.

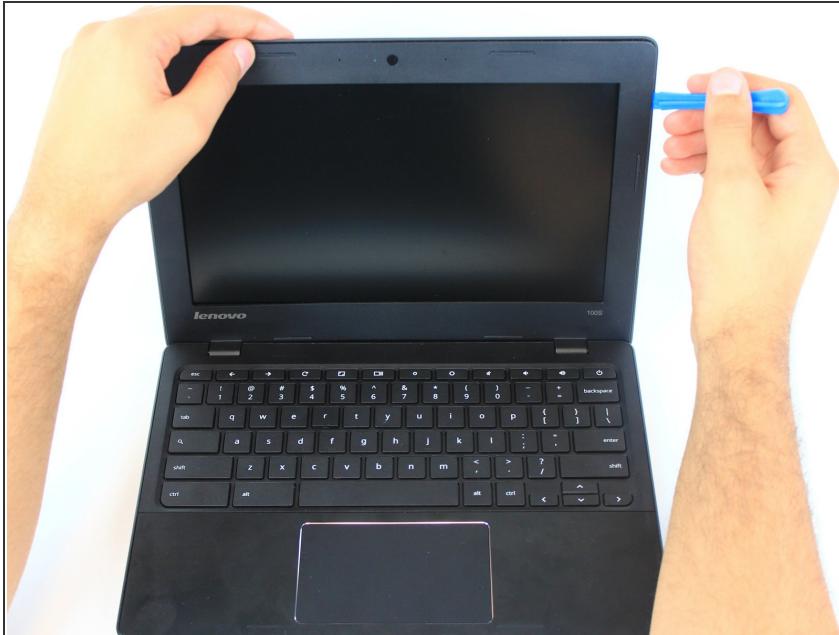
Step 2

- Use the plastic opening tool on the recessed notch to gently pry each side of around the screen up.

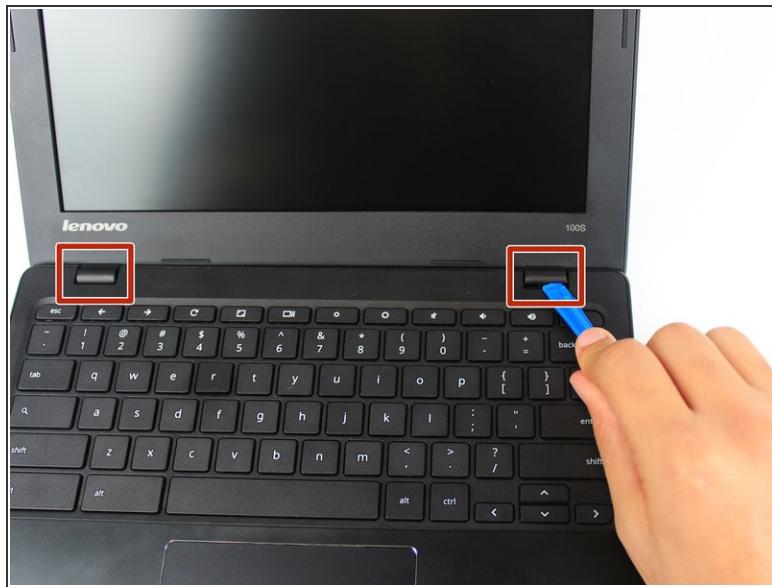
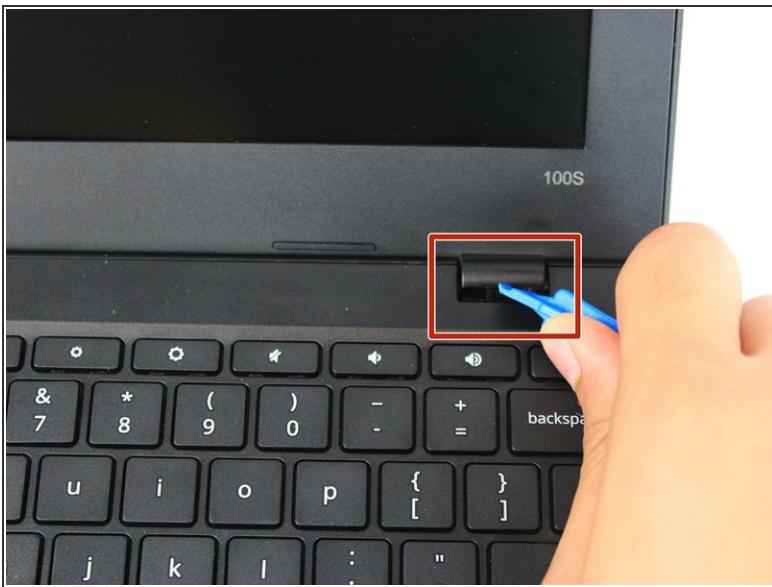
Step 3

- Carefully pry up and underneath both the (left & right) hinges of the screen cover.

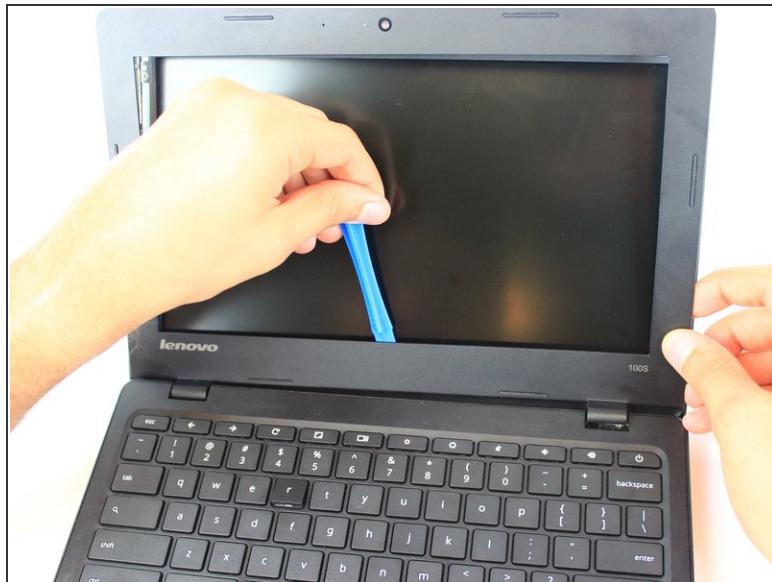
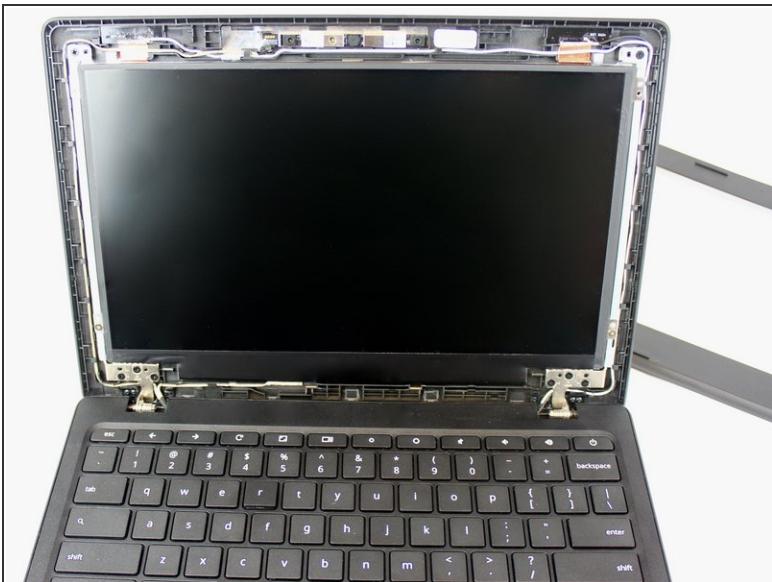
Step 4

- Use the plastic opening tool on the inside of the screen plate and again on the sides to gently remove it.

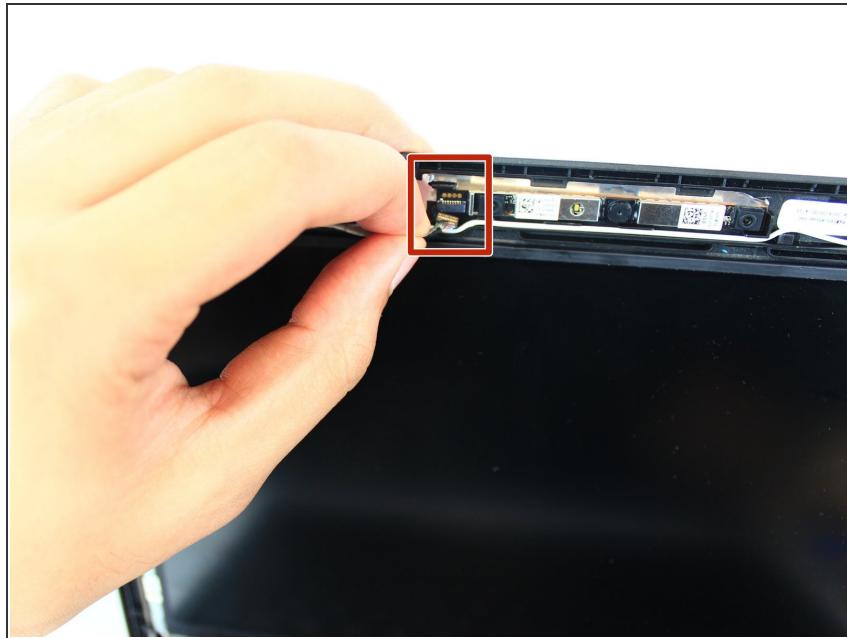
Step 5

- Gently unplug the wire connecting the webcam to the laptop.

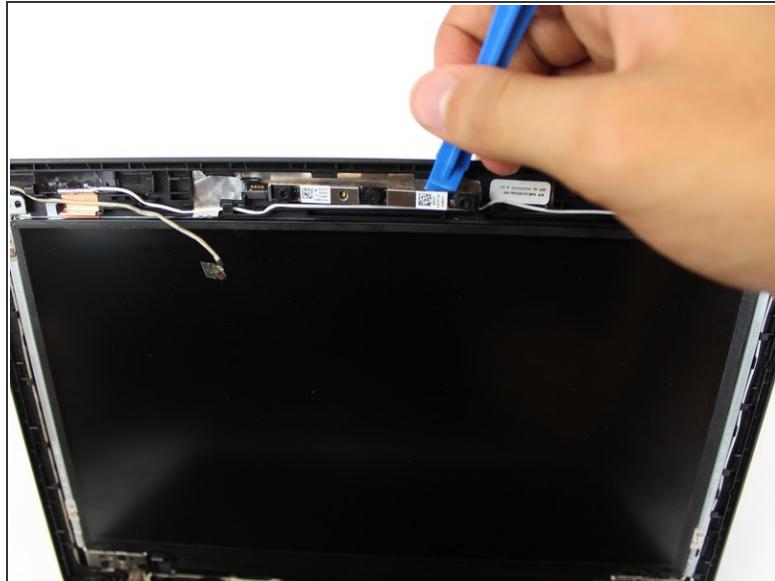
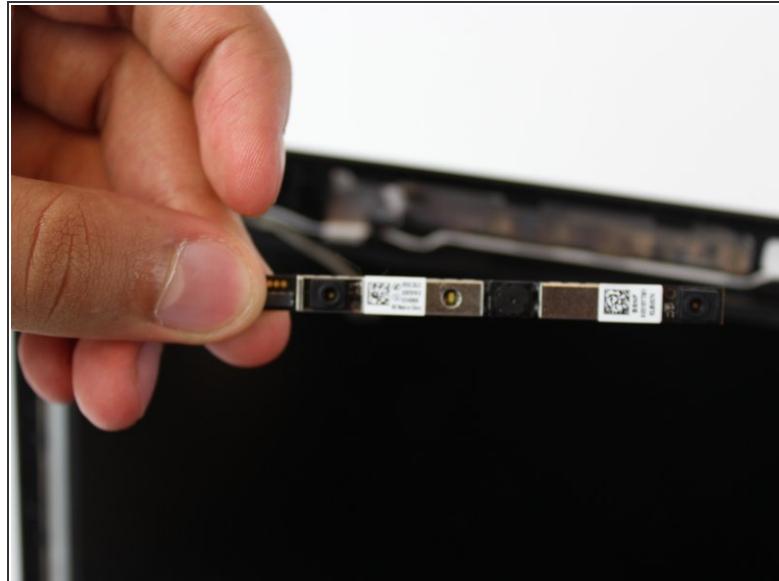
Step 6

- Using the plastic opening tool, gently lift the webcam panel from the screen. Then remove it.

To reassemble your device, follow these instructions in reverse order.
