# Lenovo IdeaPad U430 Touch Charging Port Replacement

This guide shows how to replace the Charging Port for a Lenovo IdeaPad U430 Touch. After a recall on the charging port, this became a common replacement.

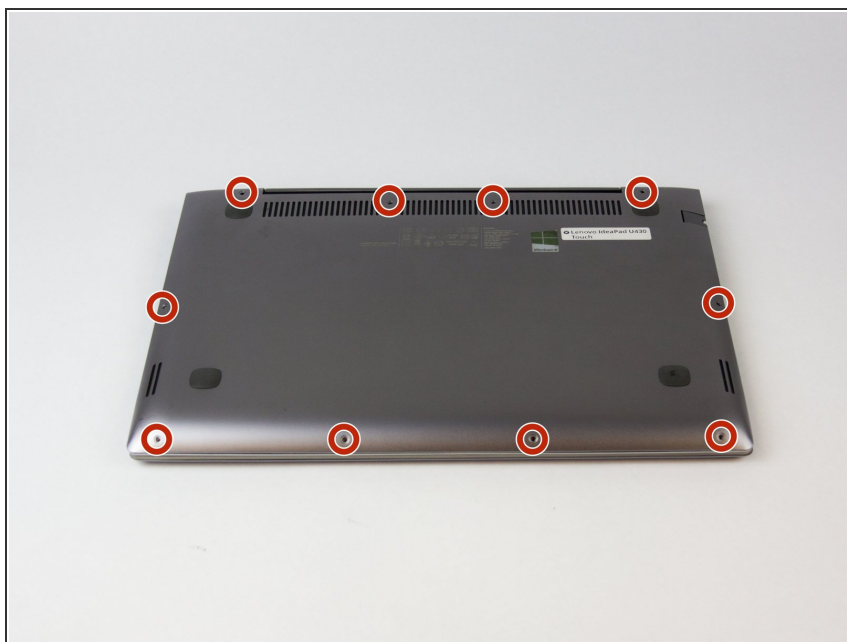
## Step 1 — Bottom Cover

- Power off your computer before you begin.
- Find and remove the 10 Phillips style body screws on the bottom of the laptop case.

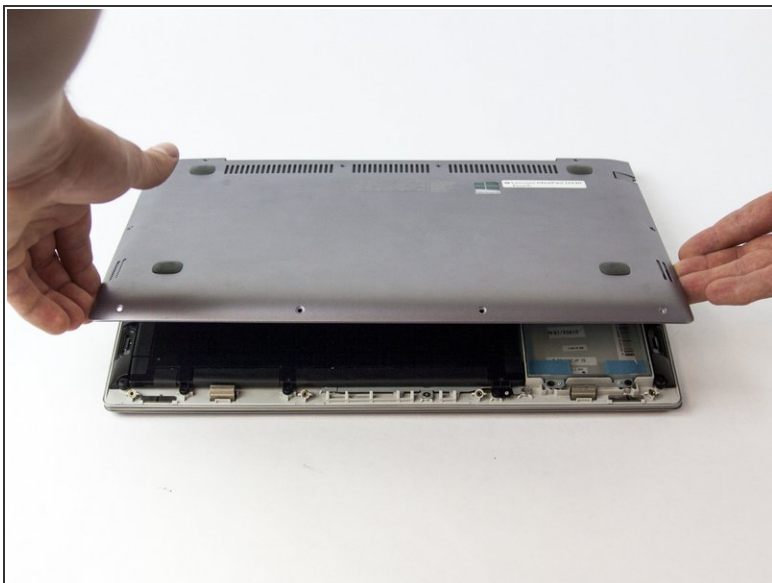
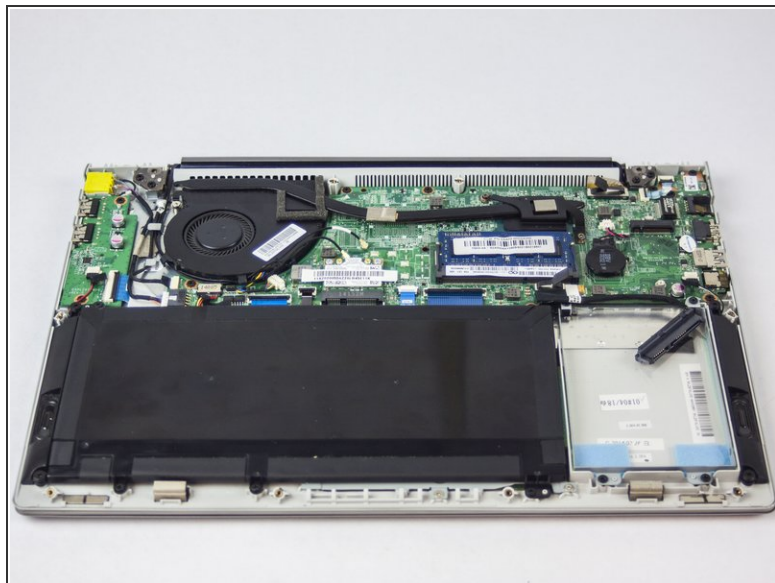
### Step 3

- Starting from the front, use a plastic opening tool to separate the bottom of the case from the body of the laptop.

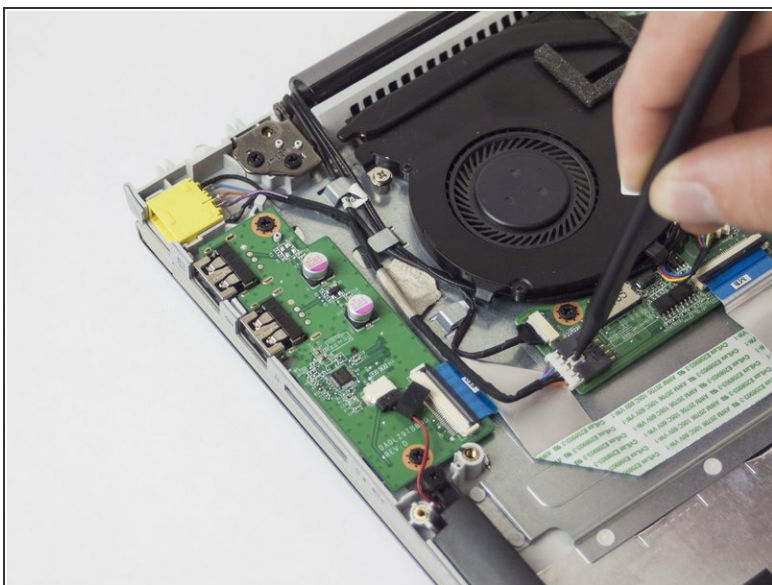
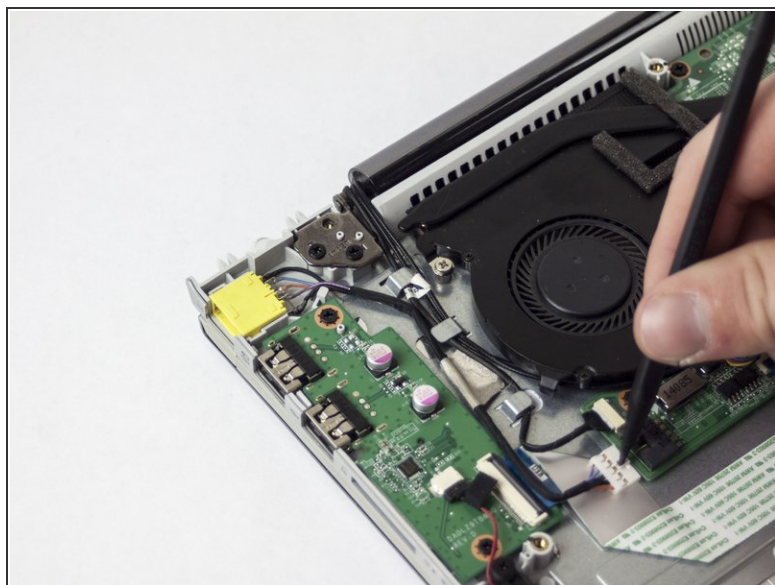
### Step 4 — Charging Port

- Disconnect charging port from motherboard.
- To do this, press the spudger on the center dimple and push the connector out.

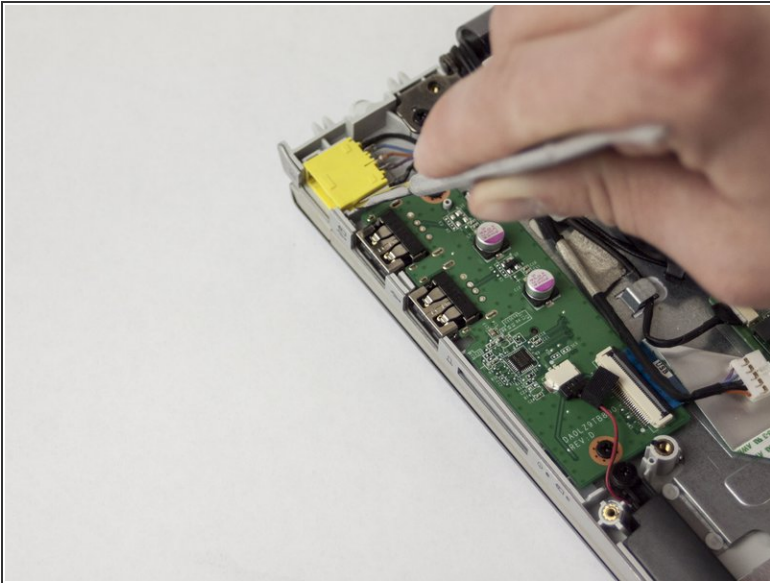
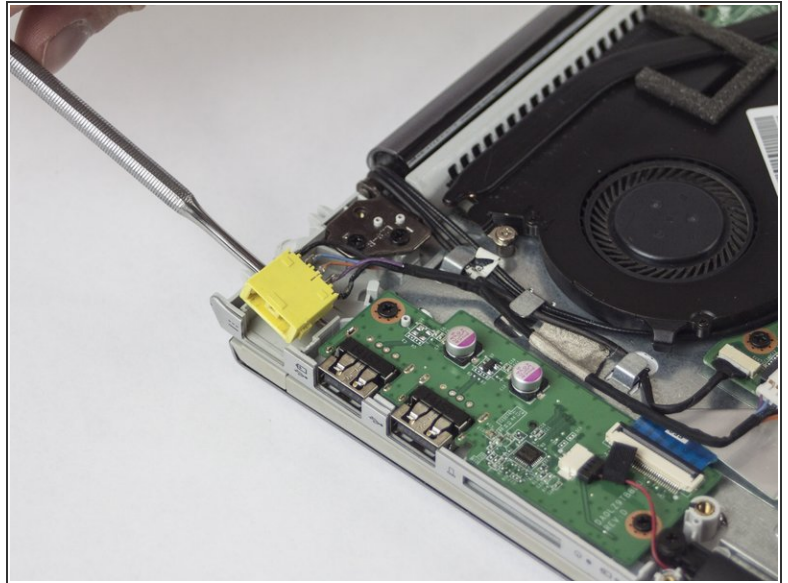
## Step 5

- Pry the charging port out of the socket with a metal spudger.
- It may be necessary to pry from each side.

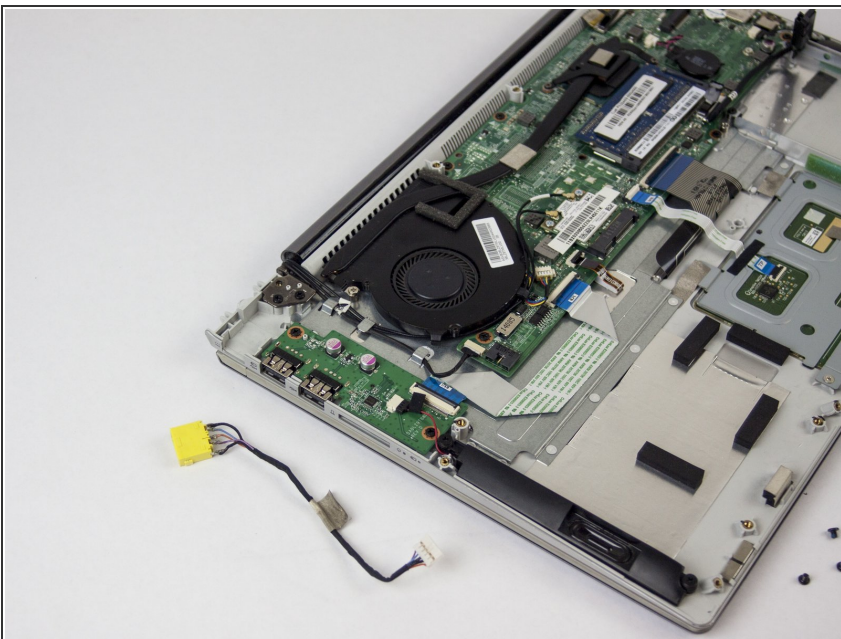
## Step 6

- Remove charging port from laptop.
