Lenovo Tab 2 A10-70 Rear Facing Camera Replacement

This guide will illustrate the remove and replace the Lenovo Tab 2 A10-70 camera.

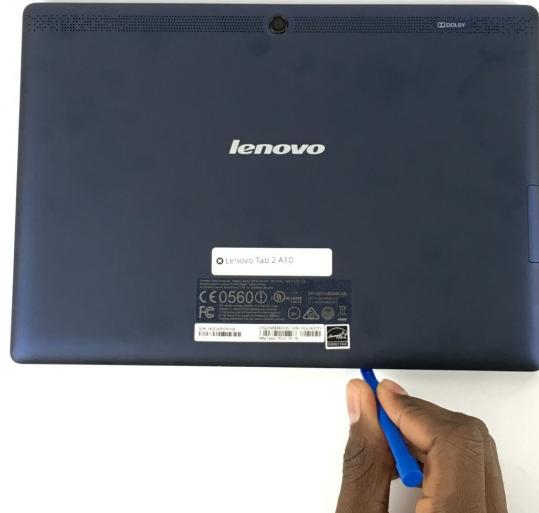
Step 1 — Rear Facing Camera

- Before removing the camera, make sure the device is powered off
- Use a plastic opening tool to pry open the back cover of the tablet..

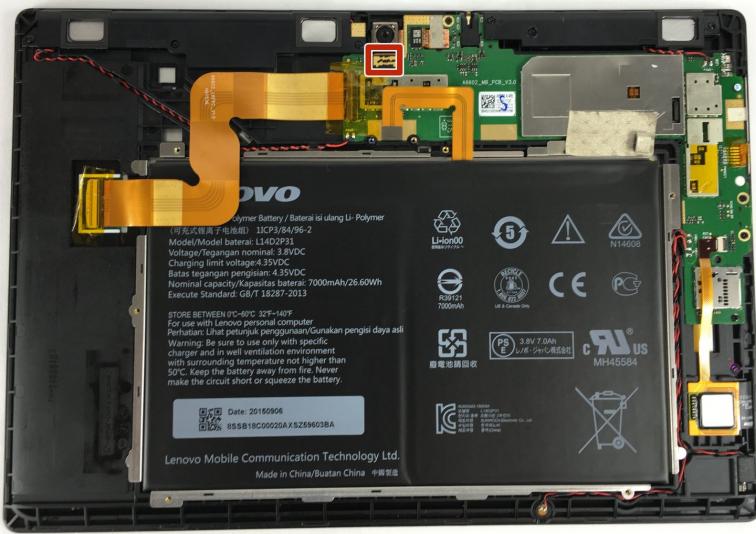
Step 2

- Locate the cable that is connecting the camera to the tablet

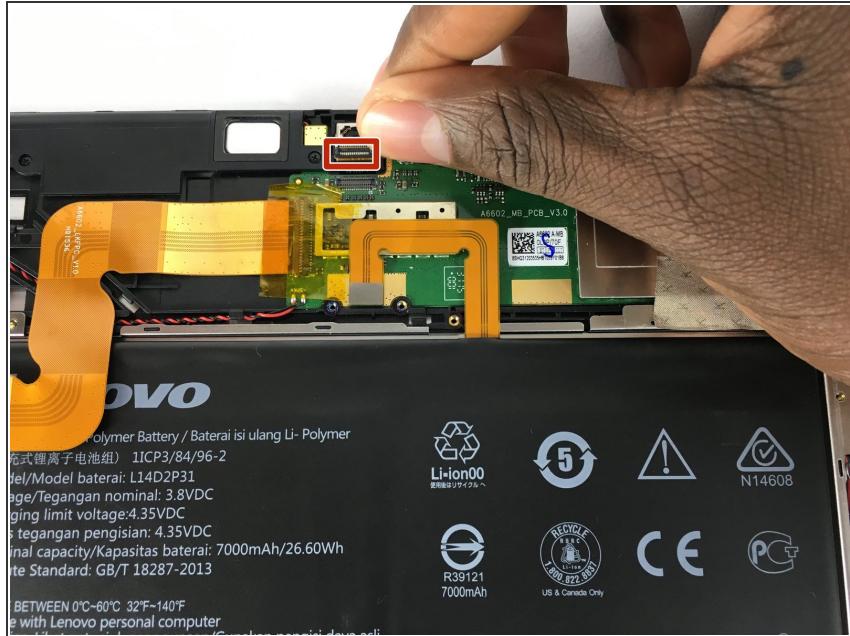
Step 3

- Disconnect the cable that is connecting the camera to the tablet

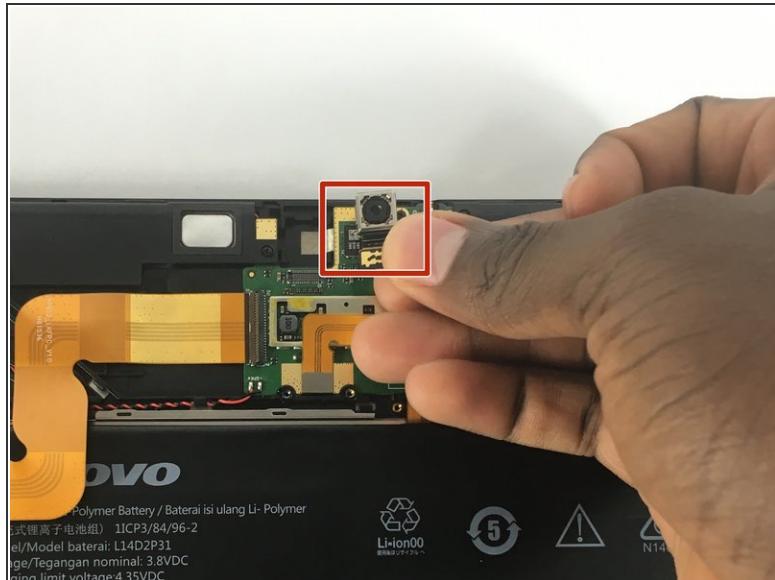
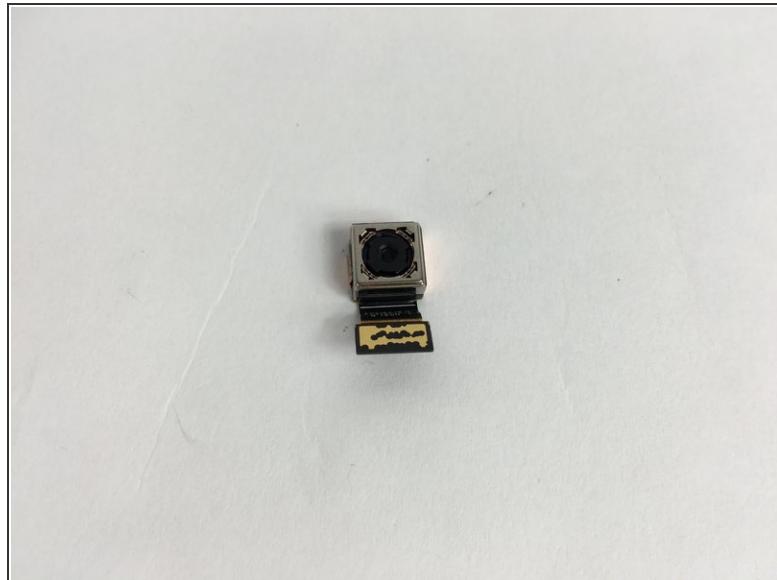
Step 4

- Simply remove the camera from the tablet by lifting it up
- Repeat Steps in reverse order with a new camera for reassembly
