Logitech K830 Repair USB connector Replacement

Written By: mathieubernou

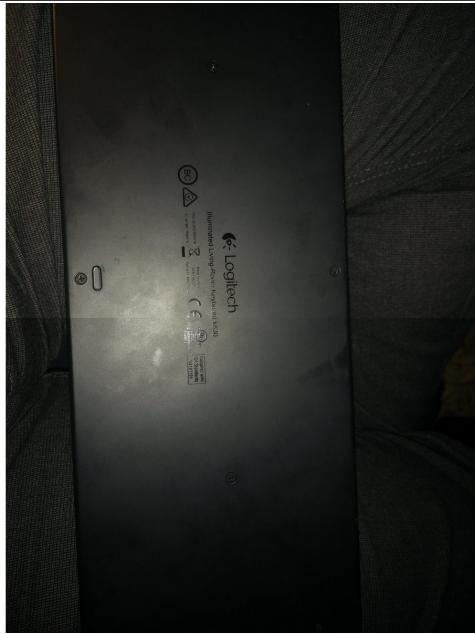
Step 1 — Repair USB connector

- Turn the keyboard over so the back is facing up.

- Repair the soldering of the micro USB connector
