Logitech Webcam Pro 9000 USB Connection Replacement

Written By: Cory Davis

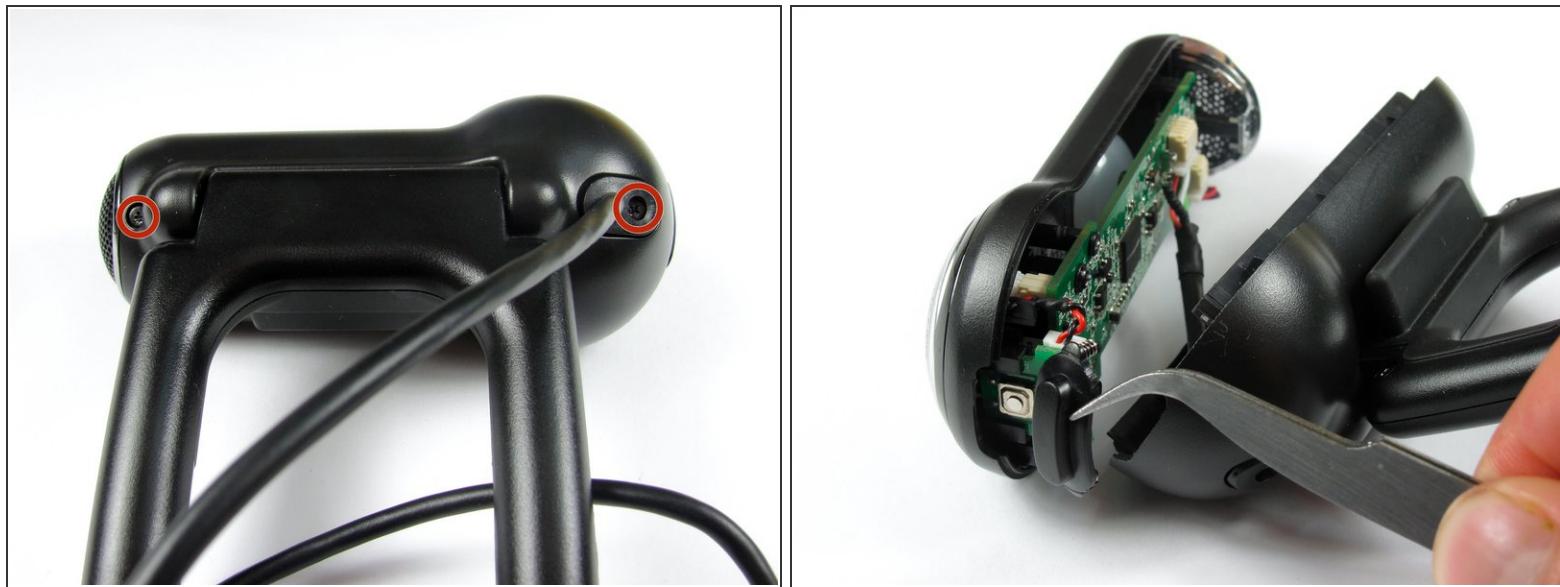
Step 1 — Front and Back Cover

- Remove the two 8 mm Phillips #0 screws on the back cover.

⚠ The motherboard is attaching the two covers together, so don't separate them entirely just yet.

i There is a button that loosens as the Phillips screws are removed. Don't be alarmed if it falls out.

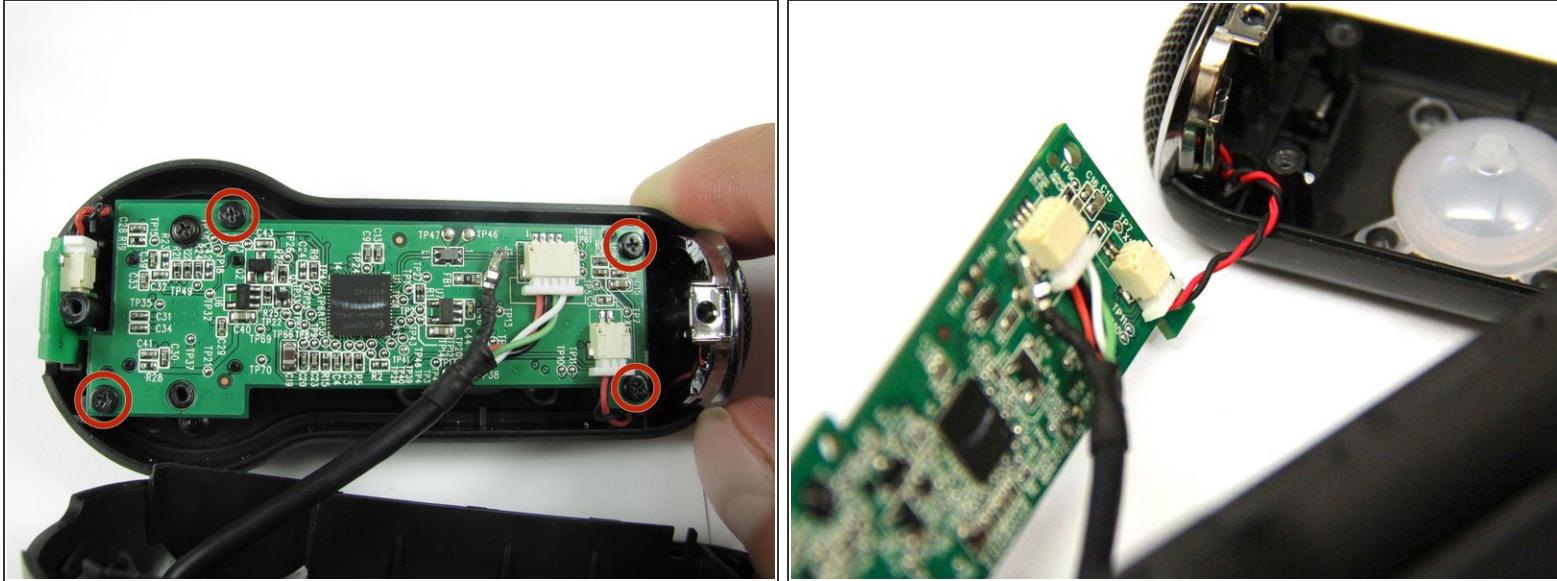
Step 2

- Remove the four 6mm Phillips#0 screws connecting the motherboard and front cover.

⚠ DO NOT detach the wire connecting the motherboard to the front cover.

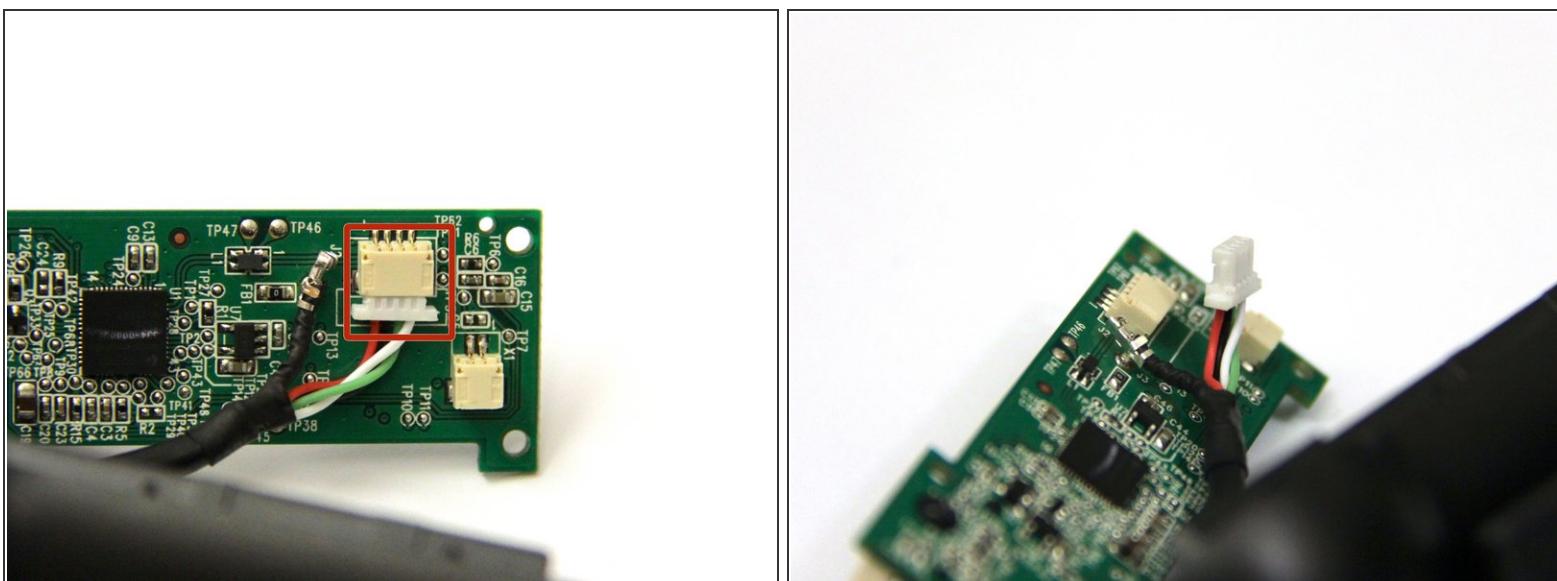
Step 3 — USB Connection

- Grasp the white wire connector on the back of the motherboard to remove the USB cable.
- Wiggle the connector back and forth to remove it from the socket.

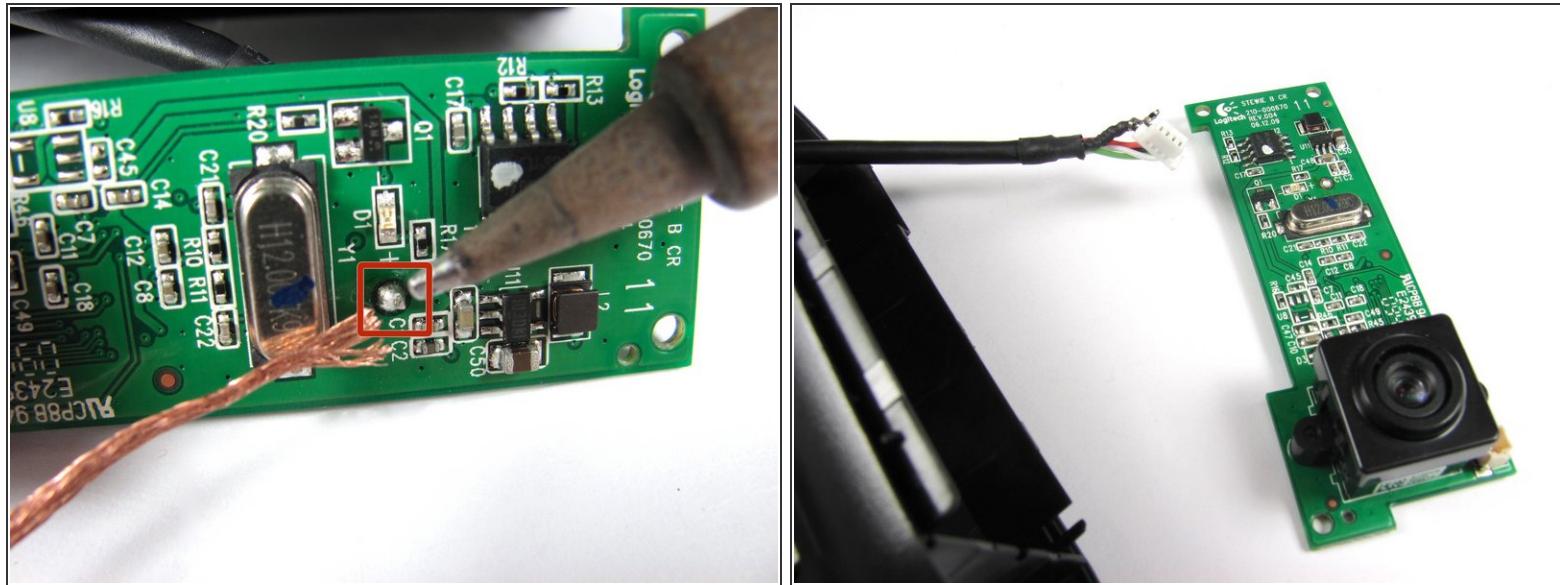
Step 4

- Desolder the joint on the front of the motherboard to completely detach the USB cable.
- ⓘ Follow this [link](#) to learn how to properly solder and desolder your parts.
