# Logitech WiLife and LukWerks Outdoor Security Camera Capacitor replacement

The most common cause of failure for this camera is four faulty capacitors. Replacing the damaged capacitors can restore proper function.

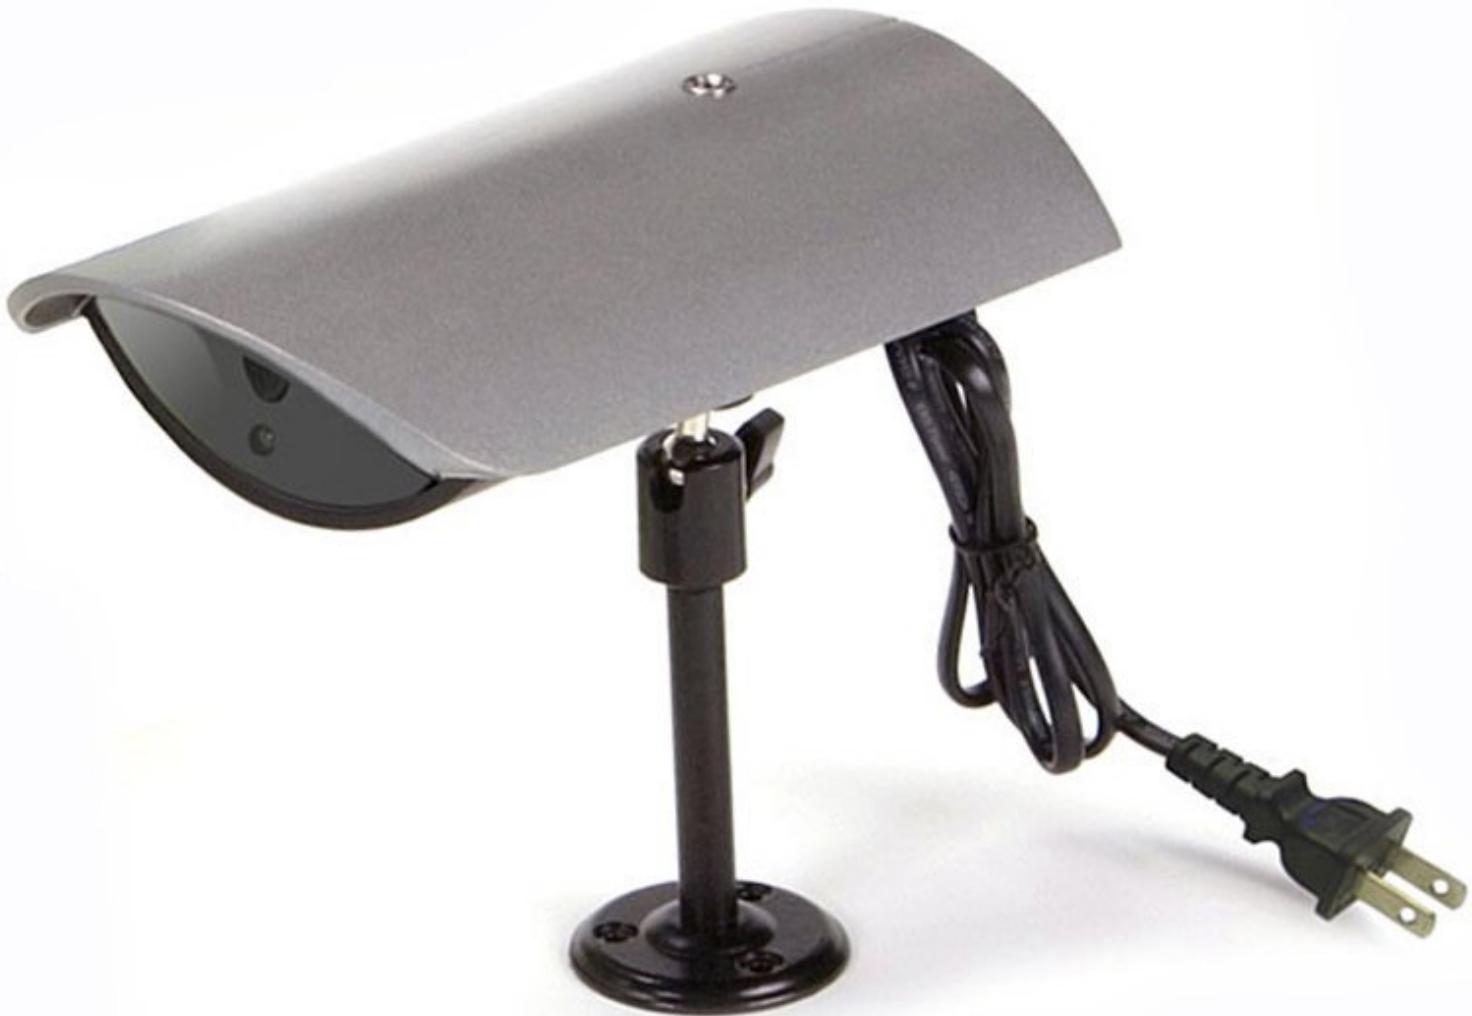
The WiLife Outdoor Camera has a high failure rate, often malfunctioning after the warranty expires. Four faulty capacitors are the most common cause of failure.

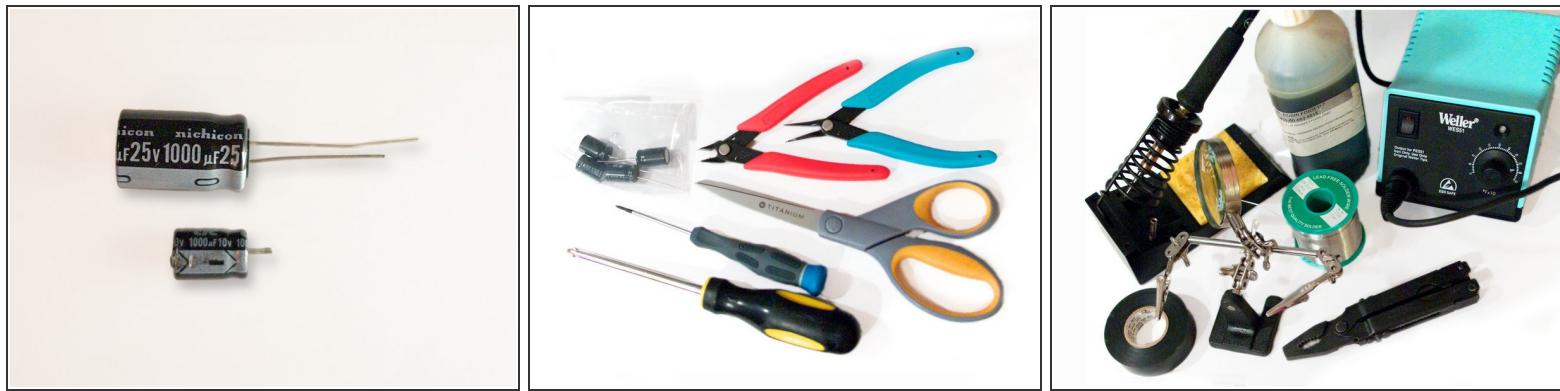
## Step 1 — Capacitors

- Obtain (4) 1000uF capacitors rated for 25 volts. The replacement capacitors featured in this guide were purchased from Digi-key. Digi-key part number: UHE1E102MHD6.  
[http://search.digikey.com/scripts/DkSearch...](http://search.digikey.com/scripts/DkSearch)
- Additional suggested tools for this repair are pictured.

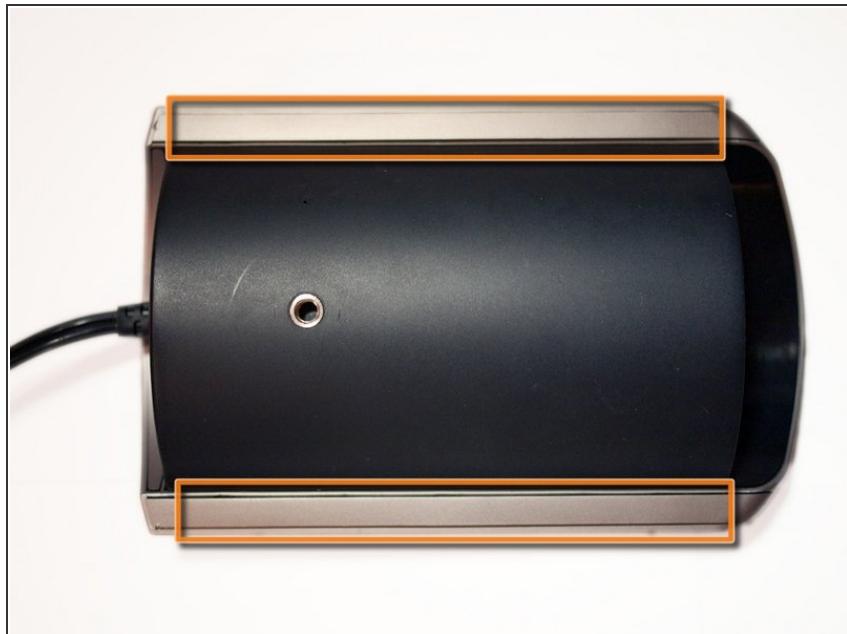
## Step 2

- ***Caution: Be mindful of the dangerous high voltage that exist in this device when powered and for a short time afterward.***
- Place the camera upside down.
- Using a small flat tool, pry off the plastic covers on each side of the case (outlined in orange)

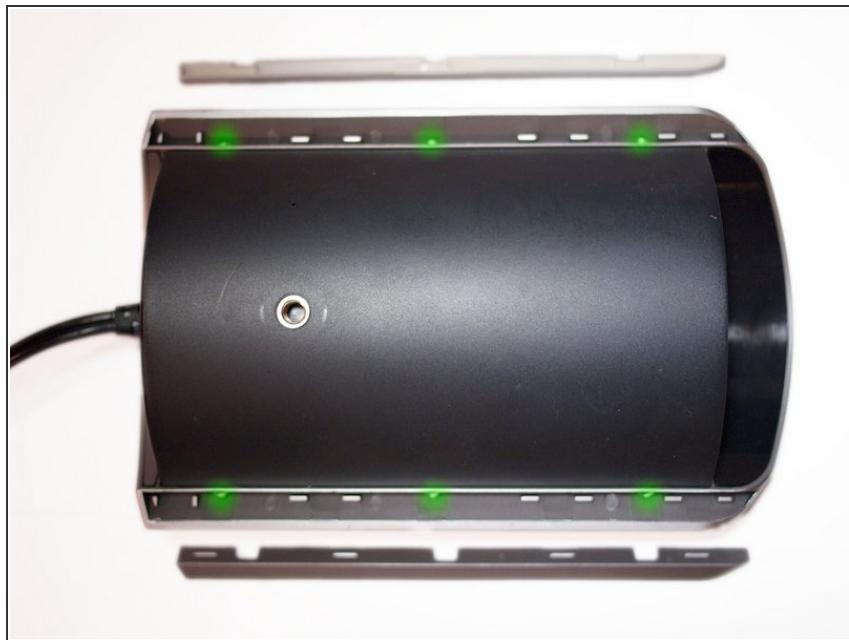
## Step 3

- Removal of the covers reveal six philips head screws (green highlight).
- Unscrew all six screws.

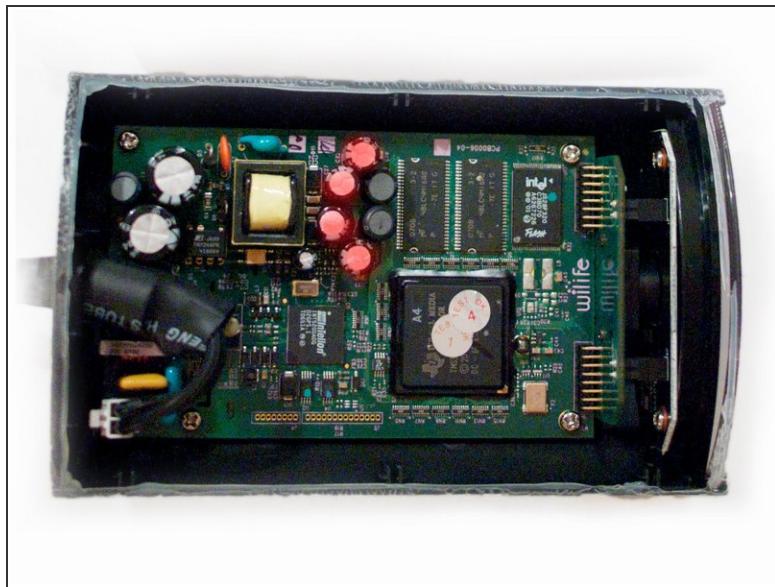
## Step 4

- Flip the camera so the top is right-side up.
- Remove the top of the case.
- Notice the four damaged capacitors C26, C27, C31 and C32 (red highlight).

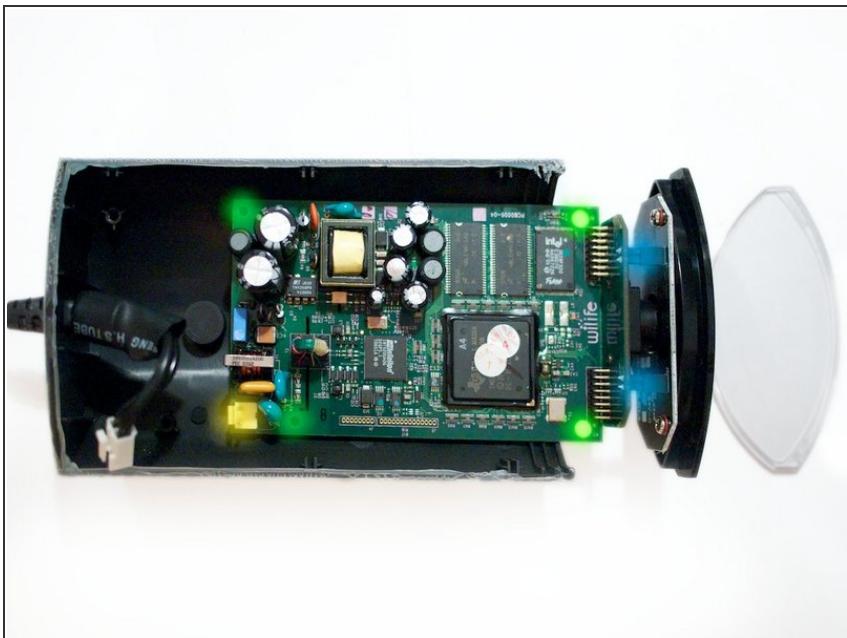
## Step 5

- Unscrew all four phillips head screws in each corner (green highlight).
- Disconnect power cable (yellow highlight).
- Lift and remove the clear front plastic lens cover.
- Lift the circuit board and camera assembly out of the case.
- Carefully separate the LED assembly from the four small connectors (highlighted in blue).  
Note: This step is not required for this repair. However, it reduces the possibility of inadvertent damage during the process.
