# MacBook Pro 15" Retina Display Early 2013 I/O Board Cable Replacement

Replace the I/O board cable in a MacBook Pro 15" Retina Display Early 2013.

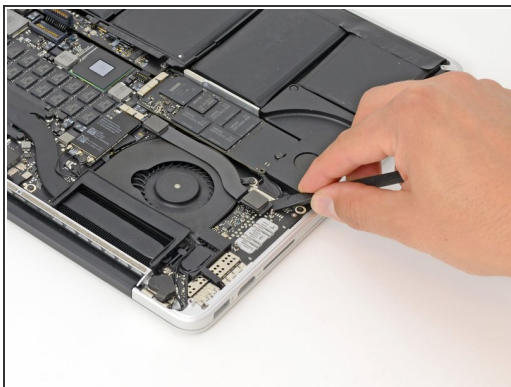
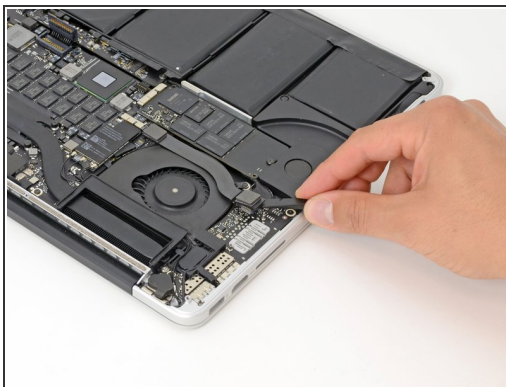
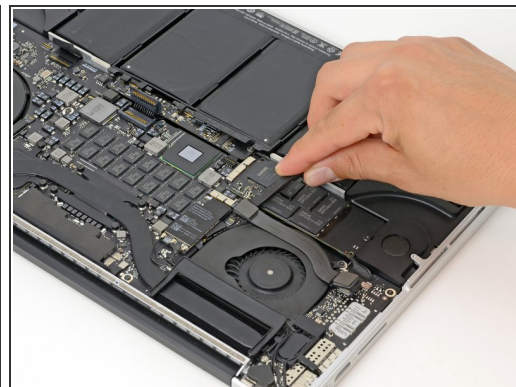
## Step 5 — I/O Board Cable

- Using the flat end of a spudger, pry the I/O board cable straight up out of its socket on the I/O board.
- In a similar fashion, remove the I/O board cable from its socket on the I/O board.
