# MacBook Pro 15" Retina Display Late 2013 I/O Board Cable Replacement

Replace the I/O board cable in a MacBook Pro 15" Retina Display Late 2013.

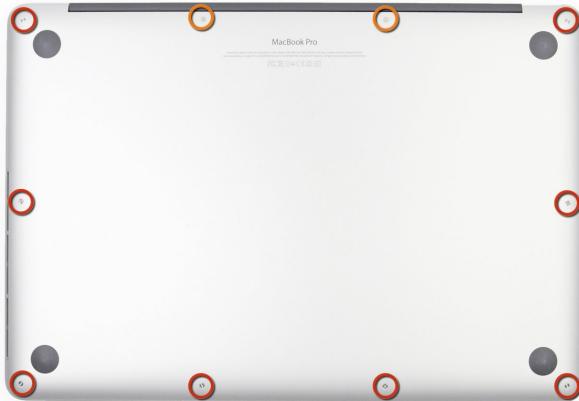
## Step 1 — Lower Case

- Remove the following P5 pentalobe screws securing the lower case to the MacBook Pro:
  - Eight 3.0 mm
  - Two 2.3 mm

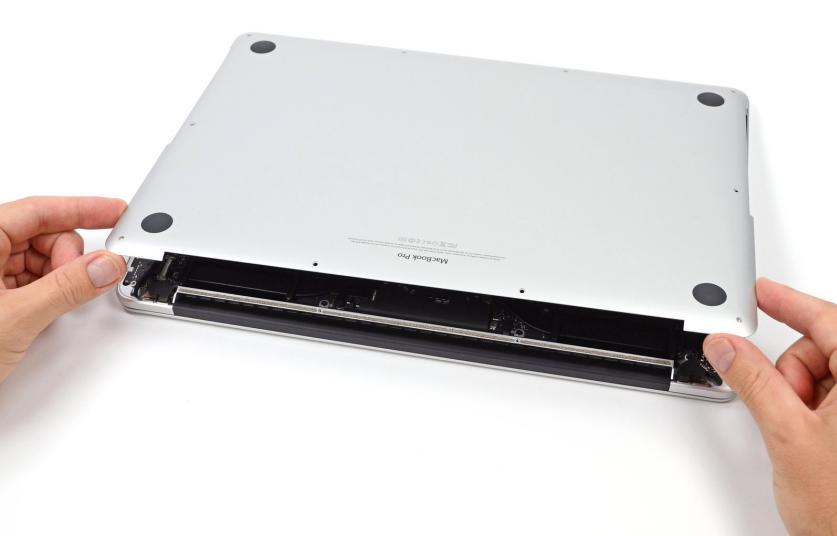
## Step 2

- Lifting from the edge nearest the clutch cover, lift the lower case off the MacBook Pro.
- Set the lower case aside.

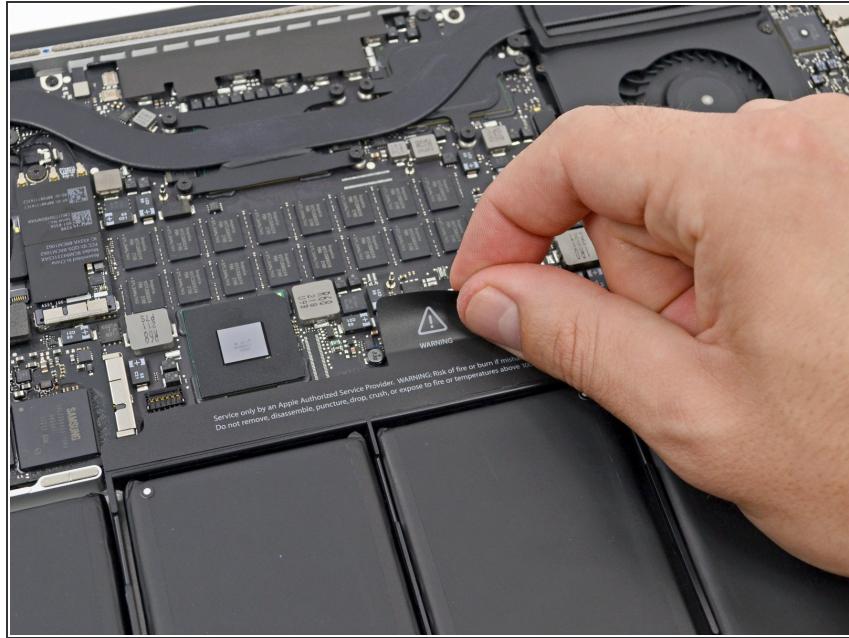
## Step 3 — Battery Connector

- Peel back the warning label covering the battery connector.

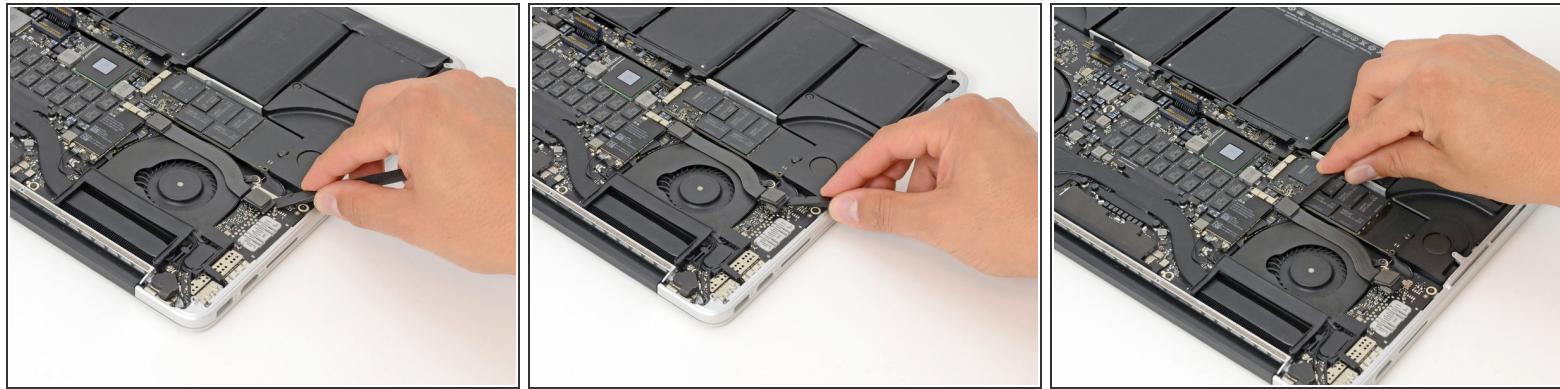
## Step 5 — I/O Board Cable

- Using the flat end of a spudger, pry the I/O board cable straight up out of its socket on the I/O board.
- In a similar fashion, remove the I/O board cable from its socket on the I/O board.
