# MacBook Pro 15" Retina Display Mid 2014 IO Board Cable Replacement

Replace the I/O board cable in a MacBook Pro 15" Retina Display Mid 2014.

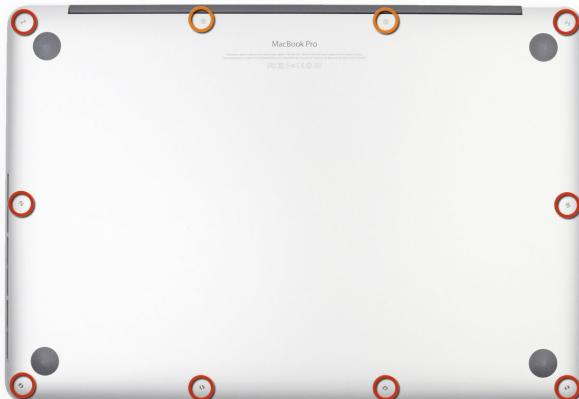
## Step 1 — Lower Case

- Remove the following P5 pentalobe screws securing the lower case to the MacBook Pro:
  - Eight 3.0 mm
  - Two 2.3 mm

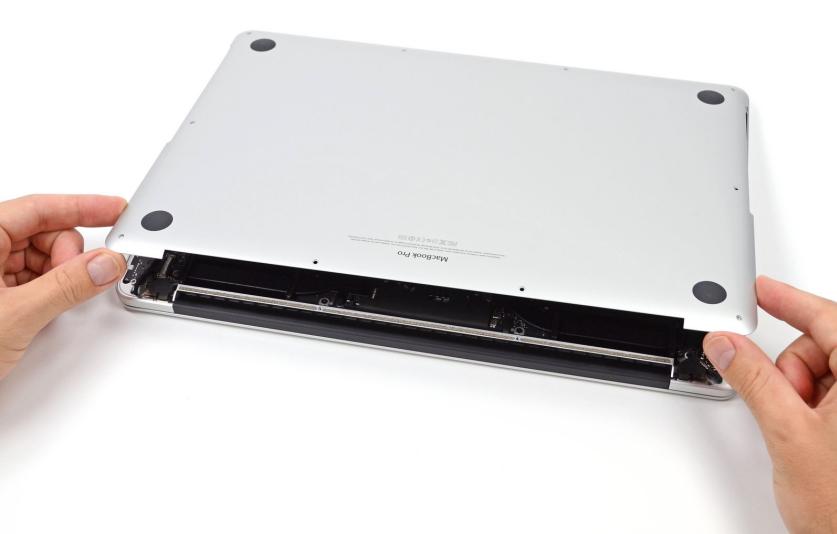
## Step 2

- Lifting from the edge nearest the clutch cover, lift the lower case off the MacBook Pro.
- Set the lower case aside.

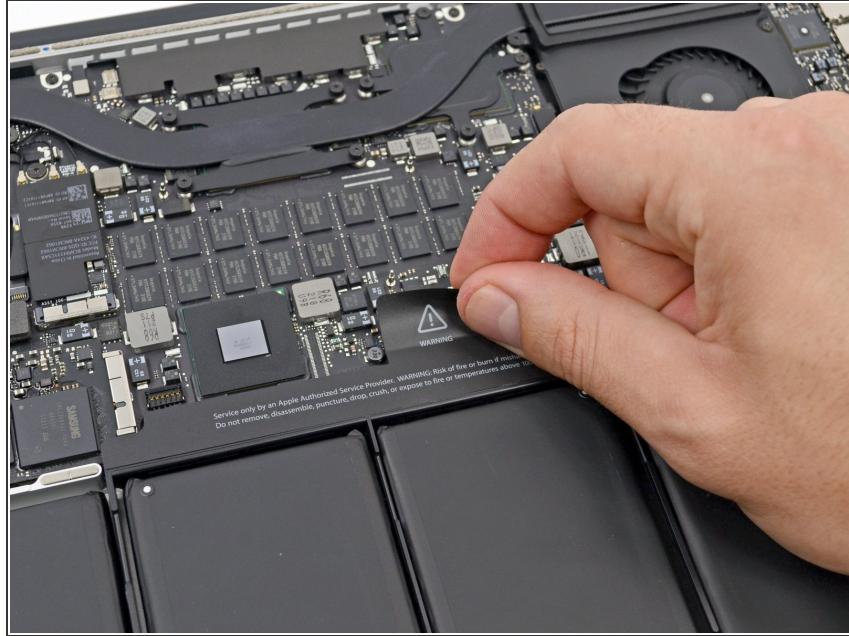
## Step 3 — Battery Connector

- Peel back the warning label covering the battery connector.

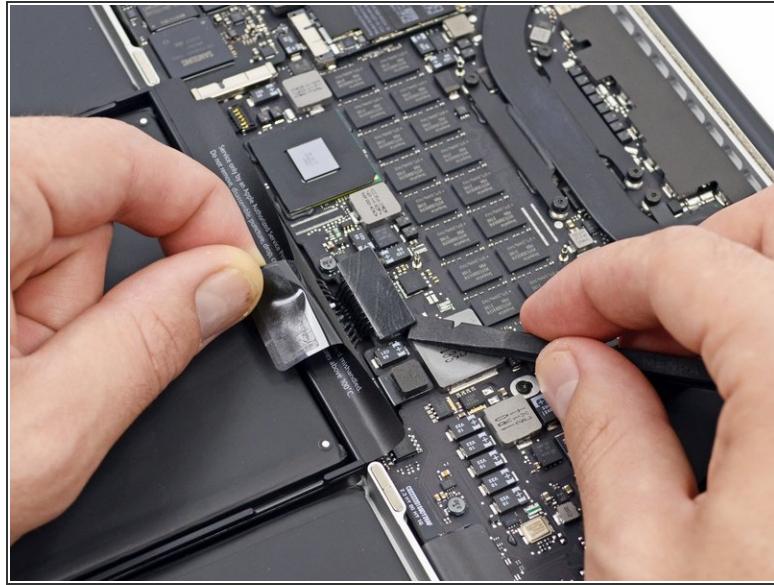
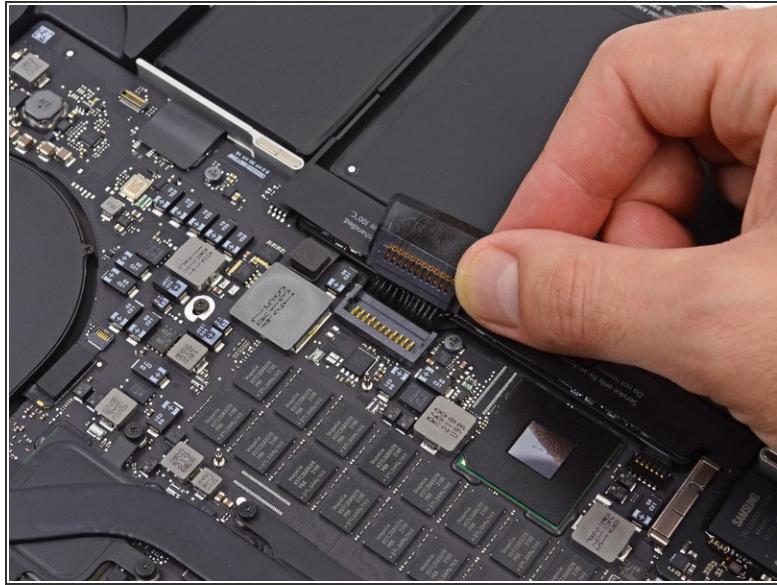
## Step 4

- Using the flat end of a spudger, gently pry the battery connector straight up out of its socket on the logic board.
- Bend the battery cables back and out of the way, ensuring that the battery connector doesn't accidentally make contact with the logic board.

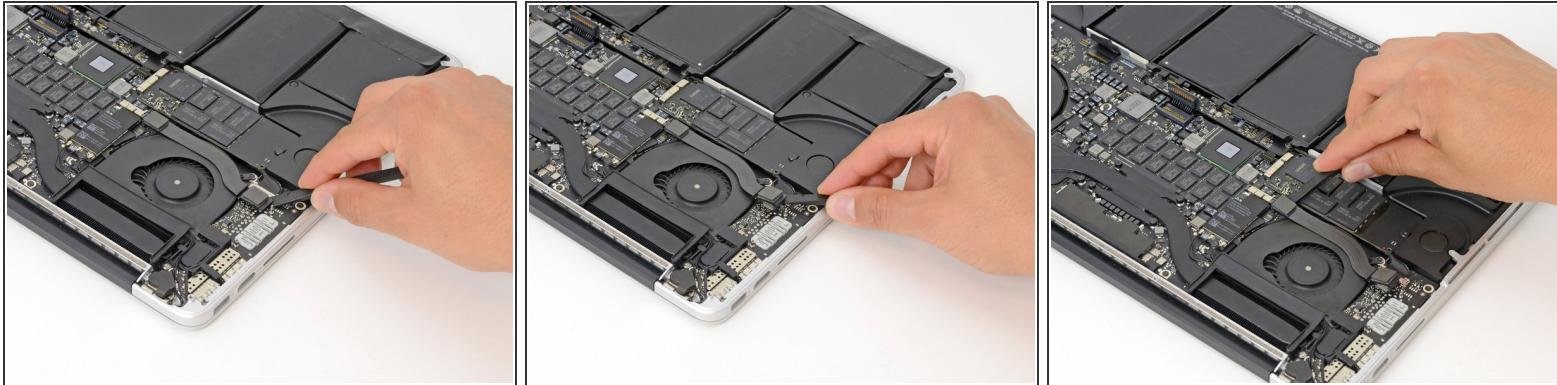
## Step 5 — I/O Board Cable

- Using the flat end of a spudger, pry the I/O board cable straight up out of its socket on the I/O board.
- In a similar fashion, remove the I/O board cable from its socket on the I/O board.

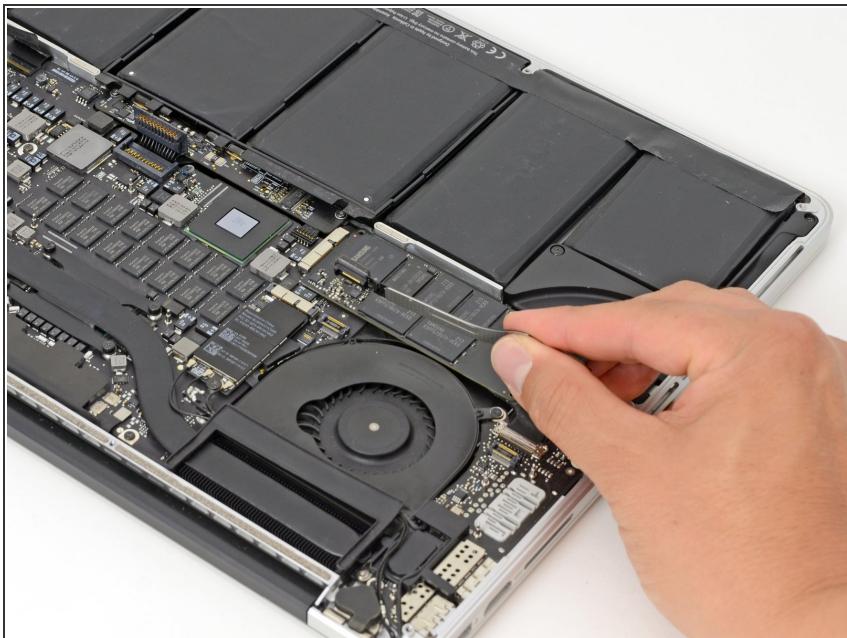
## Step 6

- Remove the I/O board cable from the MacBook Pro.
